Manhole Inspection Report

Date:	04/24/2018	Weather:		Coding:	RZMACP
MH#:	M-506-009	Owner:	NA	Len. Surveyed:	7.0
P.O.#:		Surveyor:	John Kuglmaier	Rim to Invert:	6.8
Customer:		Cert. #:	U-1215-07002349	Wall Material:	Concrete (reinforced)

Street:	Cardinal Ct. 435' South of 8th St.	Project:	Hobart, IN
City:	Hobart, IN	GPS Northing:	2900348.302
Location:		GPS Easting:	2900348.302
Drain Area:	Southwest	GPS Accuracy:	Sub-Meter
Cover Shape:	Circular	Evidence of Surcharge:	No
Cover Size:	22.5	Potential for Runoff:	None
Comments:

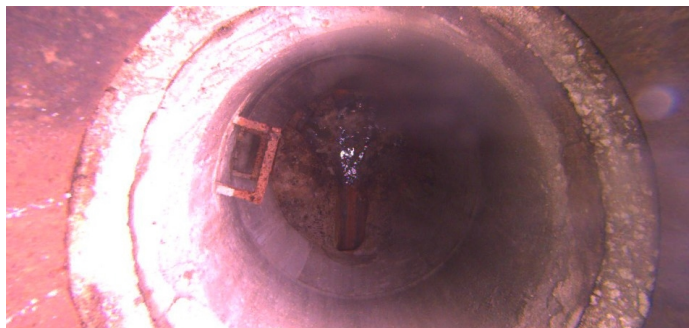
Code: **MGP**
Description: **General Photo**

Distance (ft): **.0**
Structural Grade: **0**
O&M Grade: **0**
Clock Start/From:
Clock To:
1st Value:
2nd Value:
Value Percent:
Step: **NO**
Remarks:

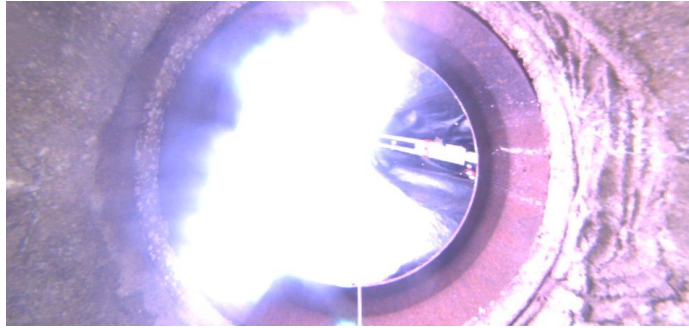
Code: **MGP**
Description: **General Photo**

Distance (ft): **2.7**
Structural Grade: **0**
O&M Grade: **0**
Clock Start/From:
Clock To:
1st Value:
2nd Value:
Value Percent:
Step: **NO**
Remarks:

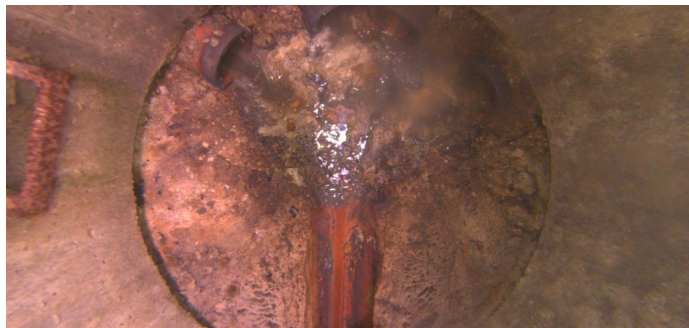
Code: **DAZ**
Description: **Deposits Attached Other**

Distance (ft): **4.3**
Structural Grade: **0**
O&M Grade: **2**
Clock Start/From: **12**
Clock To: **12**
1st Value:
2nd Value:
Value Percent: **5.000**
Step: **NO**
Remarks: **Mixed materials**

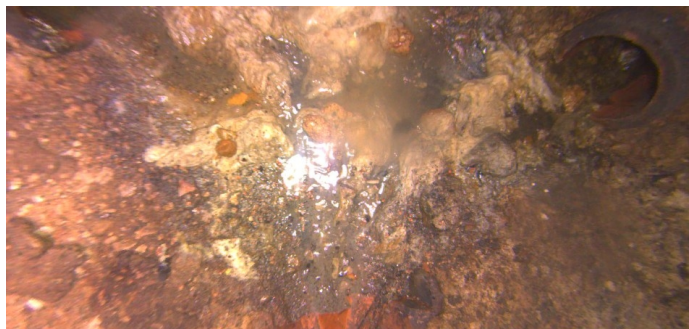
Code: **MGO**
Description: **General Observation**

Distance (ft): **6.0**
Structural Grade: **0**
O&M Grade: **0**
Clock Start/From:
Clock To:
1st Value:
2nd Value:
Value Percent:
Step: **NO**
Remarks: **Ins. Comp.**
