# Manhole Inspection Report

Date:	<b>04/24/2018</b>	Weather:		Coding:	<b>RZMACP</b>
MH#:	<b>M-506-011</b>	Owner:	<b>NA</b>	Len. Surveyed:	<b>6.7</b>
P.O.#:		Surveyor:	<b>John Kuglmaier</b>	Rim to Invert:	<b>6.6</b>
Customer:		Cert. #:	<b>U-1215-07002349</b>	Wall Material:	<b>Concrete (reinforced)</b>

Street:	<b>Intersection of Colorado St. and 7th</b>	Project:	<b>Hobart, IN</b>
City:	<b>Hobart, IN</b>	GPS Northing:	<b>2900547.695</b>
Location:		GPS Easting:	<b>2900547.695</b>
Drain Area:	<b>Southwest</b>	GPS Accuracy:	<b>Sub-Meter</b>
Cover Shape:	<b>Circular</b>	Evidence of Surcharge:	<b>No</b>
Cover Size:	<b>22.5</b>	Potential for Runoff:	<b>None</b>
Comments:

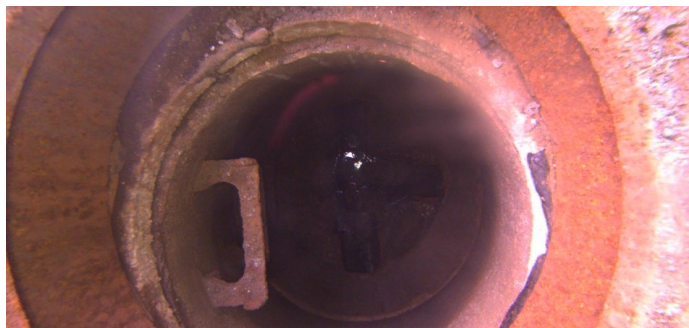
Code: **MGP**  
Description: **General Photo**

Distance (ft): **.0**  
Structural Grade: **0**  
O&M Grade: **0**  
Clock Start/From:  
Clock To:  
1st Value:  
2nd Value:  
Value Percent:  
Step: **NO**  
Remarks:

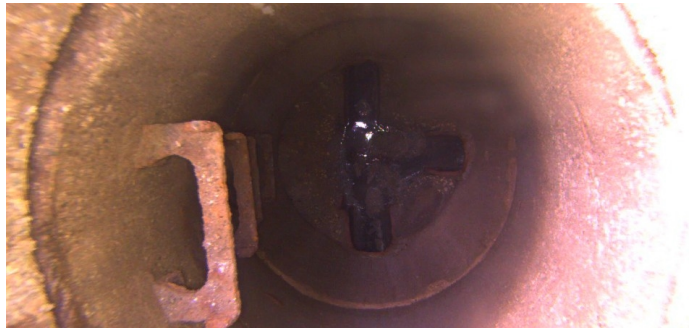
Code: **IS**  
Description: **Infil Stain**

Distance (ft): **.7**  
Structural Grade: **0**  
O&M Grade: **0**  
Clock Start/From: **12**  
Clock To: **12**  
1st Value:  
2nd Value:  
Value Percent:  
Step: **NO**  
Remarks:

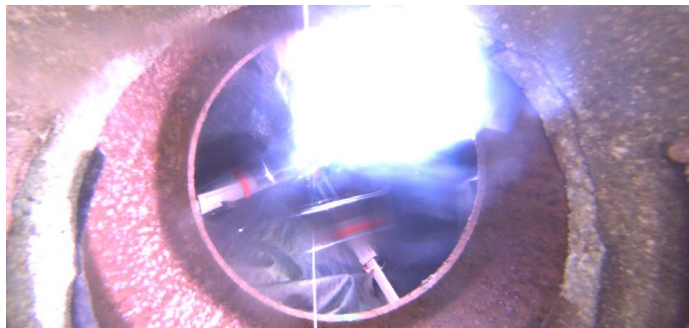
Code: **MGP**  
Description: **General Photo**

Distance (ft): **2.6**  
Structural Grade: **0**  
O&M Grade: **0**  
Clock Start/From:  
Clock To:  
1st Value:  
2nd Value:  
Value Percent:  
Step: **NO**  
Remarks:

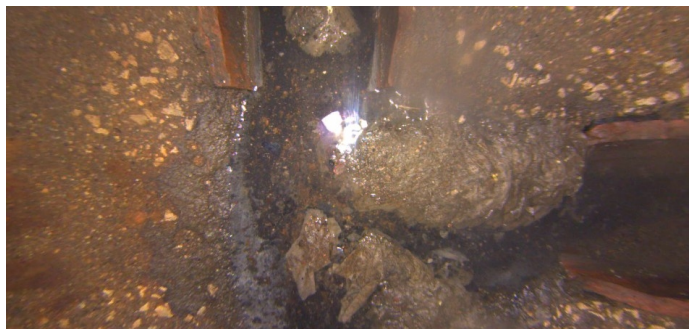
Code: **MGO**  
Description: **General Observation**

Distance (ft): **5.6**  
Structural Grade: **0**  
O&M Grade: **0**  
Clock Start/From:  
Clock To:  
1st Value:  
2nd Value:  
Value Percent:  
Step: **NO**  
Remarks: **Ins. Comp.**
