Manhole Inspection Report

Date:	04/24/2018	Weather:		Coding:	RZMACP
MH#:	M-506-014	Owner:	NA	Len. Surveyed:	8.3
P.O.#:		Surveyor:	John Kuglmaier	Rim to Invert:	9.2
Customer:		Cert. #:	U-1215-07002349	Wall Material:	Concrete (reinforced)

Street:	7th Pl. 715' West of Wisconsin St.	Project:	Hobart, IN
City:	Hobart, IN	GPS Northing:	2901145.811
Location:		GPS Easting:	2901145.811
Drain Area:	Southwest	GPS Accuracy:	Sub-Meter
Cover Shape:	Circular	Evidence of Surcharge:	No
Cover Size:	22.5	Potential for Runoff:	None
Comments:

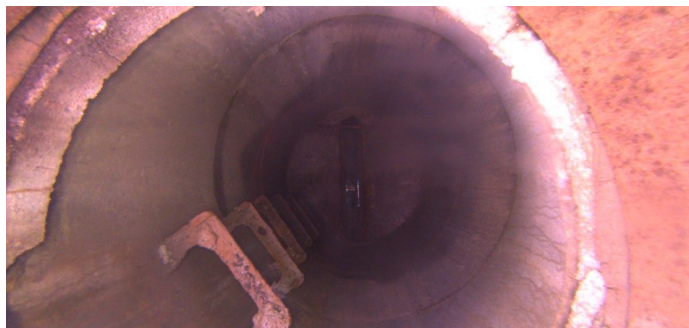
Code: **MGP**
Description: **General Photo**

Distance (ft): **.0**
Structural Grade: **0**
O&M Grade: **0**
Clock Start/From:
Clock To:
1st Value:
2nd Value:
Value Percent:
Step: **NO**
Remarks:

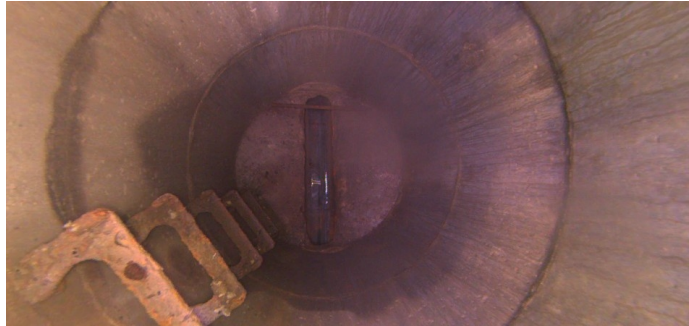
Code: **IS**
Description: **Infil Stain**

Distance (ft): **1.5**
Structural Grade: **0**
O&M Grade: **0**
Clock Start/From: **12**
Clock To: **12**
1st Value:
2nd Value:
Value Percent:
Step: **NO**
Remarks:

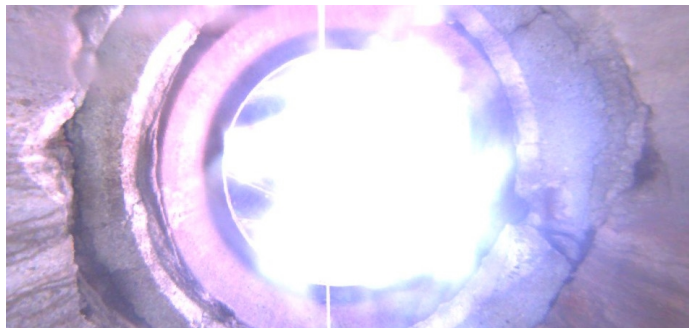
Code: **MGP**
Description: **General Photo**

Distance (ft): **2.6**
Structural Grade: **0**
O&M Grade: **0**
Clock Start/From:
Clock To:
1st Value:
2nd Value:
Value Percent:
Step: **NO**
Remarks:

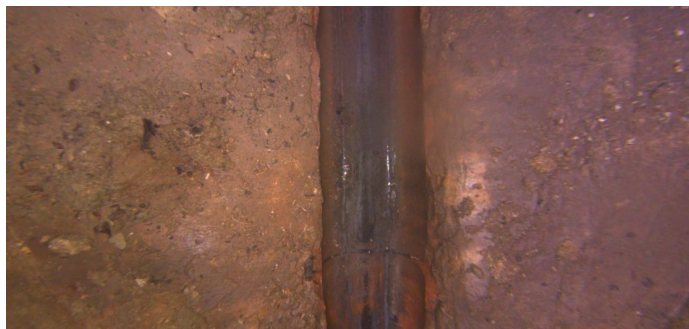
Code: **MGO**
Description: **General Observation**

Distance (ft): **7.0**
Structural Grade: **0**
O&M Grade: **0**
Clock Start/From:
Clock To:
1st Value:
2nd Value:
Value Percent:
Step: **NO**
Remarks: **Ins. Comp.**
