Manhole Inspection Report

Date:	04/24/2018	Weather:		Coding:	RZMACP
MH#:	M-506-022	Owner:	NA	Len. Surveyed:	8.8
P.O.#:		Surveyor:	John Kuglmaier	Rim to Invert:	8.9
Customer:		Cert. #:	U-1215-07002349	Wall Material:	Concrete (reinforced)

Street:	Intersection of River Terrace and 8th	Project:	Hobart, IN
City:	Hobart, IN	GPS Northing:	2900192.793
Location:		GPS Easting:	2900192.793
Drain Area:	Southwest	GPS Accuracy:	Sub-Meter
Cover Shape:	Circular	Evidence of Surcharge:	No
Cover Size:	22.5	Potential for Runoff:	None
Comments:

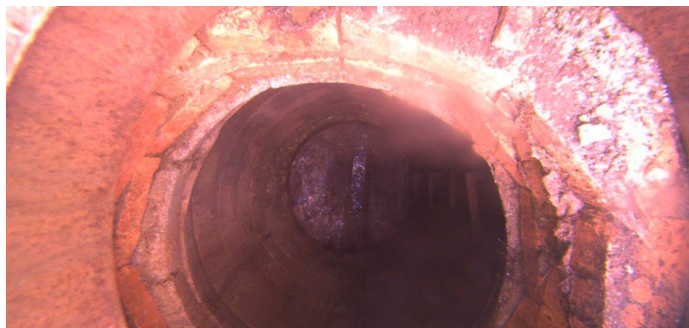
Code: **MGP**
Description: **General Photo**

Distance (ft): **.0**
Structural Grade: **0**
O&M Grade: **0**
Clock Start/From:
Clock To:
1st Value:
2nd Value:
Value Percent:
Step: **NO**
Remarks:

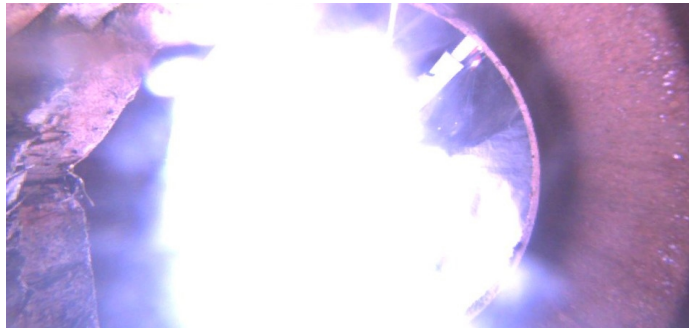
Code: **MGP**
Description: **General Photo**

Distance (ft): **2.0**
Structural Grade: **0**
O&M Grade: **0**
Clock Start/From:
Clock To:
1st Value:
2nd Value:
Value Percent:
Step: **NO**
Remarks:

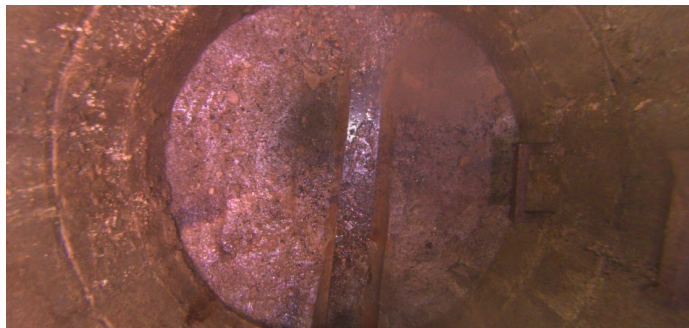
Code: **DAZ**
Description: **Deposits Attached Other**

Distance (ft): **5.9**
Structural Grade: **0**
O&M Grade: **2**
Clock Start/From: **12**
Clock To: **12**
1st Value:
2nd Value:
Value Percent: **10.000**
Step: **NO**
Remarks: **Mixed materials**

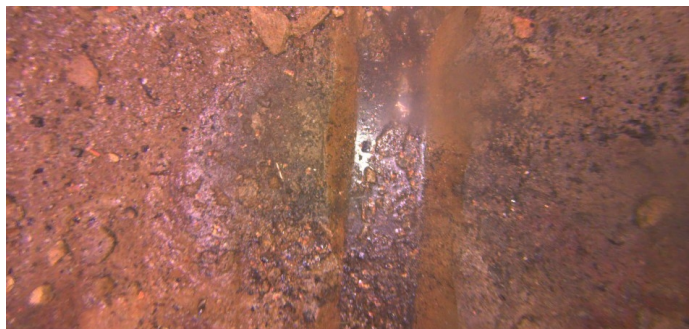
Code: **MGO**
Description: **General Observation**

Distance (ft): **7.8**
Structural Grade: **0**
O&M Grade: **0**
Clock Start/From:
Clock To:
1st Value:
2nd Value:
Value Percent:
Step: **NO**
Remarks: **Ins. Comp.**
