Manhole Inspection Report

Date:	04/24/2018	Weather:		Coding:	RZMACP
MH#:	M-506-023	Owner:	NA	Len. Surveyed:	12.1
P.O.#:		Surveyor:	John Kuglmaier	Rim to Invert:	12.4
Customer:		Cert. #:	U-1215-07002349	Wall Material:	Concrete (reinforced)

Street:	North of 8th St. 188' West of Colora	Project:	Hobart, IN
City:	Hobart, IN	GPS Northing:	2900357.503
Location:		GPS Easting:	2900357.503
Drain Area:	Southwest	GPS Accuracy:	Sub-Meter
Cover Shape:	Circular	Evidence of Surcharge:	No
Cover Size:	22.5	Potential for Runoff:	None
Comments:

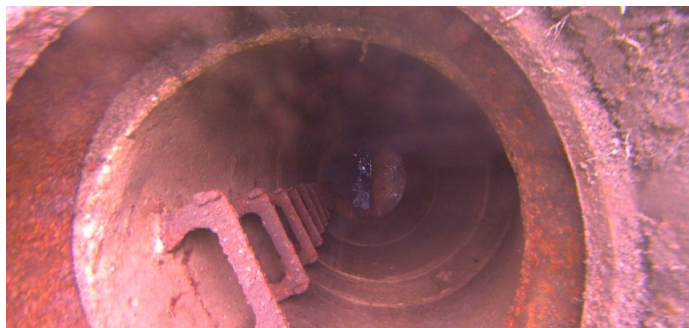
Code: **MGP**
 Description: **General Photo**

Distance (ft): **.0**
 Structural Grade: **0**
 O&M Grade: **0**
 Clock Start/From:
 Clock To:
 1st Value:
 2nd Value:
 Value Percent:
 Step: **NO**
 Remarks:

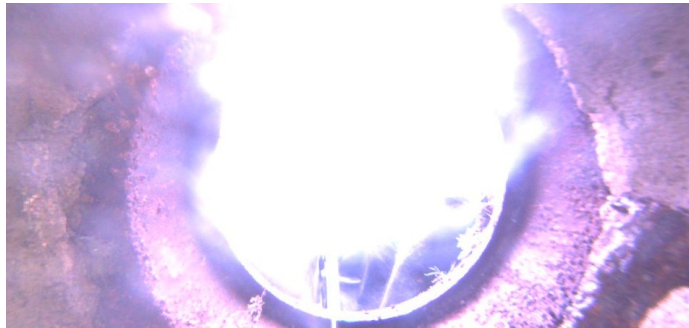
Code:	MGP
Description:	General Photo
Distance (ft):	2.5
Structural Grade:	0
O&M Grade:	0
Clock Start/From:	
Clock To:	
1st Value:	
2nd Value:	
Value Percent:	
Step:	NO
Remarks:

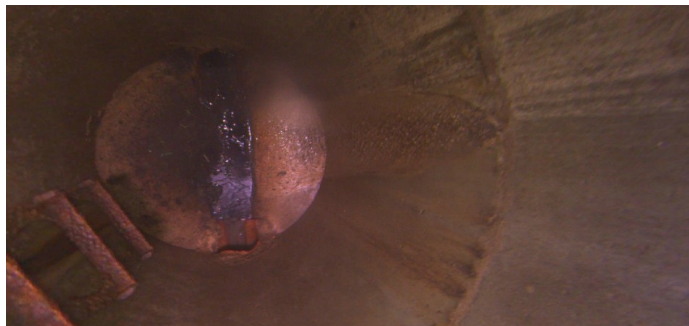
Code:	IS
Description:	Infil Stain
Distance (ft):	6.7
Structural Grade:	0
O&M Grade:	0
Clock Start/From:	3
Clock To:	4
1st Value:	
2nd Value:	
Value Percent:	
Step:	NO
Remarks:

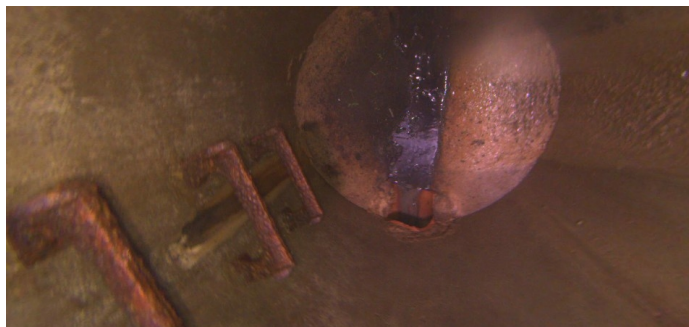
Code:	IS
Description:	Infil Stain
Distance (ft):	8.1
Structural Grade:	0
O&M Grade:	0
Clock Start/From:	8
Clock To:	
1st Value:	
2nd Value:	
Value Percent:	
Step:	NO
Remarks:

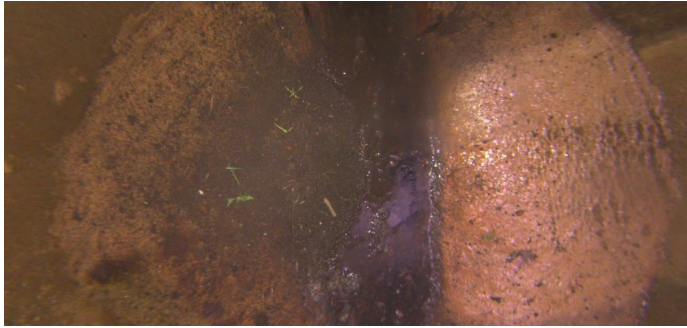
Code:	MGO
Description:	General Observation
Distance (ft):	10.9
Structural Grade:	0
O&M Grade:	0
Clock Start/From:	
Clock To:	
1st Value:	
2nd Value:	
Value Percent:	
Step:	NO
Remarks:	Ins. Comp.
