Manhole Inspection Report

Date:	04/24/2018	Weather:		Coding:	RZMACP
MH#:	M-506-026	Owner:	NA	Len. Surveyed:	4.4
P.O.#:		Surveyor:	John Kuglmaier	Rim to Invert:	4.1
Customer:		Cert. #:	U-1215-07002349	Wall Material:	Concrete (reinforced)

Street:	Colorado St. 74' North of 7th Pl.	Project:	Hobart, IN
City:	Hobart, IN	GPS Northing:	2900541.392
Location:		GPS Easting:	2900541.392
Drain Area:	Southwest	GPS Accuracy:	Sub-Meter
Cover Shape:	Circular	Evidence of Surcharge:	No
Cover Size:	22.5	Potential for Runoff:	None
Comments:

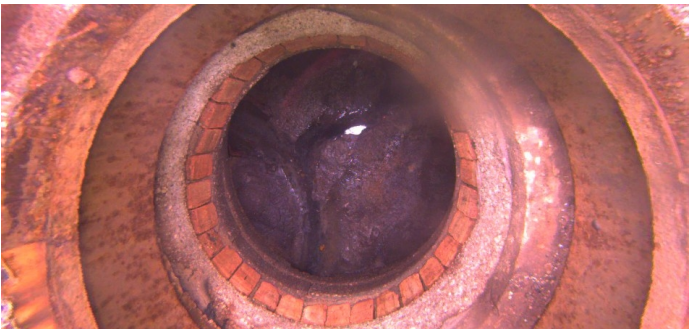
Code: **MGP**
 Description: **General Photo**

Distance (ft): **.0**
 Structural Grade: **0**
 O&M Grade: **0**
 Clock Start/From:
 Clock To:
 1st Value:
 2nd Value:
 Value Percent:
 Step: **NO**
 Remarks:

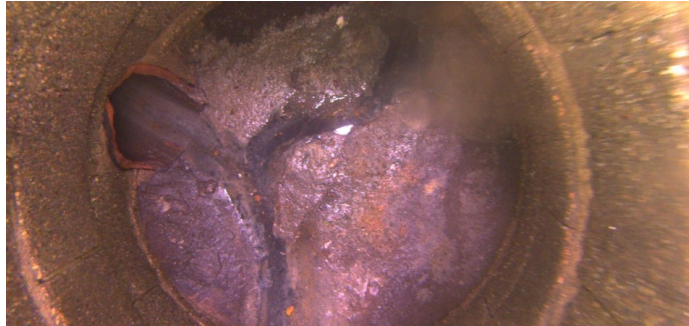
Code: **DAZ**
Description: **Deposits Attached Other**

Distance (ft): **1.8**
Structural Grade: **0**
O&M Grade: **2**
Clock Start/From: **12**
Clock To: **12**
1st Value:
2nd Value:
Value Percent: **10.000**
Step: **NO**
Remarks: **Mixed materials**

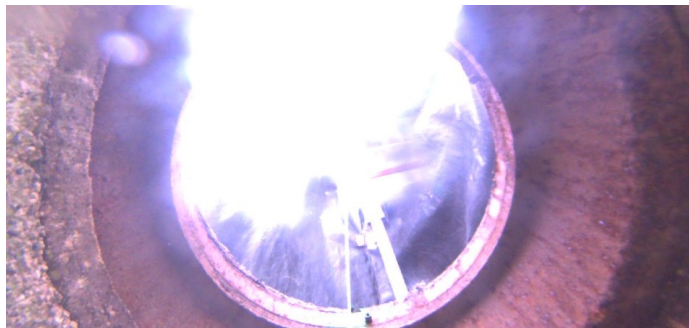
Code: **MGP**
Description: **General Photo**

Distance (ft): **2.5**
Structural Grade: **0**
O&M Grade: **0**
Clock Start/From:
Clock To:
1st Value:
2nd Value:
Value Percent:
Step: **NO**
Remarks:

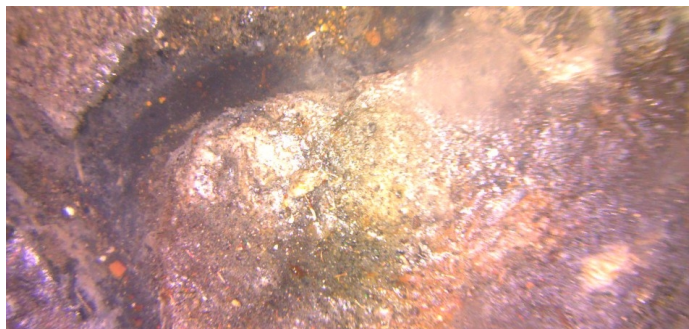
Code: **MGO**
Description: **General Observation**

Distance (ft): **3.9**
Structural Grade: **0**
O&M Grade: **0**
Clock Start/From:
Clock To:
1st Value:
2nd Value:
Value Percent:
Step: **NO**
Remarks: **Ins. Comp.**
