Manhole Inspection Report

Date:	09/28/2022	Weather:		Coding:	RZMACP
MH#:	M-506-028	Owner:	NA	Len. Surveyed:	9.1
P.O.#:		Surveyor:	Jen Costello	Rim to Invert:	10.0
Customer:		Cert. #:	U-907-5518	Wall Material:	Brick

Street:	North of 7th Pl. 67' East of River Ter	Project:	Hobart, IN
City:	Hobart, IN	GPS Northing:	2286907.368
Location:	Yard	GPS Easting:	2900211.312
Drain Area:	Southwest	GPS Accuracy:	Sub-Meter
Cover Shape:	Circular	Evidence of Surcharge:	No
Cover Size:	24.0	Potential for Runoff:	None
Comments:

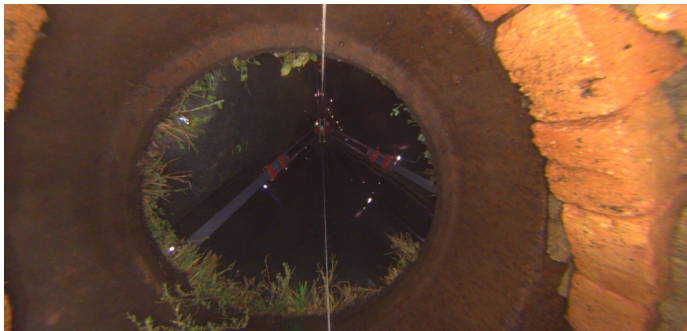
Code: **MGO**
Description: **General Observation**

Distance (ft): **1.6**
Structural Grade: **0**
O&M Grade: **0**
Clock Start/From:
Clock To:
1st Value:
2nd Value:
Value Percent:
Step: **NO**
Remarks: **underside of frame**

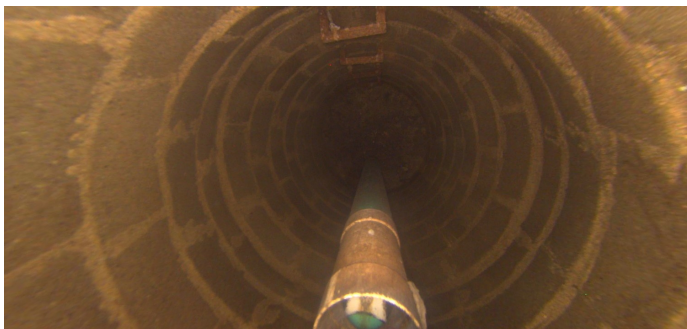
Code: **SAV**
Description: **Surface Aggregate Visible**

Distance (ft): **1.6**
Structural Grade: **3**
O&M Grade: **0**
Clock Start/From: **12**
Clock To: **12**
1st Value:
2nd Value:
Value Percent:
Step: **NO**
Remarks:

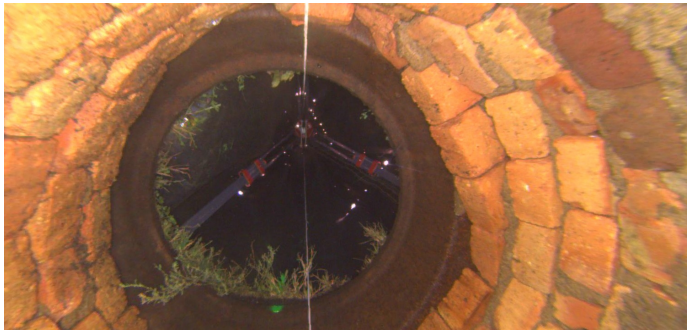
Code:	MGO
Description:	General Observation
Distance (ft):	2.3
Structural Grade:	0
O&M Grade:	0
Clock Start/From:	
Clock To:	
1st Value:	
2nd Value:	
Value Percent:	
Step:	NO
Remarks:	underside of frame

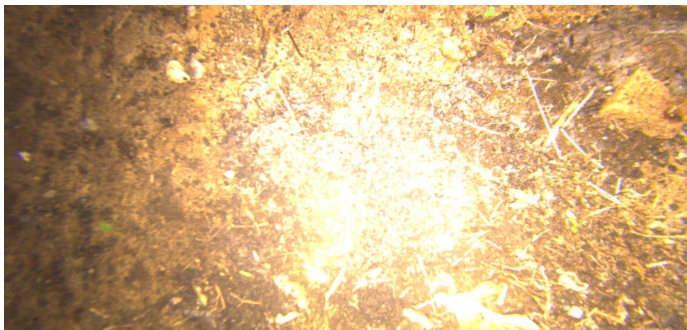
Code:	DSF
Description:	Deposits Settled Fine
Distance (ft):	9.1
Structural Grade:	0
O&M Grade:	2
Clock Start/From:	12
Clock To:	12
1st Value:	
2nd Value:	
Value Percent:	5.000
Step:	NO
Remarks:

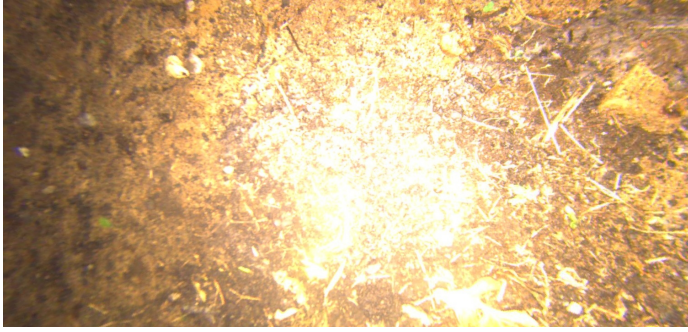
Code:	SAV
Description:	Surface Aggregate Visible
Distance (ft):	9.1
Structural Grade:	3
O&M Grade:	0
Clock Start/From:	12
Clock To:	12
1st Value:	
2nd Value:	
Value Percent:	
Step:	NO
Remarks:
