Manhole Inspection Report

Date:	04/24/2018	Weather:		Coding:	RZMACP
MH#:	M-506-029	Owner:	NA	Len. Surveyed:	3.5
P.O.#:		Surveyor:	John Kuglmaier	Rim to Invert:	3.5
Customer:		Cert. #:	U-1215-07002349	Wall Material:	Concrete (reinforced)

Street:	Intersection of Colorado St. and Riv	Project:	Hobart, IN
City:	Hobart, IN	GPS Northing:	2900518.624
Location:		GPS Easting:	2900518.624
Drain Area:	Southwest	GPS Accuracy:	Sub-Meter
Cover Shape:	Circular	Evidence of Surcharge:	No
Cover Size:	22.5	Potential for Runoff:	None
Comments:

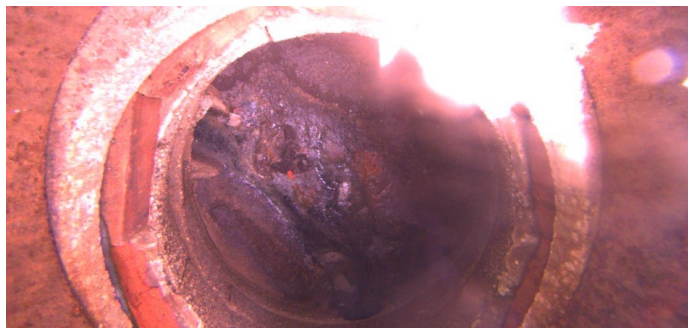
Code: **MGP**
 Description: **General Photo**

Distance (ft): **.0**
 Structural Grade: **0**
 O&M Grade: **0**
 Clock Start/From:
 Clock To:
 1st Value:
 2nd Value:
 Value Percent:
 Step: **NO**
 Remarks:

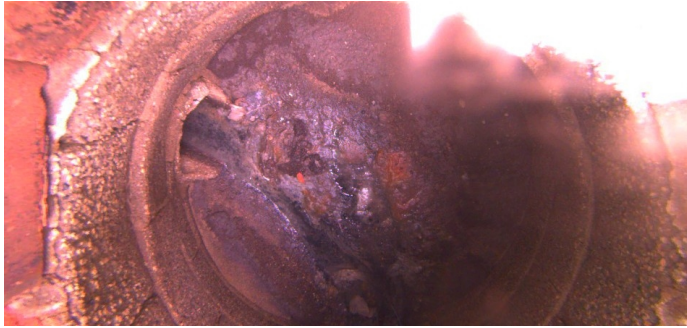
Code: **DAZ**
Description: **Deposits Attached Other**

Distance (ft): **.7**
Structural Grade: **0**
O&M Grade: **2**
Clock Start/From: **12**
Clock To: **12**
1st Value:
2nd Value:
Value Percent: **10.000**
Step: **NO**
Remarks: **Mixed materials**

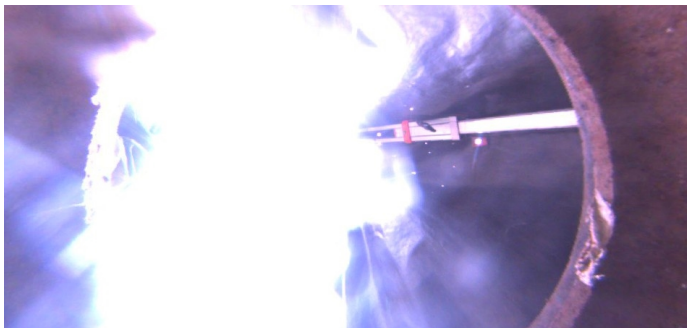
Code: **MGP**
Description: **General Photo**

Distance (ft): **1.6**
Structural Grade: **0**
O&M Grade: **0**
Clock Start/From:
Clock To:
1st Value:
2nd Value:
Value Percent:
Step: **NO**
Remarks:

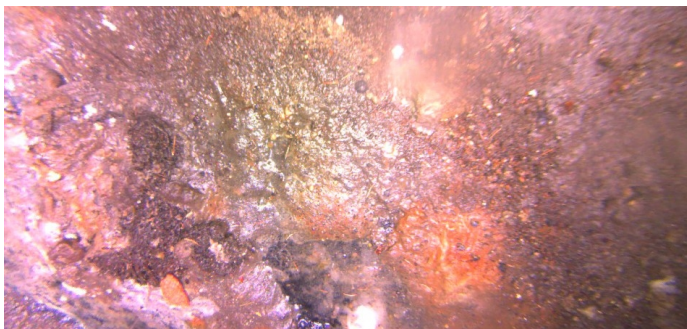
Code: **MGO**
Description: **General Observation**

Distance (ft): **2.9**
Structural Grade: **0**
O&M Grade: **0**
Clock Start/From:
Clock To:
1st Value:
2nd Value:
Value Percent:
Step: **NO**
Remarks: **Ins. Comp.**
