Manhole Inspection Report

Date:	04/24/2018	Weather:		Coding:	RZMACP
MH#:	M-506-030	Owner:	NA	Len. Surveyed:	5.7
P.O.#:		Surveyor:	John Kuglmaier	Rim to Invert:	6.7
Customer:		Cert. #:	U-1215-07002349	Wall Material:	Concrete (reinforced)

Street:	River Terrace 270' West of Colorado	Project:	Hobart, IN
City:	Hobart, IN	GPS Northing:	2900278.81
Location:		GPS Easting:	2900278.81
Drain Area:	Southwest	GPS Accuracy:	Sub-Meter
Cover Shape:	Circular	Evidence of Surcharge:	No
Cover Size:	22.5	Potential for Runoff:	None
Comments:

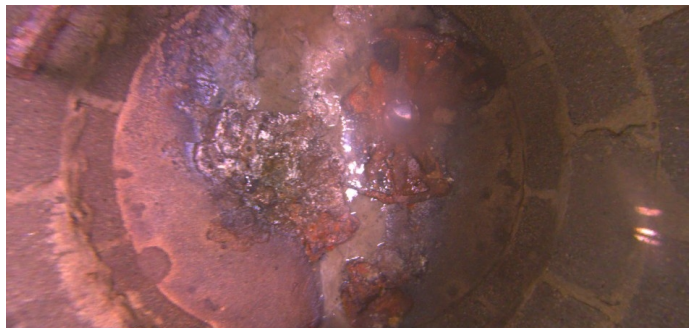
Code:	DAZ
Description:	Deposits Attached Other
Distance (ft):	3.2
Structural Grade:	0
O&M Grade:	2
Clock Start/From:	12
Clock To:	12
1st Value:	
2nd Value:	
Value Percent:	5.000
Step:	NO
Remarks:	Mixed materials

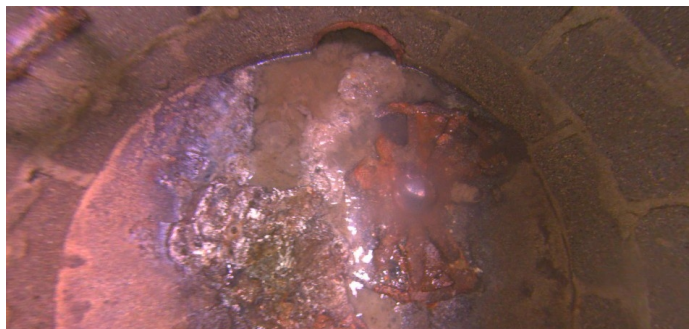
Code:	OBZ
Description:	Obstacle Other
Distance (ft):	3.8
Structural Grade:	0
O&M Grade:	2
Clock Start/From:	1
Clock To:	3
1st Value:	
2nd Value:	
Value Percent:	5.000
Step:	NO
Remarks:	Manhole cover

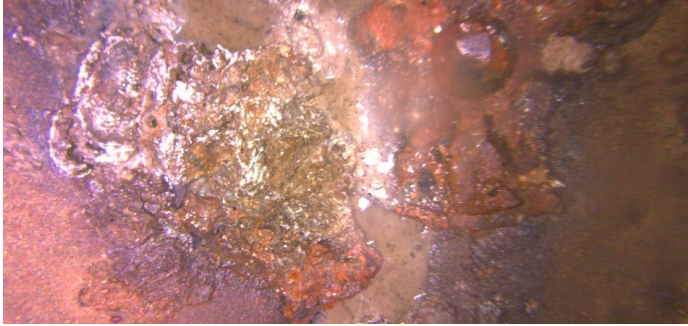
Code:	MGO
Description:	General Observation
Distance (ft):	4.9
Structural Grade:	0
O&M Grade:	0
Clock Start/From:	
Clock To:	
1st Value:	
2nd Value:	
Value Percent:	
Step:	NO
Remarks:	Ins. Comp.
