Manhole Inspection Report

Date:	04/24/2018	Weather:		Coding:	RZMACP
MH#:	M-506-031	Owner:	NA	Len. Surveyed:	7.5
P.O.#:		Surveyor:	John Kuglmaier	Rim to Invert:	7.9
Customer:		Cert. #:	U-1215-07002349	Wall Material:	Concrete (reinforced)

Street:	River Terrace 229' North of 7th Pl.	Project:	Hobart, IN
City:	Hobart, IN	GPS Northing:	2900174.515
Location:		GPS Easting:	2900174.515
Drain Area:	Southwest	GPS Accuracy:	Sub-Meter
Cover Shape:	Circular	Evidence of Surcharge:	No
Cover Size:	22.5	Potential for Runoff:	None
Comments:

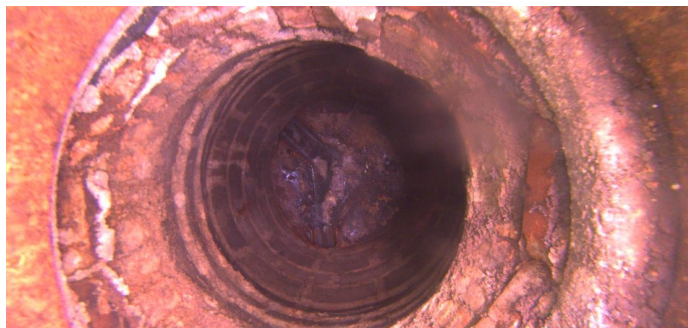
Code: **MGP**
Description: **General Photo**

Distance (ft): **.0**
Structural Grade: **0**
O&M Grade: **0**
Clock Start/From:
Clock To:
1st Value:
2nd Value:
Value Percent:
Step: **NO**
Remarks:

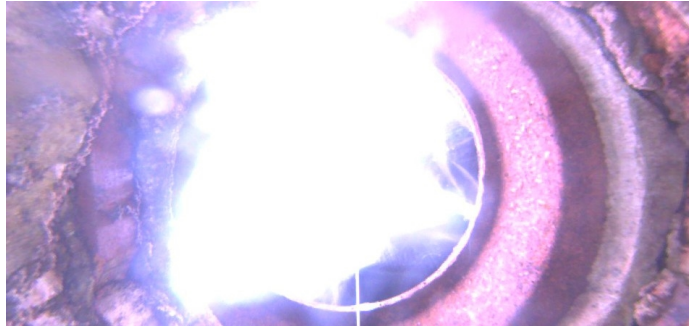
Code: **MGP**
Description: **General Photo**

Distance (ft): **2.3**
Structural Grade: **0**
O&M Grade: **0**
Clock Start/From:
Clock To:
1st Value:
2nd Value:
Value Percent:
Step: **NO**
Remarks:

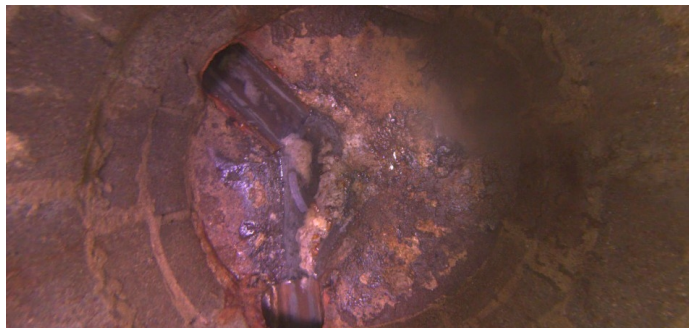
Code: **DAZ**
Description: **Deposits Attached Other**

Distance (ft): **4.3**
Structural Grade: **0**
O&M Grade: **2**
Clock Start/From: **12**
Clock To: **12**
1st Value:
2nd Value:
Value Percent: **10.000**
Step: **NO**
Remarks: **Mixed materials**

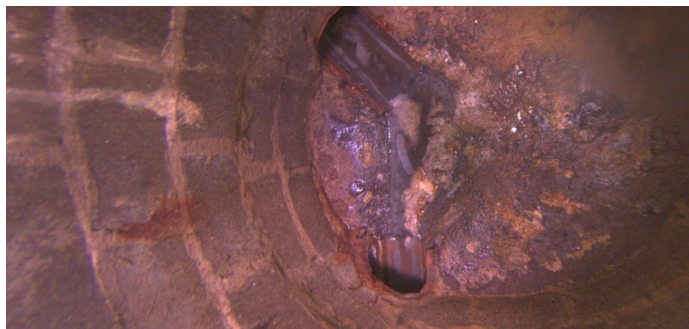
Code: **IS**
Description: **Infil Stain**

Distance (ft): **4.3**
Structural Grade: **0**
O&M Grade: **0**
Clock Start/From: **8**
Clock To:
1st Value:
2nd Value:
Value Percent:
Step: **NO**
Remarks:

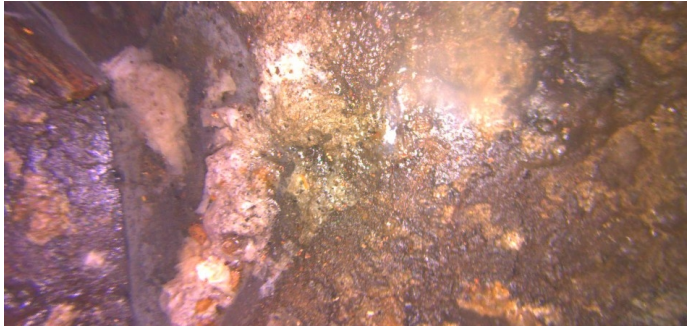
Code:	MGO
Description:	General Observation
Distance (ft):	6.6
Structural Grade:	0
O&M Grade:	0
Clock Start/From:	
Clock To:	
1st Value:	
2nd Value:	
Value Percent:	
Step:	NO
Remarks:	Ins. Comp.
