Manhole Inspection Report

Date:	04/24/2018	Weather:		Coding:	RZMACP
MH#:	M-506-032	Owner:	NA	Len. Surveyed:	9.2
P.O.#:		Surveyor:	John Kuglmaier	Rim to Invert:	9.9
Customer:		Cert. #:	U-1215-07002349	Wall Material:	Concrete (reinforced)

Street:	7th Pl. and River Terrace. To the Nor	Project:	Hobart, IN
City:	Hobart, IN	GPS Northing:	41.526371
Location:		GPS Easting:	-87.27546692
Drain Area:	Southwest	GPS Accuracy:	Nearest Meter
Cover Shape:	Circular	Evidence of Surcharge:	Yes
Cover Size:	22.5	Potential for Runoff:	None
Comments:

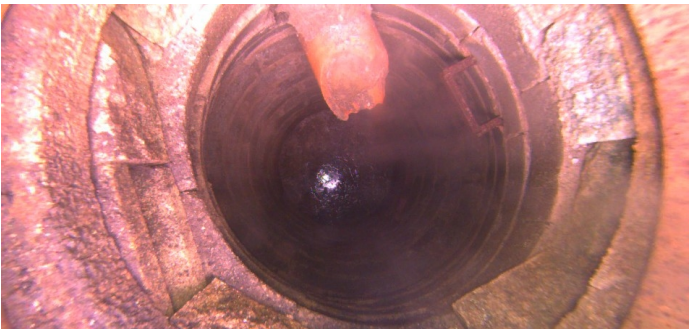
Code: **MGP**
 Description: **General Photo**

Distance (ft): **.0**
 Structural Grade: **0**
 O&M Grade: **0**
 Clock Start/From:
 Clock To:
 1st Value:
 2nd Value:
 Value Percent:
 Step: **NO**
 Remarks:

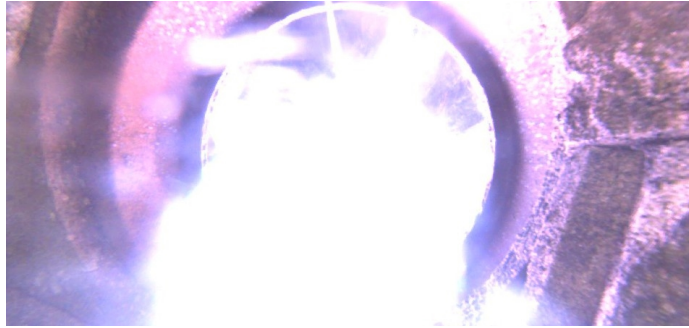
Code: **MGP**
Description: **General Photo**

Distance (ft): **2.3**
Structural Grade: **0**
O&M Grade: **0**
Clock Start/From:
Clock To:
1st Value:
2nd Value:
Value Percent:
Step: **NO**
Remarks:

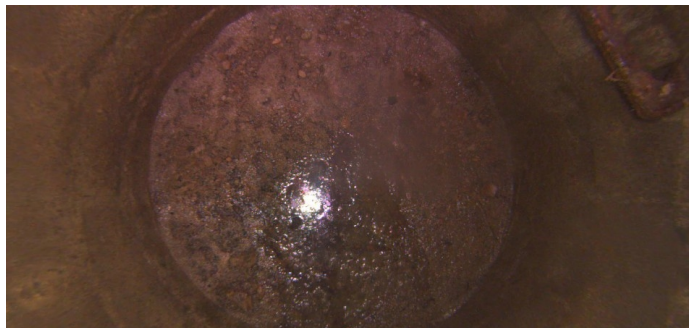
Code: **DAZ**
Description: **Deposits Attached Other**

Distance (ft): **6.8**
Structural Grade: **0**
O&M Grade: **2**
Clock Start/From: **12**
Clock To: **12**
1st Value:
2nd Value:
Value Percent: **5.000**
Step: **NO**
Remarks: **Mixed materials**

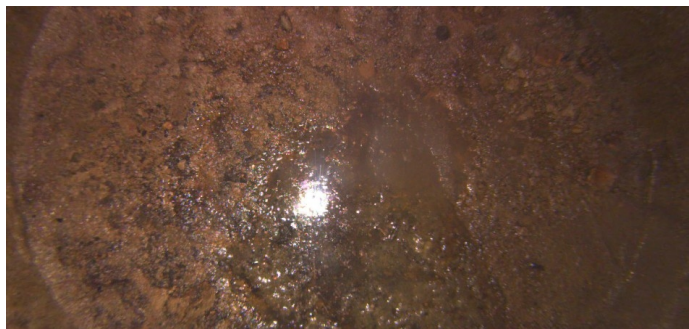
Code: **MGO**
Description: **General Observation**

Distance (ft): **8.1**
Structural Grade: **0**
O&M Grade: **0**
Clock Start/From:
Clock To:
1st Value:
2nd Value:
Value Percent:
Step: **NO**
Remarks: **Ins. Comp.**
