Manhole Inspection Report

| MH#: | M-506-032 | Owner: | NA | Len. Surveyed: | 9.1 |

| Street: | 7th Pl. and River Terrace. To the Nor | Project: | Hobart, IN |

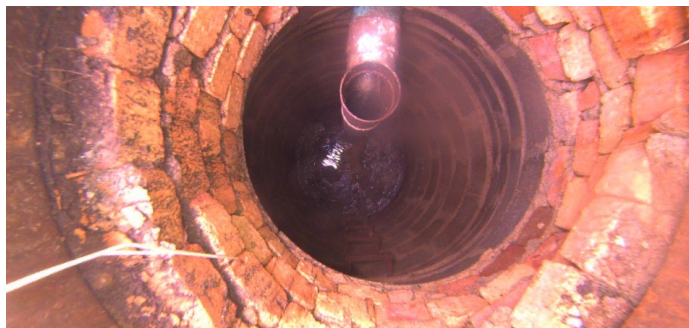
Code: **MGP**
Description: **General Photo**

Distance (ft): **.0**
Structural Grade: **0**
O&M Grade: **0**
Clock Start/From:
Clock To:
1st Value:
2nd Value:
Value Percent:
Step: **NO**
Remarks:

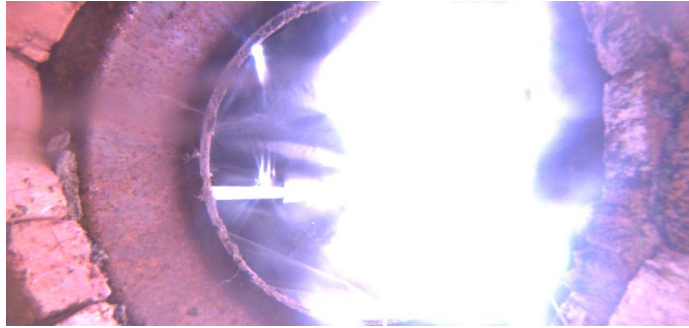
| Code: | MGP |
| Description: | General Photo |
| Distance (ft): | 1.9 |

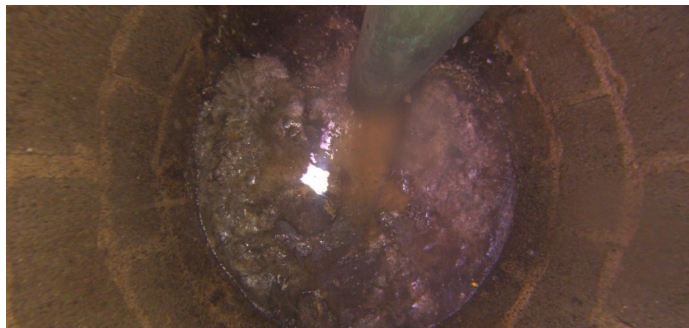
| Code: | DAZ |
| Description: | Deposits Attached Other |
| Distance (ft): | 6.4 |
| O&M Grade: | 2 |
| Clock Start/From: | 12 |
| Value Percent: | 10.000 |
| Remarks: | Mixed materials |

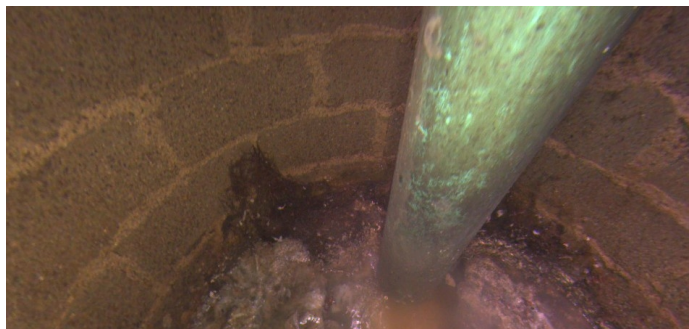
| Code: | RFJ |
| Description: | Roots Fine Joint |
| Distance (ft): | 7.0 |
| O&M Grade: | 1 |
| Clock Start/From: | 11 |

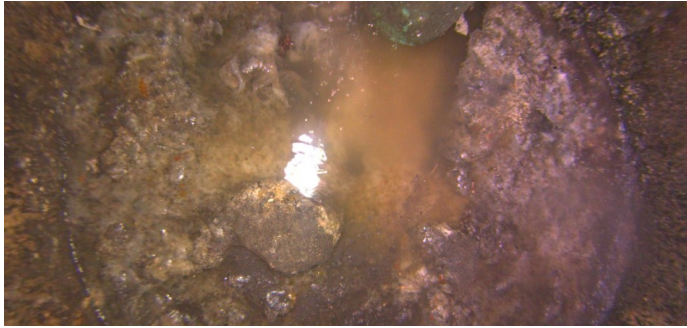
| Code: | MGO |
| Description: | General Observation |
| Distance (ft): | 8.1 |
| Remarks: | Ins. Comp. |
