Manhole Inspection Report

Date:	04/24/2018	Weather:		Coding:	RZMACP
MH#:	M-506-033	Owner:	NA	Len. Surveyed:	10.6
P.O.#:		Surveyor:	John Kuglmaier	Rim to Invert:	10.9
Customer:		Cert. #:	U-1215-07002349	Wall Material:	Concrete (reinforced)

Street:	Intersection of 8th St. and Colorado	Project:	Hobart, IN
City:	Hobart, IN	GPS Northing:	2900536.241
Location:		GPS Easting:	2900536.241
Drain Area:	Southwest	GPS Accuracy:	Sub-Meter
Cover Shape:	Circular	Evidence of Surcharge:	No
Cover Size:	22.5	Potential for Runoff:	None
Comments:

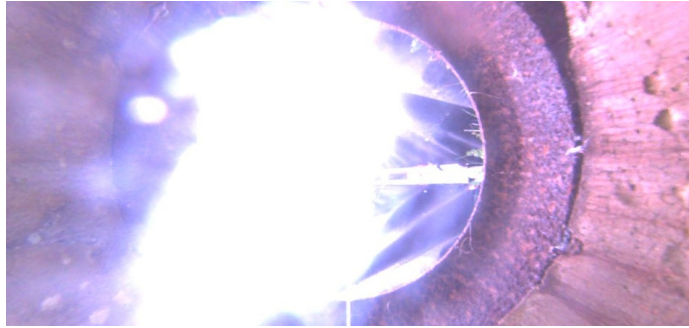
Code: **MGP**
Description: **General Photo**

Distance (ft): **2.2**
Structural Grade: **0**
O&M Grade: **0**
Clock Start/From:
Clock To:
1st Value:
2nd Value:
Value Percent:
Step: **NO**
Remarks:

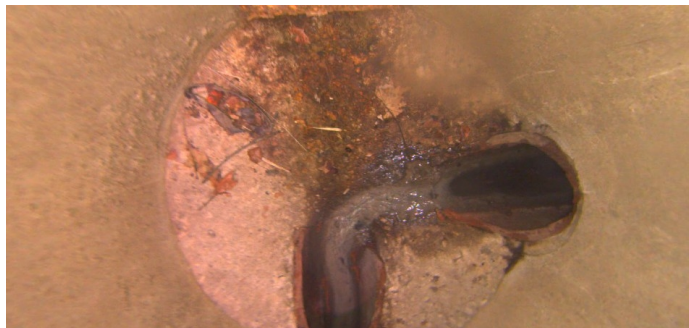
Code: **DAZ**
Description: **Deposits Attached Other**

Distance (ft): **8.4**
Structural Grade: **0**
O&M Grade: **2**
Clock Start/From: **12**
Clock To: **12**
1st Value:
2nd Value:
Value Percent: **5.000**
Step: **NO**
Remarks: **Mixed materials**

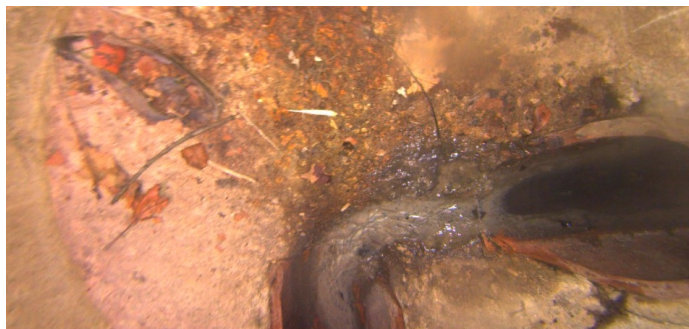
Code: **MGO**
Description: **General Observation**

Distance (ft): **9.5**
Structural Grade: **0**
O&M Grade: **0**
Clock Start/From:
Clock To:
1st Value:
2nd Value:
Value Percent:
Step: **NO**
Remarks: **Ins. Comp.**
