Manhole Inspection Report

Date:	04/24/2018	Weather:		Coding:	RZMACP
MH#:	M-506-040	Owner:	NA	Len. Surveyed:	.7
P.O.#:		Surveyor:	Jen Costello	Rim to Invert:	1.4
Customer:		Cert. #:	U-907-5518	Wall Material:	Concrete (reinforced)

Street:	448' West of Decatur St. And 10th S	Project:	Hobart, IN
City:	Hobart, IN	GPS Northing:	2899671.487
Location:		GPS Easting:	2899671.487
Drain Area:	Southwest	GPS Accuracy:	Sub-Meter
Cover Shape:	Circular	Evidence of Surcharge:	No
Cover Size:	22.5	Potential for Runoff:	None
Comments:

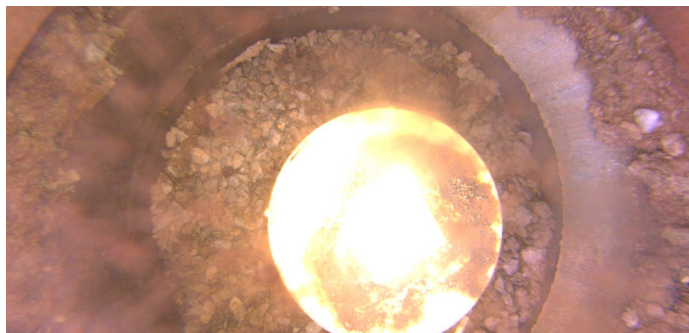
Code: **MGO**
Description: **General Observation**

Distance (ft): **.0**
Structural Grade: **0**
O&M Grade: **0**
Clock Start/From:
Clock To:
1st Value:
2nd Value:
Value Percent:
Step: **NO**
Remarks: **ACCESS MH**

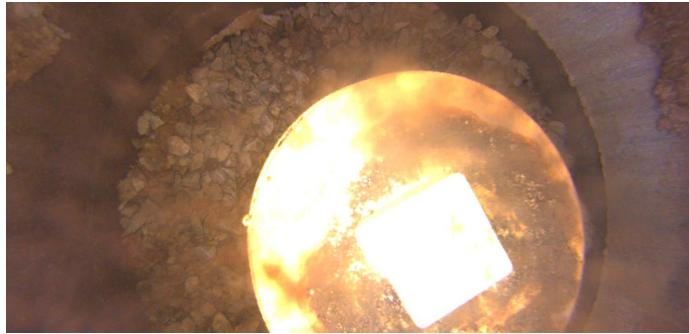
Code: **DSGV**
Description: **Deposits Settled Gravel**

Distance (ft): **.4**
Structural Grade: **0**
O&M Grade: **2**
Clock Start/From: **12**
Clock To: **12**
1st Value:
2nd Value:
Value Percent: **10.000**
Step: **NO**
Remarks:

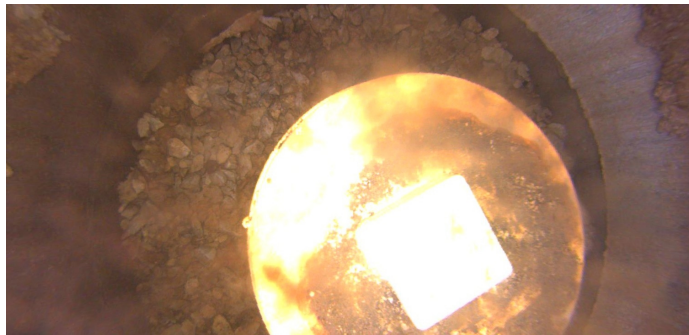
Code: **OBN**
Description: **Obstacle Construction Debris**

Distance (ft): **.4**
Structural Grade: **0**
O&M Grade: **5**
Clock Start/From: **12**
Clock To: **12**
1st Value:
2nd Value:
Value Percent: **80.000**
Step: **NO**
Remarks:

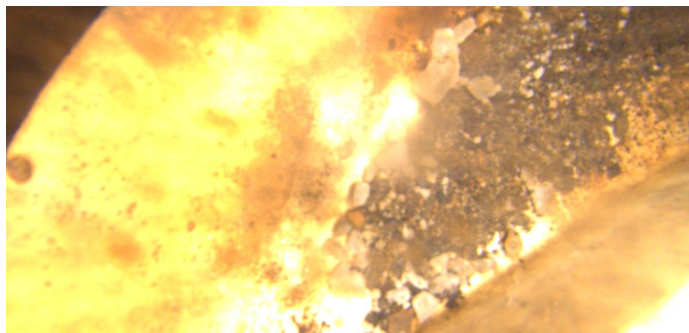
Code: **MSA**
Description: **Abandoned Survey**

Distance (ft): **.7**
Structural Grade: **0**
O&M Grade: **0**
Clock Start/From:
Clock To:
1st Value:
2nd Value:
Value Percent:
Step: **NO**
Remarks: **DEBRIS**
