Manhole Inspection Report

Date:	04/05/2018	Weather:		Coding:	RZMACP
MH#:	M-507-001	Owner:	NA	Len. Surveyed:	8.8
P.O.#:		Surveyor:	John Kuglmaier	Rim to Invert:	9.0
Customer:		Cert. #:	U-1215-07002349	Wall Material:	Concrete (reinforced)

Street:	13th Pl. Virginia Pl. to the Southwes	Project:	Hobart, IN
City:	Hobart, IN	GPS Northing:	0.0
Location:		GPS Easting:	0.0
Drain Area:	Southwest	GPS Accuracy:	Nearest Meter
Cover Shape:	Circular	Evidence of Surcharge:	No
Cover Size:	22.5	Potential for Runoff:	None
Comments:

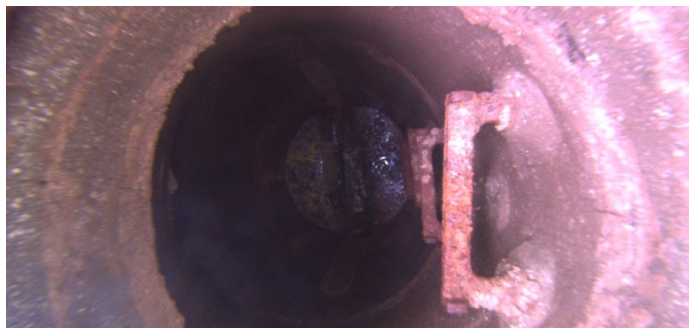
Code: **MGP**
Description: **General Photo**

Distance (ft): **.0**
Structural Grade: **0**
O&M Grade: **0**
Clock Start/From:
Clock To:
1st Value:
2nd Value:
Value Percent:
Step: **NO**
Remarks:

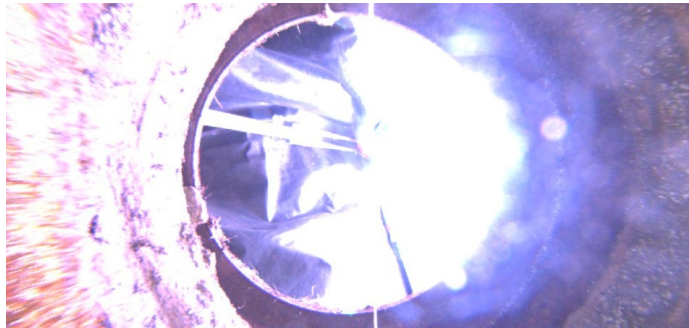
Code: **MGP**
Description: **General Photo**

Distance (ft): **2.2**
Structural Grade: **0**
O&M Grade: **0**
Clock Start/From:
Clock To:
1st Value:
2nd Value:
Value Percent:
Step: **NO**
Remarks:

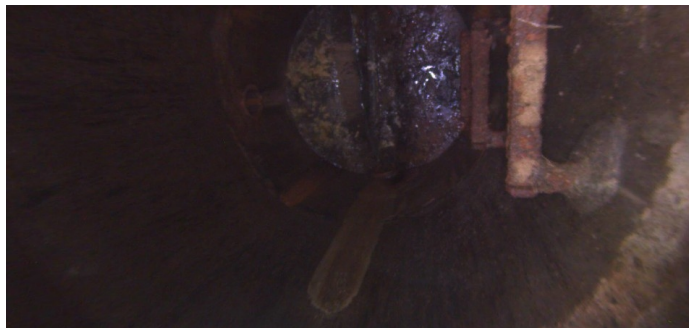
Code: **IS**
Description: **Infil Stain**

Distance (ft): **2.7**
Structural Grade: **0**
O&M Grade: **0**
Clock Start/From: **6**
Clock To:
1st Value:
2nd Value:
Value Percent:
Step: **NO**
Remarks:

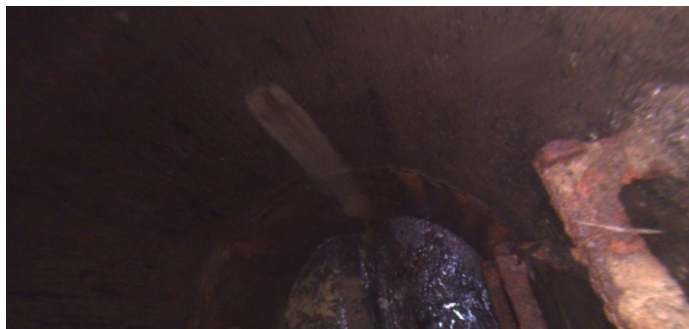
Code: **IS**
Description: **Infil Stain**

Distance (ft): **3.5**
Structural Grade: **0**
O&M Grade: **0**
Clock Start/From: **12**
Clock To:
1st Value:
2nd Value:
Value Percent:
Step: **NO**
Remarks:

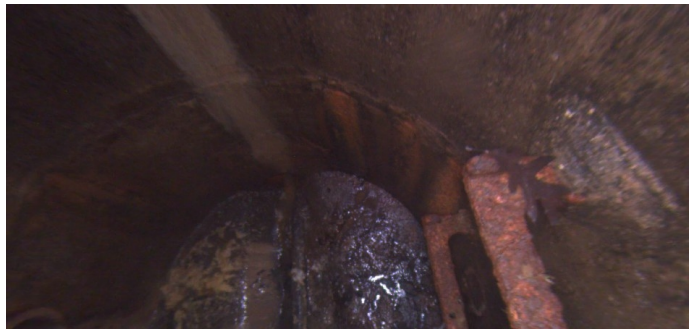
Code: **IS**
Description: **Infil Stain**

Distance (ft): **4.7**
Structural Grade: **0**
O&M Grade: **0**
Clock Start/From: **1**
Clock To: **2**
1st Value:
2nd Value:
Value Percent:
Step: **NO**
Remarks:

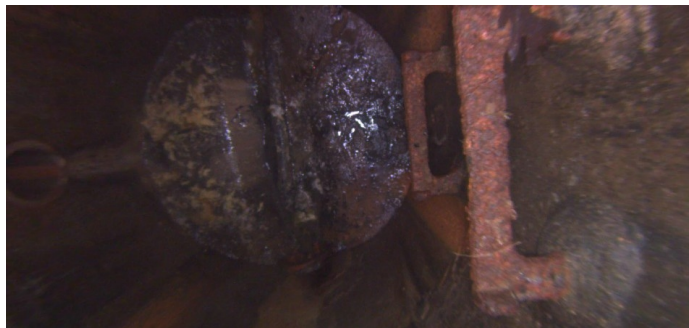
Code: **IS**
Description: **Infil Stain**

Distance (ft): **4.7**
Structural Grade: **0**
O&M Grade: **0**
Clock Start/From: **4**
Clock To:
1st Value:
2nd Value:
Value Percent:
Step: **NO**
Remarks:

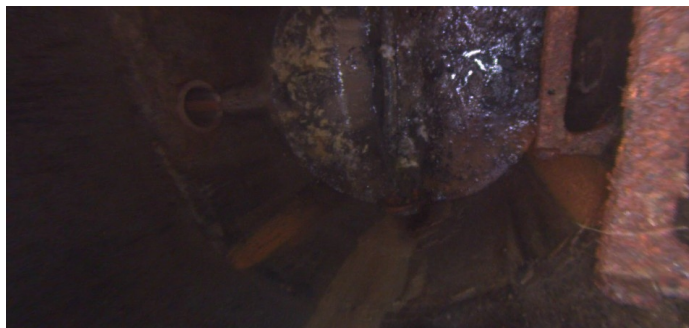
Code: **IS**
Description: **Infil Stain**

Distance (ft): **4.7**
Structural Grade: **0**
O&M Grade: **0**
Clock Start/From: **7**
Clock To:
1st Value:
2nd Value:
Value Percent:
Step: **NO**
Remarks:

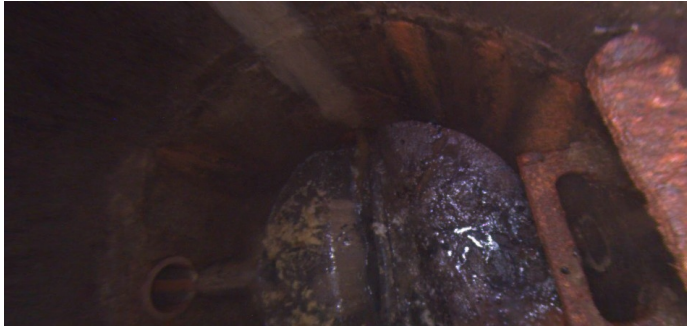
Code: **IS**
Description: **Infil Stain**

Distance (ft): **5.0**
Structural Grade: **0**
O&M Grade: **0**
Clock Start/From: **10**
Clock To:
1st Value:
2nd Value:
Value Percent:
Step: **NO**
Remarks:

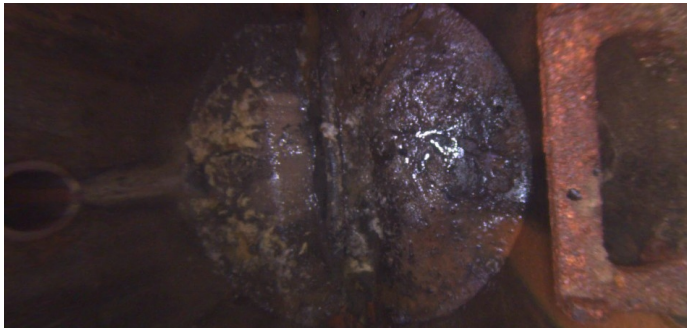
Code: **DAZ**
Description: **Deposits Attached Other**

Distance (ft): **5.9**
Structural Grade: **0**
O&M Grade: **2**
Clock Start/From: **12**
Clock To: **12**
1st Value:
2nd Value:
Value Percent: **5.000**
Step: **NO**
Remarks: **Mixed materials**

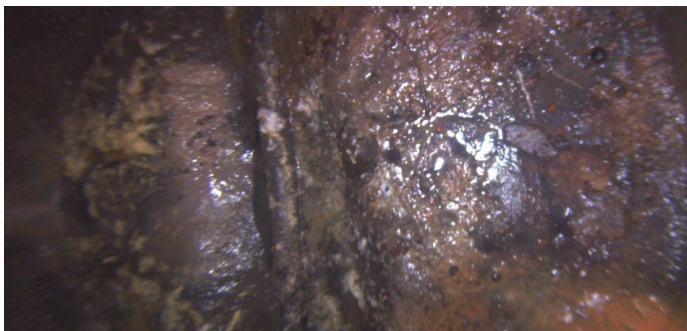
Code: **MGO**
Description: **General Observation**

Distance (ft): **7.5**
Structural Grade: **0**
O&M Grade: **0**
Clock Start/From:
Clock To:
1st Value:
2nd Value:
Value Percent:
Step: **NO**
Remarks: **Ins. Comp.**
