# Manhole Inspection Report

Date:	<b>04/05/2018</b>	Weather:		Coding:	<b>RZMACP</b>
MH#:	<b>M-507-003</b>	Owner:	<b>NA</b>	Len. Surveyed:	<b>7.8</b>
P.O.#:		Surveyor:	<b>John Kuglmaier</b>	Rim to Invert:	<b>8.2</b>
Customer:		Cert. #:	<b>U-1215-07002349</b>	Wall Material:	<b>Concrete (reinforced)</b>

Street:	<b>West of Delaware St. South of L/S 7.</b>	Project:	<b>Hobart, IN</b>
City:	<b>Hobart, IN</b>	GPS Northing:	<b>0.0</b>
Location:		GPS Easting:	<b>0.0</b>
Drain Area:	<b>Southwest</b>	GPS Accuracy:	<b>Nearest Meter</b>
Cover Shape:	<b>Circular</b>	Evidence of Surcharge:	<b>Yes</b>
Cover Size:	<b>22.5</b>	Potential for Runoff:	<b>None</b>
Comments:

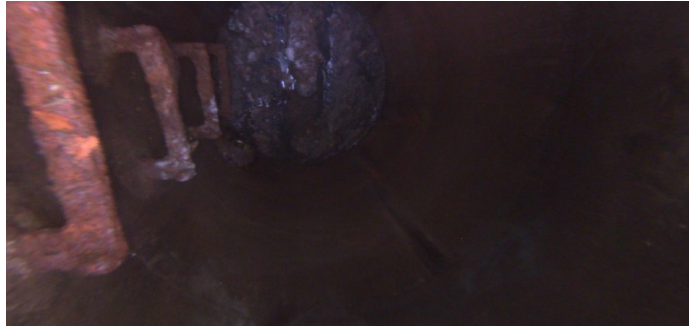
Code: **IS**  
Description: **Infil Stain**

Distance (ft): **1.0**  
Structural Grade: **0**  
O&M Grade: **0**  
Clock Start/From: **5**  
Clock To:  
1st Value:  
2nd Value:  
Value Percent:  
Step: **NO**  
Remarks:

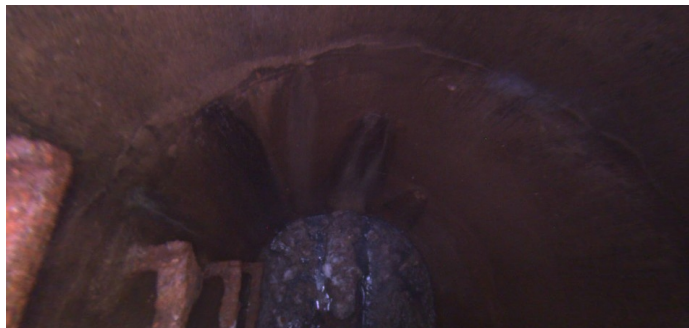
Code: **IS**  
Description: **Infil Stain**

Distance (ft): **1.6**  
Structural Grade: **0**  
O&M Grade: **0**  
Clock Start/From: **10**  
Clock To: **11**  
1st Value:  
2nd Value:  
Value Percent:  
Step: **NO**  
Remarks:

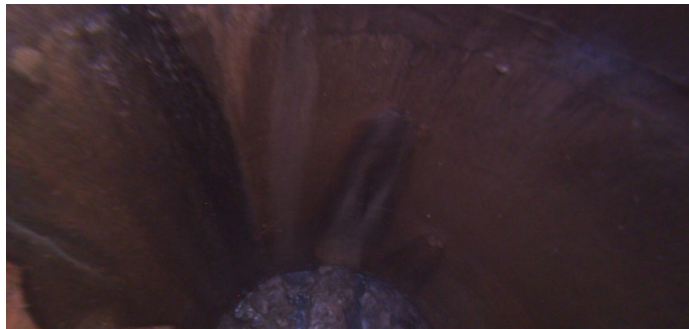
Code: **IS**  
Description: **Infil Stain**

Distance (ft): **2.7**  
Structural Grade: **0**  
O&M Grade: **0**  
Clock Start/From: **1**  
Clock To:  
1st Value:  
2nd Value:  
Value Percent:  
Step: **NO**  
Remarks:

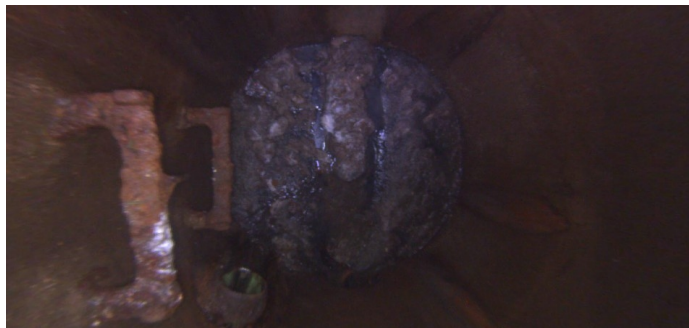
Code: **IS**  
Description: **Infil Stain**

Distance (ft): **3.5**  
Structural Grade: **0**  
O&M Grade: **0**  
Clock Start/From: **4**  
Clock To:  
1st Value:  
2nd Value:  
Value Percent:  
Step: **NO**  
Remarks:

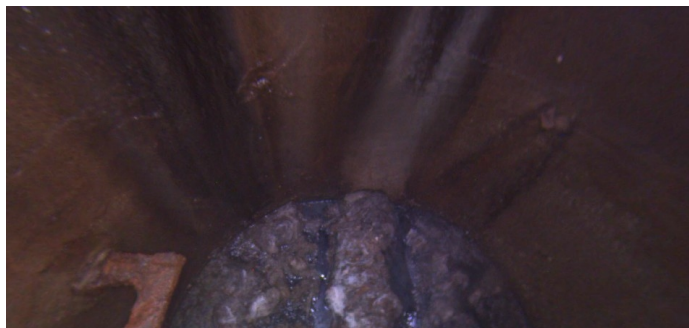
Code: **IS**  
Description: **Infil Stain**

Distance (ft): **4.7**  
Structural Grade: **0**  
O&M Grade: **0**  
Clock Start/From: **2**  
Clock To:  
1st Value:  
2nd Value:  
Value Percent:  
Step: **NO**  
Remarks:

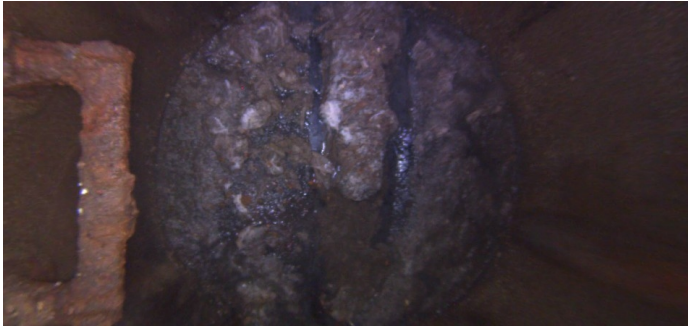
Code: **DAZ**  
Description: **Deposits Attached Other**

Distance (ft): **5.2**  
Structural Grade: **0**  
O&M Grade: **3**  
Clock Start/From: **12**  
Clock To: **12**  
1st Value:  
2nd Value:  
Value Percent: **15.000**  
Step: **NO**  
Remarks: **Mixed materials**
