Manhole Inspection Report

Date:	04/05/2018	Weather:		Coding:	RZMACP
MH#:	M-507-004	Owner:	NA	Len. Surveyed:	13.2
P.O.#:		Surveyor:	John Kuglmaier	Rim to Invert:	13.3
Customer:		Cert. #:	U-1215-07002349	Wall Material:	Concrete (reinforced)

Street:	Delaware St. North of L/S.	Project:	Hobart, IN
City:	Hobart, IN	GPS Northing:	0.0
Location:		GPS Easting:	0.0
Drain Area:	Southwest	GPS Accuracy:	Nearest Meter
Cover Shape:	Circular	Evidence of Surcharge:	Yes
Cover Size:	22.5	Potential for Runoff:	None
Comments:

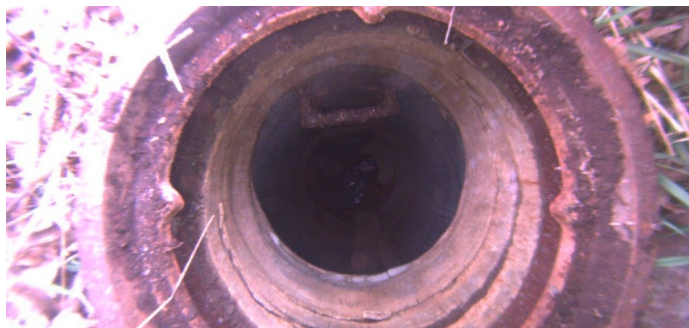
Code: **MGP**
Description: **General Photo**

Distance (ft): **.0**
Structural Grade: **0**
O&M Grade: **0**
Clock Start/From:
Clock To:
1st Value:
2nd Value:
Value Percent:
Step: **NO**
Remarks:

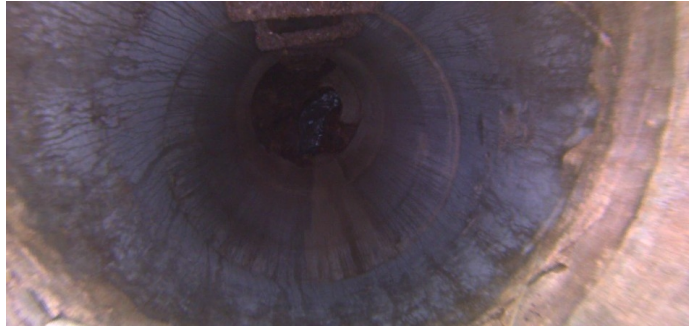
Code: **IS**
Description: **Infil Stain**

Distance (ft): **1.8**
Structural Grade: **0**
O&M Grade: **0**
Clock Start/From: **5**
Clock To:
1st Value:
2nd Value:
Value Percent:
Step: **NO**
Remarks:

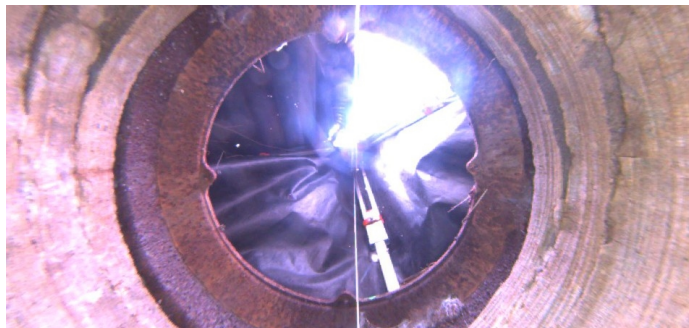
Code: **MGP**
Description: **General Photo**

Distance (ft): **3.2**
Structural Grade: **0**
O&M Grade: **0**
Clock Start/From:
Clock To:
1st Value:
2nd Value:
Value Percent:
Step: **NO**
Remarks:

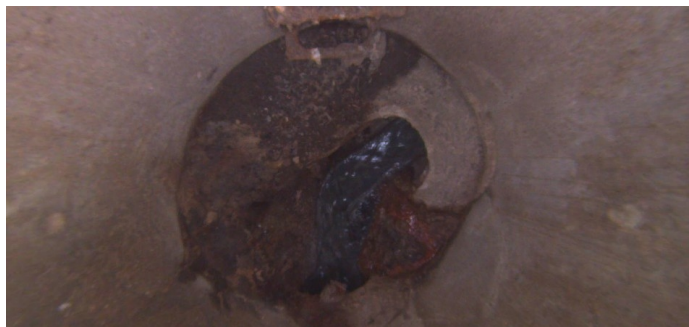
Code: **DAZ**
Description: **Deposits Attached Other**

Distance (ft): **9.0**
Structural Grade: **0**
O&M Grade: **2**
Clock Start/From: **12**
Clock To: **12**
1st Value:
2nd Value:
Value Percent: **10.000**
Step: **NO**
Remarks: **Mixed materials**

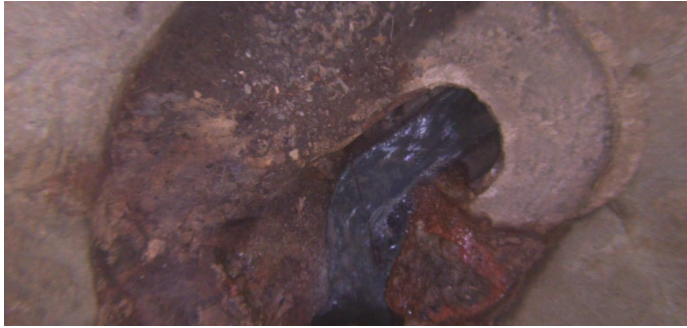
Code:	MGO
Description:	General Observation
Distance (ft):	10.6
Structural Grade:	0
O&M Grade:	0
Clock Start/From:	
Clock To:	
1st Value:	
2nd Value:	
Value Percent:	
Step:	NO
Remarks:	Ins. Comp.
