Manhole Inspection Report

Date:	03/28/2018	Weather:		Coding:	RZMACP
MH#:	M-507-013	Owner:	NA	Len. Surveyed:	8.9
P.O.#:		Surveyor:	John Kuglmaier	Rim to Invert:	9.4
Customer:		Cert. #:	U-1215-07002349	Wall Material:	Concrete (reinforced)

Street:	Csokasy Ln. 170' Northwest of Dela	Project:	Hobart, IN
City:	Hobart, IN	GPS Northing:	0.0
Location:		GPS Easting:	0.0
Drain Area:	Southwest	GPS Accuracy:	Nearest Meter
Cover Shape:	Circular	Evidence of Surcharge:	No
Cover Size:	22.5	Potential for Runoff:	None
Comments:

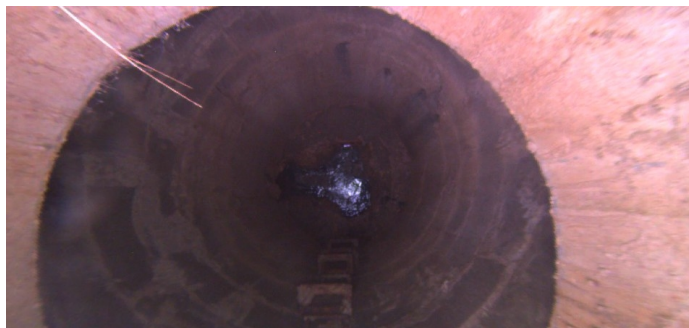
Code: **MGP**
Description: **General Photo**

Distance (ft): **.0**
Structural Grade: **0**
O&M Grade: **0**
Clock Start/From:
Clock To:
1st Value:
2nd Value:
Value Percent:
Step: **NO**
Remarks:

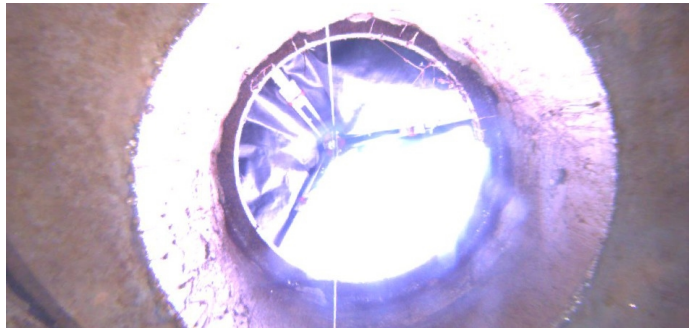
Code: **MGP**
Description: **General Photo**

Distance (ft): **2.4**
Structural Grade: **0**
O&M Grade: **0**
Clock Start/From:
Clock To:
1st Value:
2nd Value:
Value Percent:
Step: **NO**
Remarks:

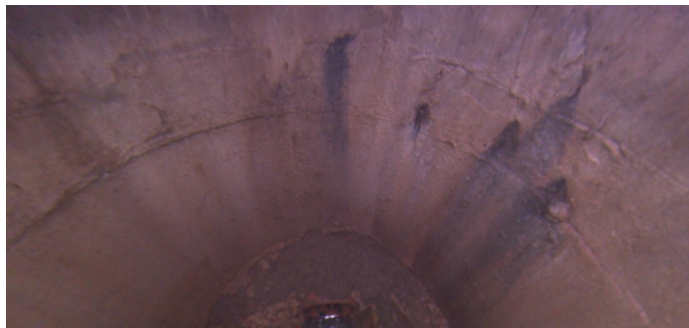
Code: **IS**
Description: **Infil Stain**

Distance (ft): **3.6**
Structural Grade: **0**
O&M Grade: **0**
Clock Start/From: **1**
Clock To: **2**
1st Value:
2nd Value:
Value Percent:
Step: **NO**
Remarks:

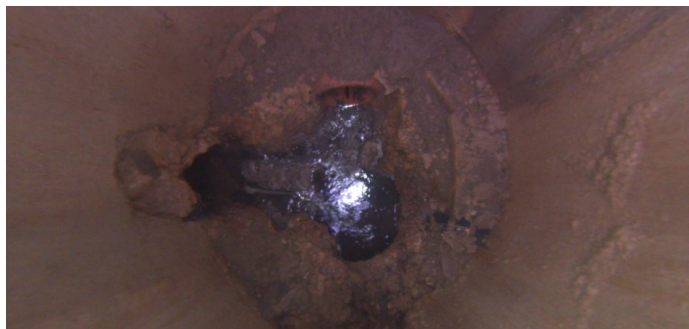
Code: **DSF**
Description: **Deposits Settled Fine**

Distance (ft): **4.9**
Structural Grade: **0**
O&M Grade: **3**
Clock Start/From: **12**
Clock To: **12**
1st Value:
2nd Value:
Value Percent: **15.000**
Step: **NO**
Remarks:

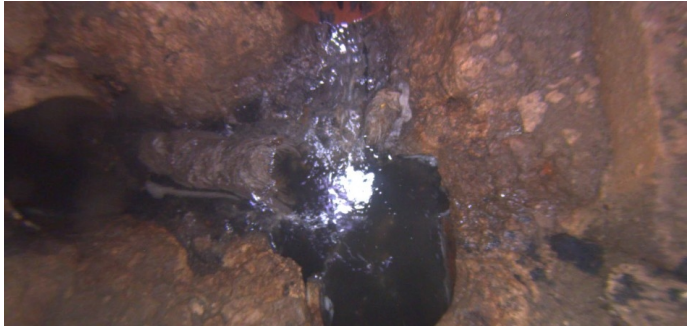
Code:	MGO
Description:	General Observation
Distance (ft):	7.2
Structural Grade:	0
O&M Grade:	0
Clock Start/From:	
Clock To:	
1st Value:	
2nd Value:	
Value Percent:	
Step:	NO
Remarks:	Ins. Comp.
