Manhole Inspection Report

Date:	04/07/2018	Weather:		Coding:	RZMACP
MH#:	M-507-014	Owner:	NA	Len. Surveyed:	8.4
P.O.#:		Surveyor:	John Kuglmaier	Rim to Invert:	8.6
Customer:		Cert. #:	U-1215-07002349	Wall Material:	Concrete (reinforced)

Street:	West of Delaware St. 265' North of	Project:	Hobart, IN
City:	Hobart, IN	GPS Northing:	0.0
Location:		GPS Easting:	0.0
Drain Area:	Southwest	GPS Accuracy:	Nearest Meter
Cover Shape:	Circular	Evidence of Surcharge:	Yes
Cover Size:	22.5	Potential for Runoff:	None
Comments:

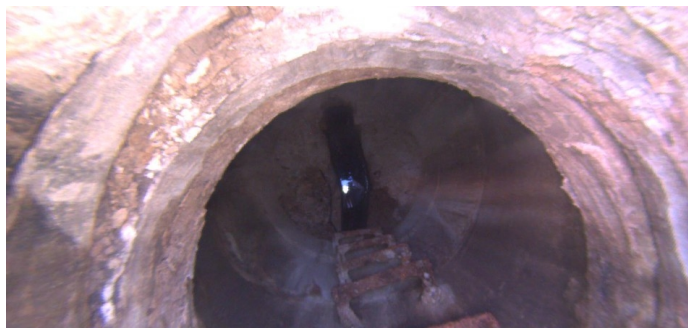
Code: **MGP**
Description: **General Photo**

Distance (ft): **.0**
Structural Grade: **0**
O&M Grade: **0**
Clock Start/From:
Clock To:
1st Value:
2nd Value:
Value Percent:
Step: **NO**
Remarks:

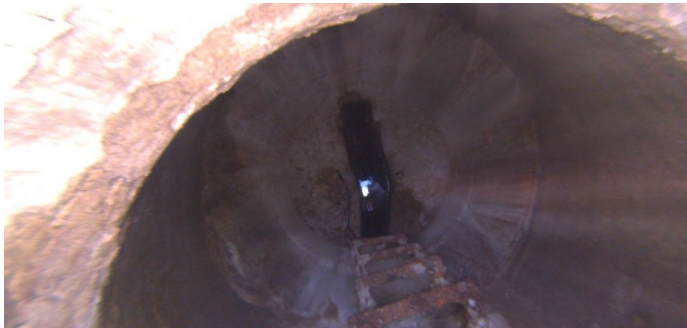
Code: **IS**
Description: **Infil Stain**

Distance (ft): **.8**
Structural Grade: **0**
O&M Grade: **0**
Clock Start/From: **12**
Clock To: **12**
1st Value:
2nd Value:
Value Percent:
Step: **NO**
Remarks:

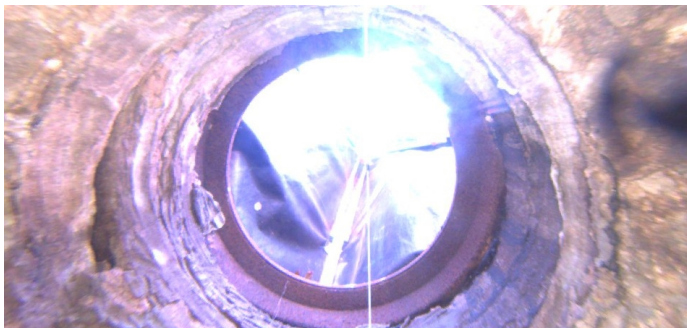
Code: **MGP**
Description: **General Photo**

Distance (ft): **2.5**
Structural Grade: **0**
O&M Grade: **0**
Clock Start/From:
Clock To:
1st Value:
2nd Value:
Value Percent:
Step: **NO**
Remarks:

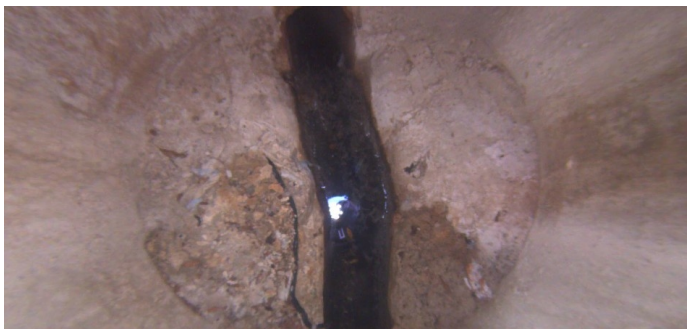
Code: **DAGS**
Description: **Deposits Attached Grease**

Distance (ft): **5.1**
Structural Grade: **0**
O&M Grade: **3**
Clock Start/From: **12**
Clock To: **12**
1st Value:
2nd Value:
Value Percent: **20.000**
Step: **NO**
Remarks:

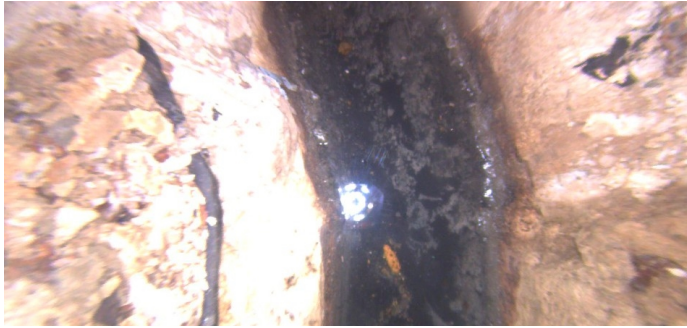
Code:	MGO
Description:	General Observation
Distance (ft):	7.3
Structural Grade:	0
O&M Grade:	0
Clock Start/From:	
Clock To:	
1st Value:	
2nd Value:	
Value Percent:	
Step:	NO
Remarks:	Ins. Comp.
