Manhole Inspection Report

Date:	04/07/2018	Weather:		Coding:	RZMACP
MH#:	M-507-016	Owner:	NA	Len. Surveyed:	6.6
P.O.#:		Surveyor:	John Kuglmaier	Rim to Invert:	7.3
Customer:		Cert. #:	U-1215-07002349	Wall Material:	Concrete (reinforced)

Street:	West of Delaware St. 358' South of	Project:	Hobart, IN
City:	Hobart, IN	GPS Northing:	0.0
Location:		GPS Easting:	0.0
Drain Area:	Southwest	GPS Accuracy:	Nearest Meter
Cover Shape:	Circular	Evidence of Surcharge:	No
Cover Size:	22.5	Potential for Runoff:	None
Comments:

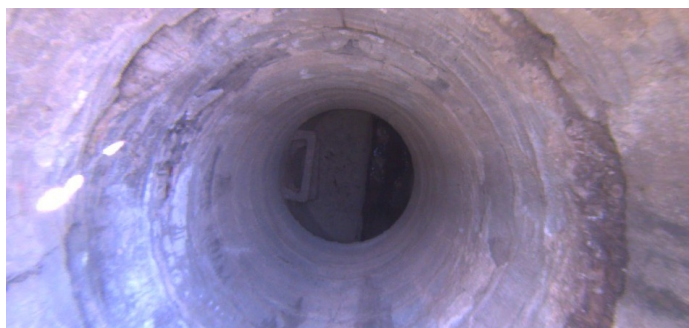
Code: **MGP**
Description: **General Photo**

Distance (ft): **.0**
Structural Grade: **0**
O&M Grade: **0**
Clock Start/From:
Clock To:
1st Value:
2nd Value:
Value Percent:
Step: **NO**
Remarks:

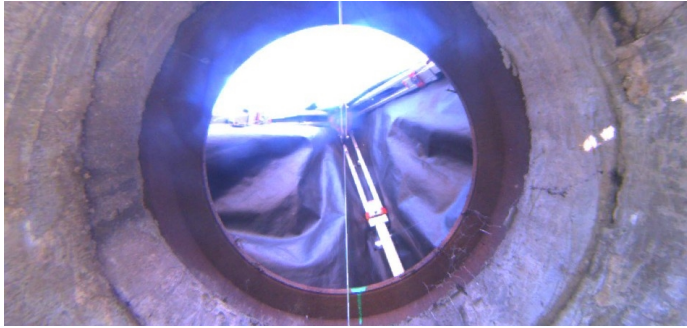
Code: **MGP**
Description: **General Photo**

Distance (ft): **2.1**
Structural Grade: **0**
O&M Grade: **0**
Clock Start/From:
Clock To:
1st Value:
2nd Value:
Value Percent:
Step: **NO**
Remarks:

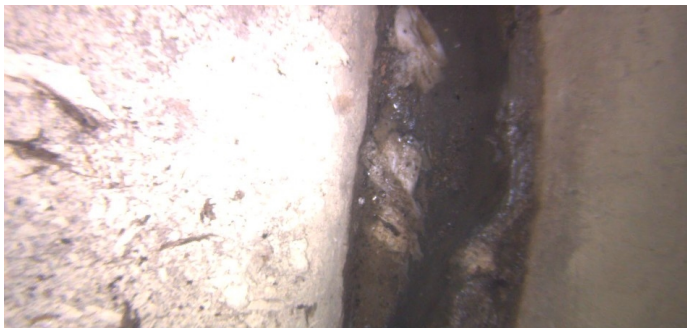
Code: **MGO**
Description: **General Observation**

Distance (ft): **5.6**
Structural Grade: **0**
O&M Grade: **0**
Clock Start/From:
Clock To:
1st Value:
2nd Value:
Value Percent:
Step: **NO**
Remarks: **Ins. Comp.**
