Manhole Inspection Report

Date:	04/07/2018	Weather:		Coding:	RZMACP
MH#:	M-507-017	Owner:	NA	Len. Surveyed:	6.8
P.O.#:		Surveyor:	John Kuglmaier	Rim to Invert:	7.7
Customer:		Cert. #:	U-1215-07002349	Wall Material:	Concrete (reinforced)

Street:	West of Delaware St. 197' South of	Project:	Hobart, IN
City:	Hobart, IN	GPS Northing:	0.0
Location:		GPS Easting:	0.0
Drain Area:	Southwest	GPS Accuracy:	Nearest Meter
Cover Shape:	Circular	Evidence of Surcharge:	No
Cover Size:	22.5	Potential for Runoff:	None
Comments:

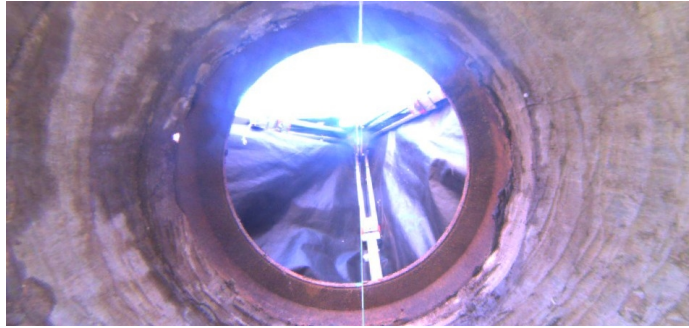
Code: **MGP**
Description: **General Photo**

Distance (ft): **2.0**
Structural Grade: **0**
O&M Grade: **0**
Clock Start/From:
Clock To:
1st Value:
2nd Value:
Value Percent:
Step: **NO**
Remarks:

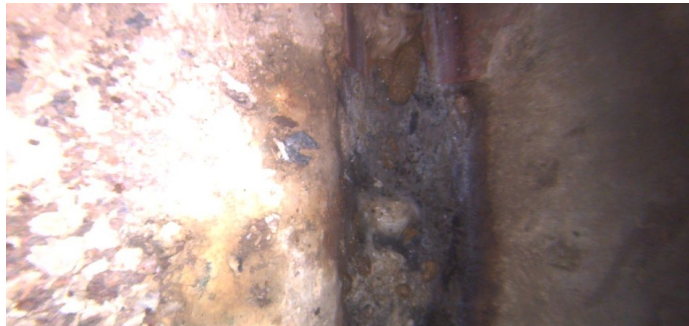
Code: **MGO**
Description: **General Observation**

Distance (ft): **6.1**
Structural Grade: **0**
O&M Grade: **0**
Clock Start/From:
Clock To:
1st Value:
2nd Value:
Value Percent:
Step: **NO**
Remarks: **Ins. Comp.**
