Manhole Inspection Report

Date:	03/28/2018	Weather:		Coding:	RZMACP
MH#:	M-507-023	Owner:	NA	Len. Surveyed:	8.6
P.O.#:		Surveyor:	John Kuglmaier	Rim to Invert:	9.1
Customer:		Cert. #:	U-1215-07002349	Wall Material:	Concrete (reinforced)

Street:	Csokasy Ln. 166' Northwest of Color	Project:	Hobart, IN
City:	Hobart, IN	GPS Northing:	0.0
Location:		GPS Easting:	0.0
Drain Area:	Southwest	GPS Accuracy:	Nearest Meter
Cover Shape:	Circular	Evidence of Surcharge:	Yes
Cover Size:	22.5	Potential for Runoff:	None
Comments:

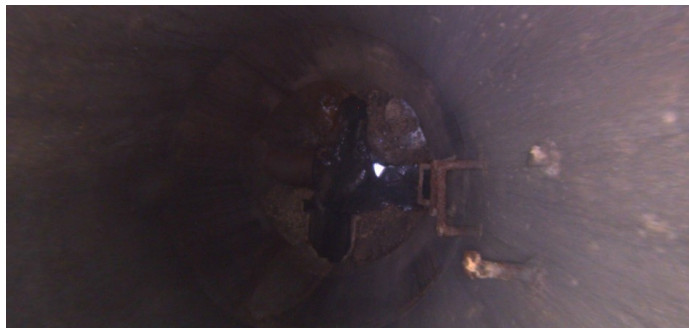
Code: **IS**
Description: **Infil Stain**

Distance (ft): **2.5**
Structural Grade: **0**
O&M Grade: **0**
Clock Start/From: **6**
Clock To: **12**
1st Value:
2nd Value:
Value Percent:
Step: **NO**
Remarks:

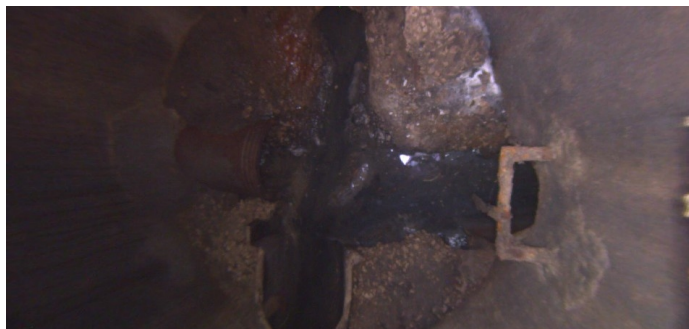
Code: **DAZ**
Description: **Deposits Attached Other**

Distance (ft): **5.8**
Structural Grade: **0**
O&M Grade: **2**
Clock Start/From: **12**
Clock To: **12**
1st Value:
2nd Value:
Value Percent: **10.000**
Step: **NO**
Remarks: **Mixed materials**

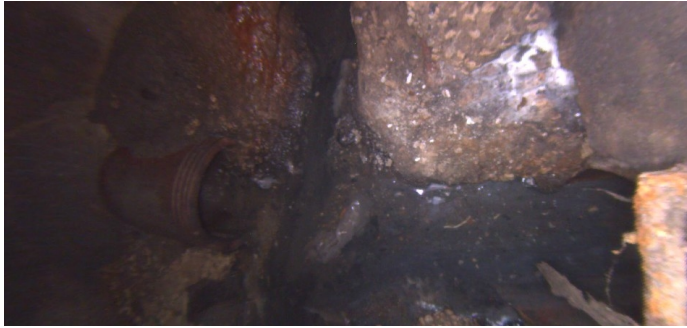
Code:	MGO
Description:	General Observation
Distance (ft):	6.9
Structural Grade:	0
O&M Grade:	0
Clock Start/From:	
Clock To:	
1st Value:	
2nd Value:	
Value Percent:	
Step:	NO
Remarks:	Ins. Comp.
