# Manhole Inspection Report

Date:	<b>04/26/2018</b>	Weather:		Coding:	<b>RZMACP</b>
MH#:	<b>M-507-028</b>	Owner:	<b>NA</b>	Len. Surveyed:	<b>5.1</b>
P.O.#:		Surveyor:	<b>Jen Costello</b>	Rim to Invert:	<b>5.6</b>
Customer:		Cert. #:	<b>U-907-5518</b>	Wall Material:	<b>Brick</b>

Street:	<b>Dekalb St. and 10th Pl. to the South.</b>	Project:	<b>Hobart, IN</b>
City:	<b>Hobart, IN</b>	GPS Northing:	<b>2900446.382</b>
Location:		GPS Easting:	<b>2900446.382</b>
Drain Area:	<b>Southwest</b>	GPS Accuracy:	<b>Sub-Meter</b>
Cover Shape:	<b>Circular</b>	Evidence of Surcharge:	<b>No</b>
Cover Size:	<b>22.5</b>	Potential for Runoff:	<b>None</b>
Comments:

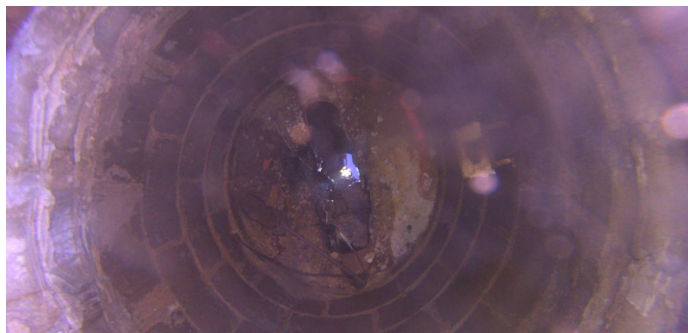
Code: **MGO**  
Description: **General Observation**

Distance (ft): **.0**  
Structural Grade: **0**  
O&M Grade: **0**  
Clock Start/From:  
Clock To:  
1st Value:  
2nd Value:  
Value Percent:  
Step: **NO**  
Remarks: **access MH**

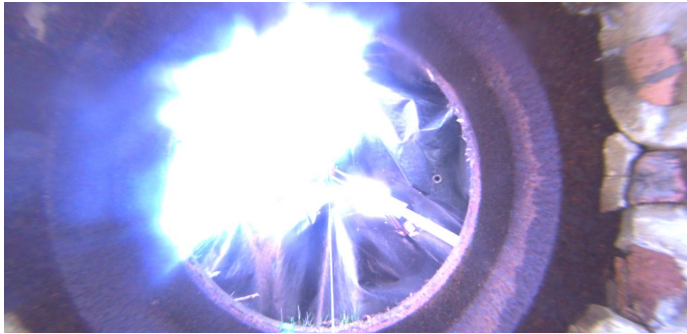
Code:	<b>MGO</b>
Description:	<b>General Observation</b>
Distance (ft):	<b>1.7</b>
Structural Grade:	<b>0</b>
O&M Grade:	<b>0</b>
Clock Start/From:	
Clock To:	
1st Value:	
2nd Value:	
Value Percent:	
Step:	<b>NO</b>
Remarks:	<b>UNDERSIDE OF FRAME</b>

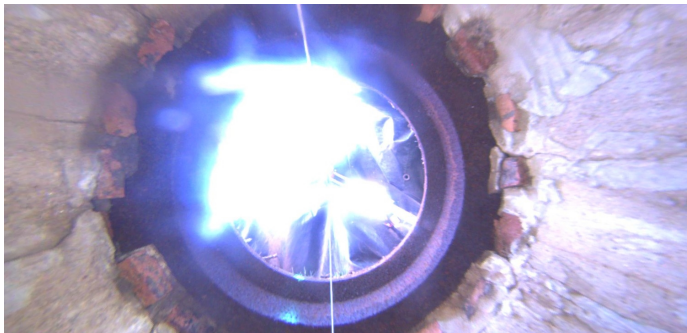
Code:	<b>FM</b>
Description:	<b>Fracture Multiple</b>
Distance (ft):	<b>2.3</b>
Structural Grade:	<b>4</b>
O&M Grade:	<b>0</b>
Clock Start/From:	<b>12</b>
Clock To:	<b>12</b>
1st Value:	
2nd Value:	
Value Percent:	
Step:	<b>NO</b>
Remarks:

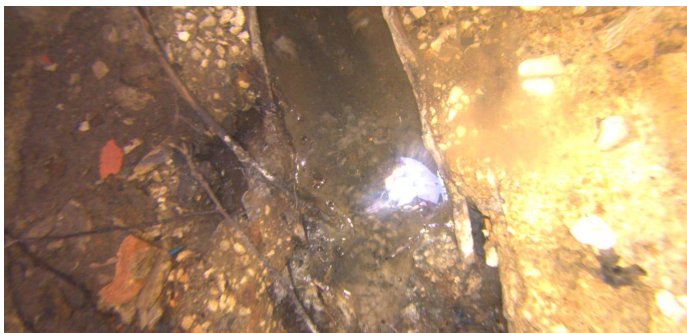
Code:	<b>B</b>
Description:	<b>Broken</b>
Distance (ft):	<b>4.3</b>
Structural Grade:	<b>3</b>
O&M Grade:	<b>0</b>
Clock Start/From:	<b>9</b>
Clock To:	
1st Value:	
2nd Value:	
Value Percent:	
Step:	<b>NO</b>
Remarks:

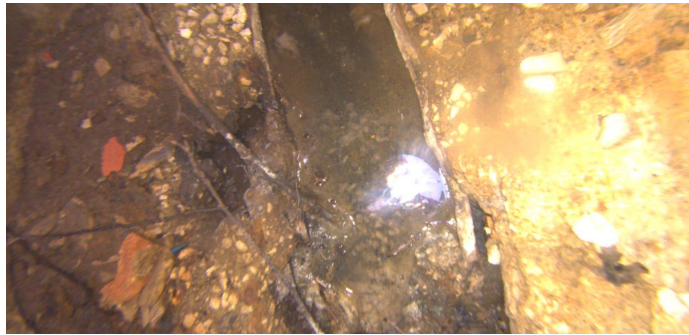
Code: **SAP**  
Description: **Surface Aggregate Projecting**

Distance (ft): **4.3**  
Structural Grade: **3**  
O&M Grade: **0**  
Clock Start/From: **12**  
Clock To: **12**  
1st Value:  
2nd Value:  
Value Percent:  
Step: **NO**  
Remarks:

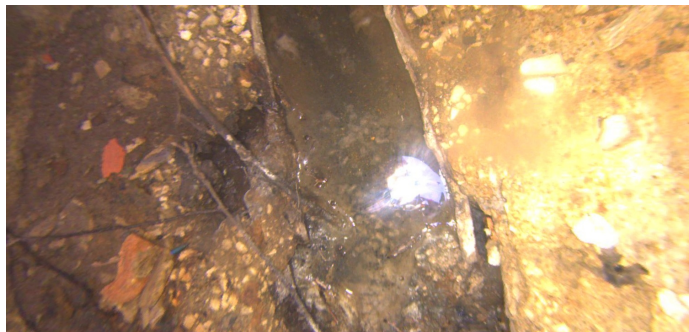
Code: **OBZ**  
Description: **Obstacle Other**

Distance (ft): **4.3**  
Structural Grade: **0**  
O&M Grade: **2**  
Clock Start/From: **12**  
Clock To: **12**  
1st Value:  
2nd Value:  
Value Percent: **5.000**  
Step: **NO**  
Remarks: **MISC**

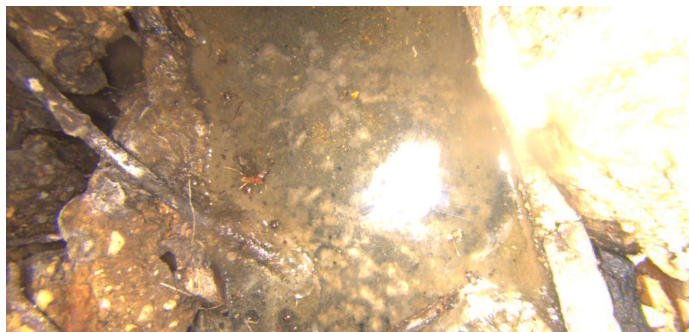
Code: **MGO**  
Description: **General Observation**

Distance (ft): **5.1**  
Structural Grade: **0**  
O&M Grade: **0**  
Clock Start/From:  
Clock To:  
1st Value:  
2nd Value:  
Value Percent:  
Step: **NO**  
Remarks: **END SURVEY**
