Manhole Inspection Report

Date:	03/27/2018	Weather:		Coding:	RZMACP
MH#:	M-507-029	Owner:	NA	Len. Surveyed:	8.8
P.O.#:		Surveyor:	John Kuglmaier	Rim to Invert:	9.3
Customer:		Cert. #:	U-1215-07002349	Wall Material:	Concrete (reinforced)

Street:	Northwest of Dekalb Ct. 188' South	Project:	Hobart, IN
City:	Hobart, IN	GPS Northing:	0.0
Location:		GPS Easting:	0.0
Drain Area:	Southwest	GPS Accuracy:	Nearest Meter
Cover Shape:	Circular	Evidence of Surcharge:	No
Cover Size:	22.5	Potential for Runoff:	None
Comments:

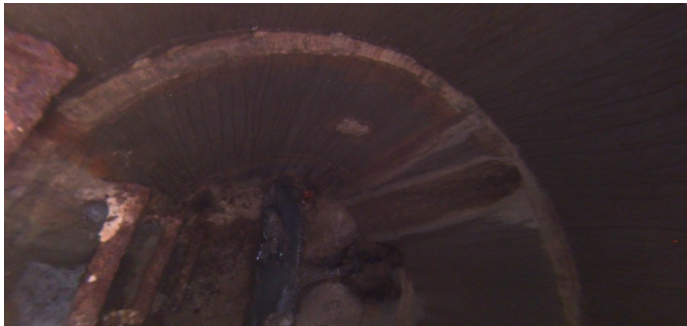
Code: **IS**
Description: **Infil Stain**

Distance (ft): **2.9**
Structural Grade: **0**
O&M Grade: **0**
Clock Start/From: **2**
Clock To:
1st Value:
2nd Value:
Value Percent:
Step: **NO**
Remarks:

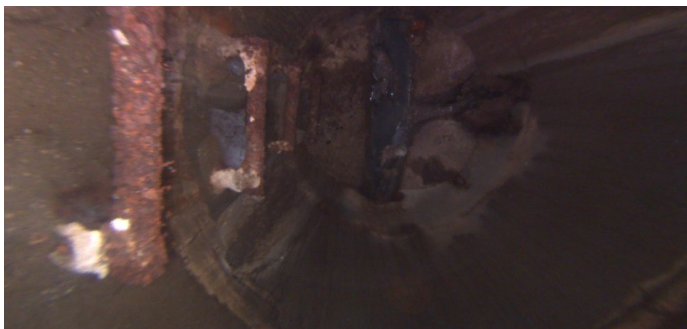
Code: **IS**
Description: **Infil Stain**

Distance (ft): **2.9**
Structural Grade: **0**
O&M Grade: **0**
Clock Start/From: **7**
Clock To:
1st Value:
2nd Value:
Value Percent:
Step: **NO**
Remarks:

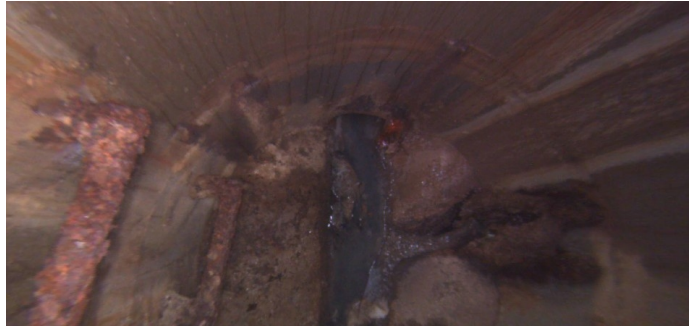
Code: **IS**
Description: **Infil Stain**

Distance (ft): **5.3**
Structural Grade: **0**
O&M Grade: **0**
Clock Start/From: **10**
Clock To:
1st Value:
2nd Value:
Value Percent:
Step: **NO**
Remarks:

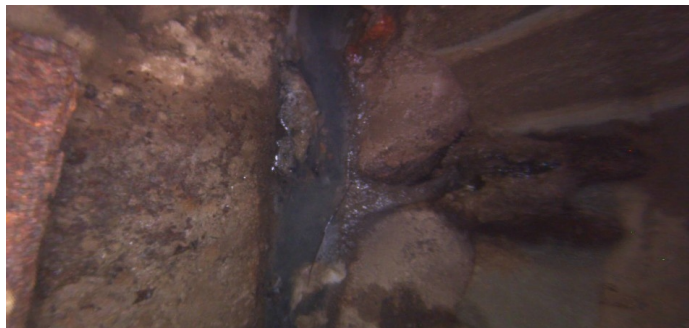
Code: **IS**
Description: **Infil Stain**

Distance (ft): **6.6**
Structural Grade: **0**
O&M Grade: **0**
Clock Start/From: **3**
Clock To:
1st Value:
2nd Value:
Value Percent:
Step: **NO**
Remarks:

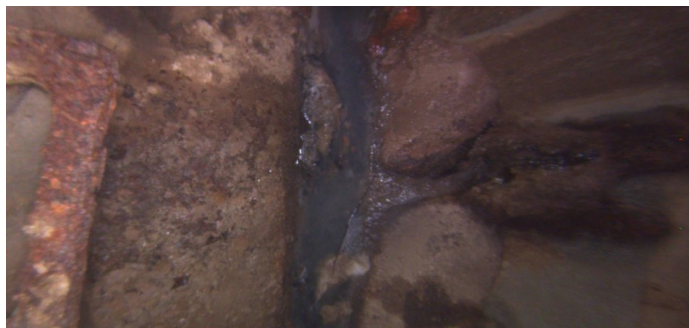
Code: **DAE**
Description: **Deposits Attached Encrustation**

Distance (ft): **6.6**
Structural Grade: **0**
O&M Grade: **2**
Clock Start/From: **3**
Clock To:
1st Value:
2nd Value:
Value Percent: **5.000**
Step: **NO**
Remarks:

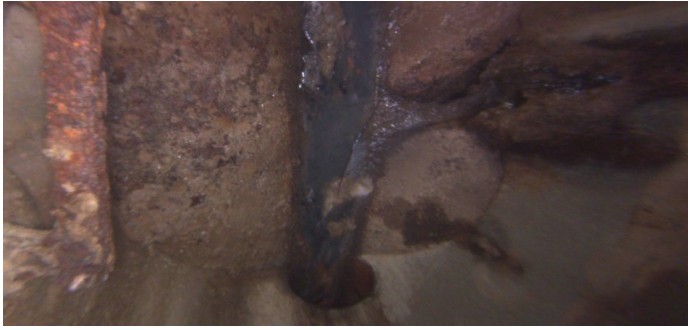
Code: **IS**
Description: **Infil Stain**

Distance (ft): **6.6**
Structural Grade: **0**
O&M Grade: **0**
Clock Start/From: **4**
Clock To:
1st Value:
2nd Value:
Value Percent:
Step: **NO**
Remarks:

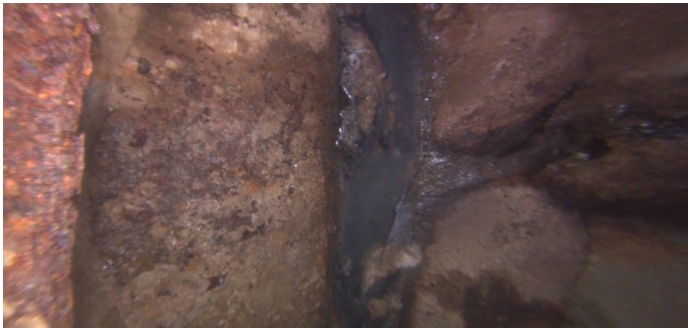
Code: **MGO**
Description: **General Observation**

Distance (ft): **7.1**
Structural Grade: **0**
O&M Grade: **0**
Clock Start/From:
Clock To:
1st Value:
2nd Value:
Value Percent:
Step: **NO**
Remarks: **Ins. Comp.**
