Manhole Inspection Report

Date:	04/07/2018	Weather:		Coding:	RZMACP
MH#:	M-507-030	Owner:	NA	Len. Surveyed:	7.4
P.O.#:		Surveyor:	John Kuglmaier	Rim to Invert:	8.0
Customer:		Cert. #:	U-1215-07002349	Wall Material:	Concrete (reinforced)

Street:	South of Decatur St. 78' Southwest	Project:	Hobart, IN
City:	Hobart, IN	GPS Northing:	0.0
Location:		GPS Easting:	0.0
Drain Area:	Southwest	GPS Accuracy:	Nearest Meter
Cover Shape:	Circular	Evidence of Surcharge:	Yes
Cover Size:	22.5	Potential for Runoff:	None
Comments:

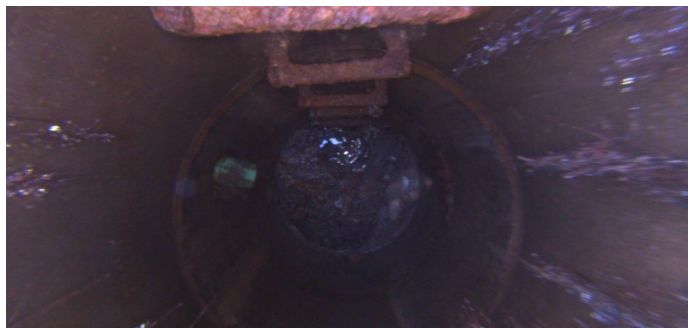
Code: **MGP**
Description: **General Photo**

Distance (ft): **.0**
Structural Grade: **0**
O&M Grade: **0**
Clock Start/From:
Clock To:
1st Value:
2nd Value:
Value Percent:
Step: **NO**
Remarks:

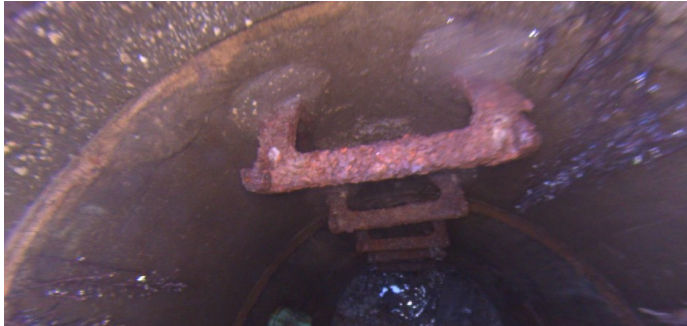
Code: **RFJ**
Description: **Roots Fine Joint**

Distance (ft): **.0**
Structural Grade: **0**
O&M Grade: **1**
Clock Start/From: **1**
Clock To: **9**
1st Value:
2nd Value:
Value Percent:
Step: **NO**
Remarks:

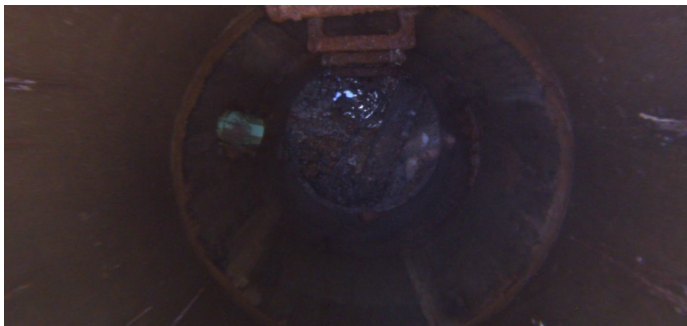
Code: **IS**
Description: **Infil Stain**

Distance (ft): **.6**
Structural Grade: **0**
O&M Grade: **0**
Clock Start/From: **12**
Clock To: **12**
1st Value:
2nd Value:
Value Percent:
Step: **NO**
Remarks:

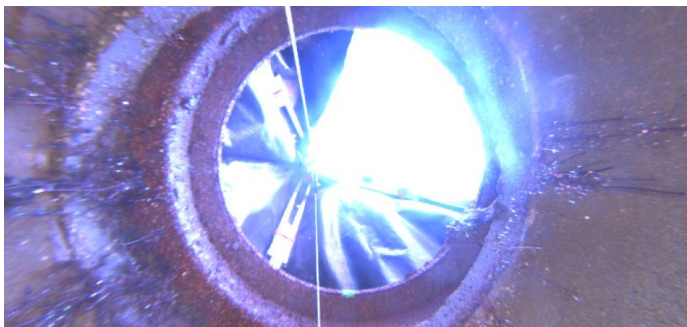
Code: **MGP**
Description: **General Photo**

Distance (ft): **2.2**
Structural Grade: **0**
O&M Grade: **0**
Clock Start/From:
Clock To:
1st Value:
2nd Value:
Value Percent:
Step: **NO**
Remarks:

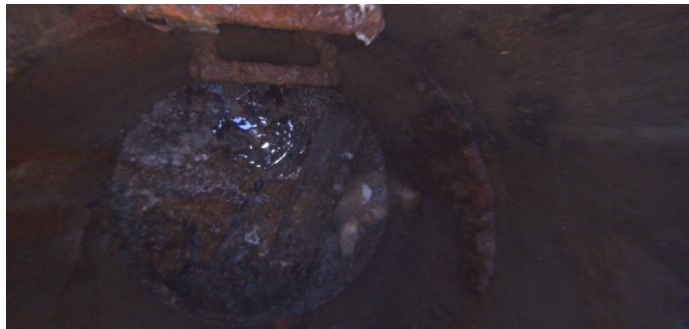
Code: **IS**
Description: **Infil Stain**

Distance (ft): **3.4**
Structural Grade: **0**
O&M Grade: **0**
Clock Start/From: **2**
Clock To: **4**
1st Value:
2nd Value:
Value Percent:
Step: **NO**
Remarks:

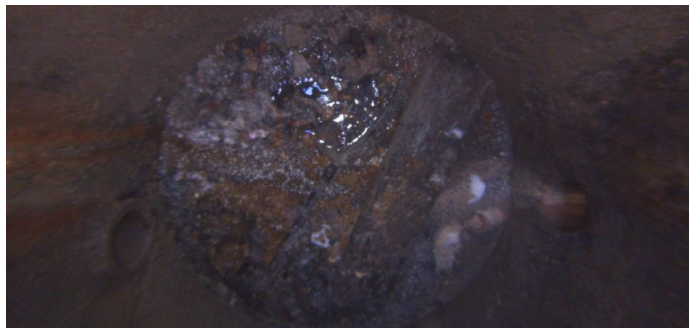
Code: **DAZ**
Description: **Deposits Attached Other**

Distance (ft): **4.8**
Structural Grade: **0**
O&M Grade: **2**
Clock Start/From: **12**
Clock To: **12**
1st Value:
2nd Value:
Value Percent: **10.000**
Step: **NO**
Remarks: **Mixed materials**

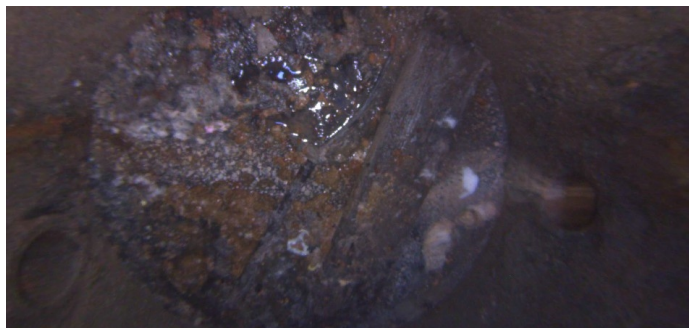
Code: **OBZ**
Description: **Obstacle Other**

Distance (ft): **5.2**
Structural Grade: **0**
O&M Grade: **2**
Clock Start/From: **2**
Clock To: **5**
1st Value:
2nd Value:
Value Percent: **10.000**
Step: **NO**
Remarks: **Wood**

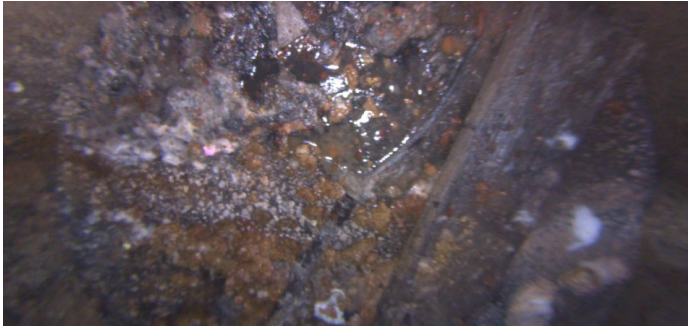
Code:	MGO
Description:	General Observation
Distance (ft):	6.2
Structural Grade:	0
O&M Grade:	0
Clock Start/From:	
Clock To:	
1st Value:	
2nd Value:	
Value Percent:	
Step:	NO
Remarks:	Ins. Comp.
