Manhole Inspection Report

Date:	03/28/2018	Weather:		Coding:	RZMACP
MH#:	M-507-031	Owner:	NA	Len. Surveyed:	6.7
P.O.#:		Surveyor:	John Kuglmaier	Rim to Invert:	7.3
Customer:		Cert. #:	U-1215-07002349	Wall Material:	Concrete (reinforced)

Street:	East of Decatur St. Csokasy Ln.	Project:	Hobart, IN
City:	Hobart, IN	GPS Northing:	0.0
Location:		GPS Easting:	0.0
Drain Area:	Southwest	GPS Accuracy:	Nearest Meter
Cover Shape:	Circular	Evidence of Surcharge:	No
Cover Size:	22.5	Potential for Runoff:	None
Comments:

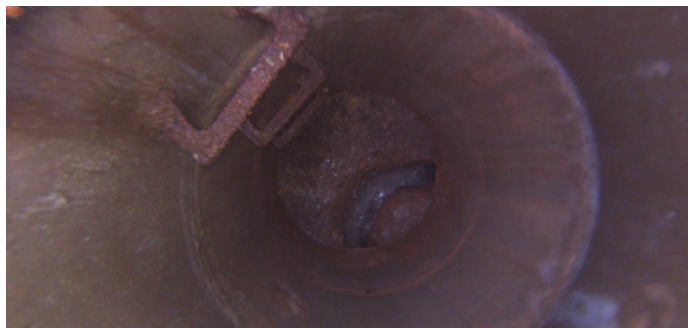
Code: **MGP**
Description: **General Photo**

Distance (ft): **.0**
Structural Grade: **0**
O&M Grade: **0**
Clock Start/From:
Clock To:
1st Value:
2nd Value:
Value Percent:
Step: **NO**
Remarks:

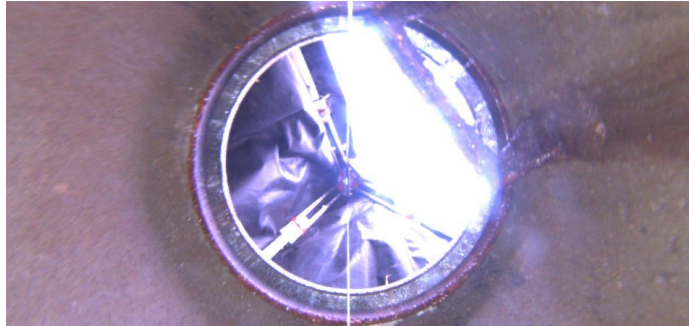
Code: **MGP**
Description: **General Photo**

Distance (ft): **2.2**
Structural Grade: **0**
O&M Grade: **0**
Clock Start/From:
Clock To:
1st Value:
2nd Value:
Value Percent:
Step: **NO**
Remarks:

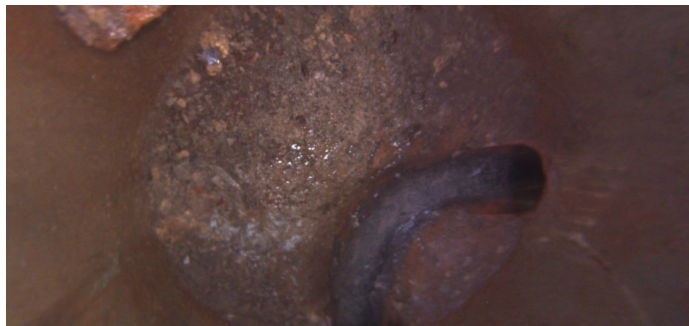
Code: **DAZ**
Description: **Deposits Attached Other**

Distance (ft): **4.2**
Structural Grade: **0**
O&M Grade: **2**
Clock Start/From: **12**
Clock To: **12**
1st Value:
2nd Value:
Value Percent: **5.000**
Step: **NO**
Remarks: **Mixed materials**

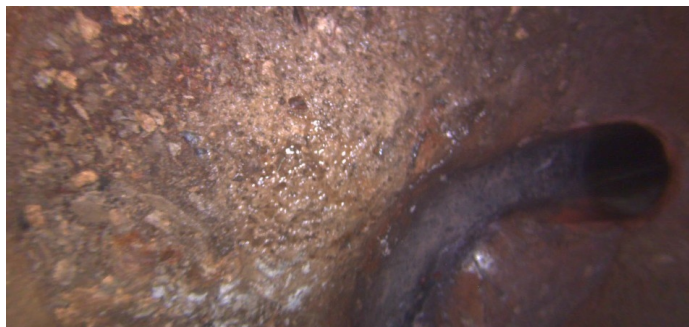
Code: **MGO**
Description: **General Observation**

Distance (ft): **5.3**
Structural Grade: **0**
O&M Grade: **0**
Clock Start/From:
Clock To:
1st Value:
2nd Value:
Value Percent:
Step: **NO**
Remarks: **Ins. Comp.**
