Manhole Inspection Report

Date:	04/24/2018	Weather:		Coding:	RZMACP
MH#:	M-507-036.1	Owner:	NA	Len. Surveyed:	5.5
P.O.#:		Surveyor:	Jen Costello	Rim to Invert:	5.8
Customer:		Cert. #:	U-907-5518	Wall Material:	Concrete (reinforced)

Street:	Decatur St. and 10th St.	Project:	Hobart, IN
City:	Hobart, IN	GPS Northing:	2900070.041
Location:		GPS Easting:	2900070.041
Drain Area:	Southwest	GPS Accuracy:	Sub-Meter
Cover Shape:	Circular	Evidence of Surcharge:	No
Cover Size:	22.5	Potential for Runoff:	None
Comments:

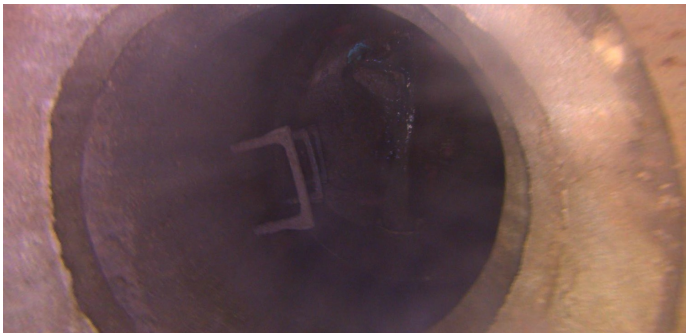
Code: **MGO**
Description: **General Observation**

Distance (ft):	.0
Structural Grade:	0
O&M Grade:	0
Clock Start/From:	
Clock To:	
1st Value:	
2nd Value:	
Value Percent:

Step: NO
Remarks: ACCESS MH

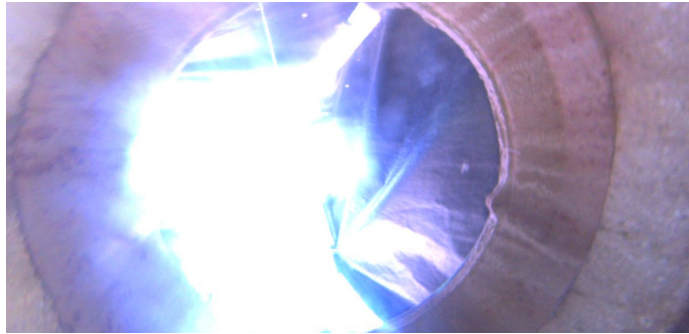
Code:	MGP
Description:	General Photo
Distance (ft):	1.7
Structural Grade:	0
O&M Grade:	0
Clock Start/From:	
Clock To:	
1st Value:	
2nd Value:	
Value Percent:	
Step:	NO
Remarks:	UNDERSIDE OF FRAME

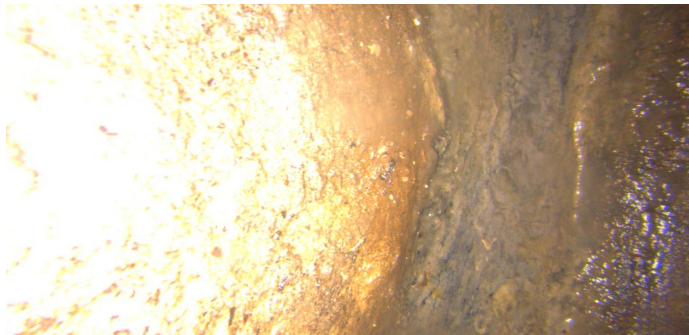
Code:	MGO
Description:	General Observation
Distance (ft):	5.5
Structural Grade:	0
O&M Grade:	0
Clock Start/From:	
Clock To:	
1st Value:	
2nd Value:	
Value Percent:	
Step:	NO
Remarks:	END SURVEY
