Manhole Inspection Report

Date:	04/26/2018	Weather:		Coding:	RZMACP
MH#:	M-507-036.2	Owner:	NA	Len. Surveyed:	6.4
P.O.#:		Surveyor:	Jen Costello	Rim to Invert:	7.0
Customer:		Cert. #:	U-907-5518	Wall Material:	Concrete (reinforced)

Street:	10th St. 357' East of Decatur St.	Project:	Hobart, IN
City:	Hobart, IN	GPS Northing:	41.52183151
Location:		GPS Easting:	-87.27423859
Drain Area:	Southwest	GPS Accuracy:	Nearest Meter
Cover Shape:	Circular	Evidence of Surcharge:	No
Cover Size:	22.5	Potential for Runoff:	None
Comments:

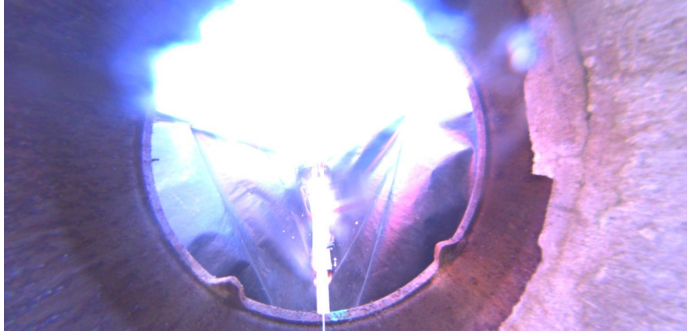
Code: **MGO**
Description: **General Observation**

Distance (ft): **1.6**
Structural Grade: **0**
O&M Grade: **0**
Clock Start/From:
Clock To:
1st Value:
2nd Value:
Value Percent:
Step: **NO**
Remarks: **UNDERSIDE OF FRAME**

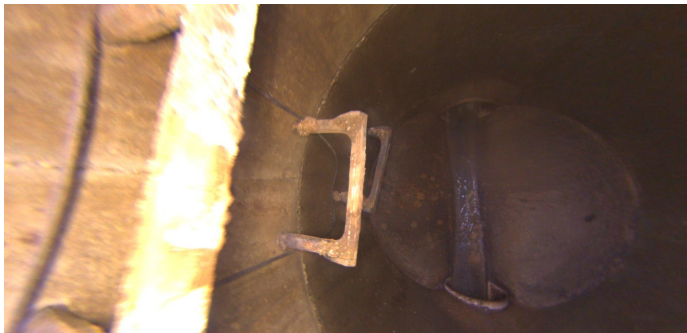
Code: **FL**
Description: **Fracture Longitudinal**

Distance (ft): **2.5**
Structural Grade: **3**
O&M Grade: **0**
Clock Start/From: **9**
Clock To:
1st Value:
2nd Value:
Value Percent:
Step: **NO**
Remarks:

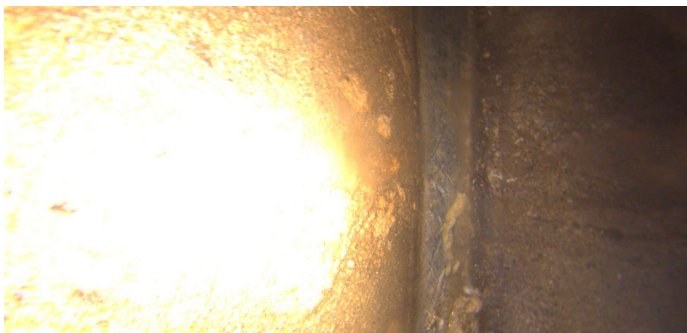
Code: **MGO**
Description: **General Observation**

Distance (ft): **6.4**
Structural Grade: **0**
O&M Grade: **0**
Clock Start/From:
Clock To:
1st Value:
2nd Value:
Value Percent:
Step: **NO**
Remarks: **END SURVEY**
