Manhole Inspection Report

Date:	04/26/2018	Weather:		Coding:	RZMACP
MH#:	M-507-036.3	Owner:	NA	Len. Surveyed:	6.1
P.O.#:		Surveyor:	Jen Costello	Rim to Invert:	6.7
Customer:		Cert. #:	U-907-5518	Wall Material:	Concrete (reinforced)

Street:	South of 10th St. 523' West of Virgin	Project:	Hobart, IN
City:	Hobart, IN	GPS Northing:	2900858.928
Location:		GPS Easting:	2900858.928
Drain Area:	Southwest	GPS Accuracy:	Sub-Meter
Cover Shape:	Circular	Evidence of Surcharge:	No
Cover Size:	22.5	Potential for Runoff:	None
Comments:

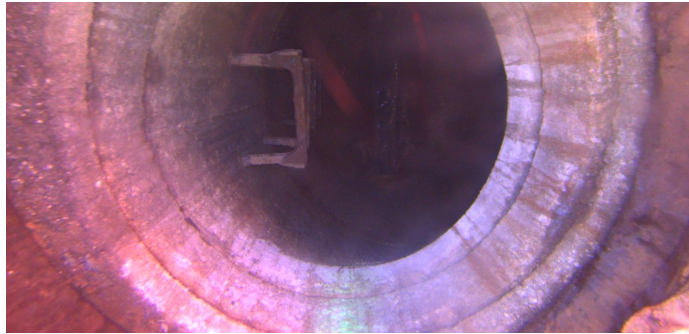
Code: **SAV**
Description: **Surface Aggregate Visible**

Distance (ft): **.0**
Structural Grade: **3**
O&M Grade: **0**
Clock Start/From: **12**
Clock To: **12**
1st Value:
2nd Value:
Value Percent:
Step: **NO**
Remarks:

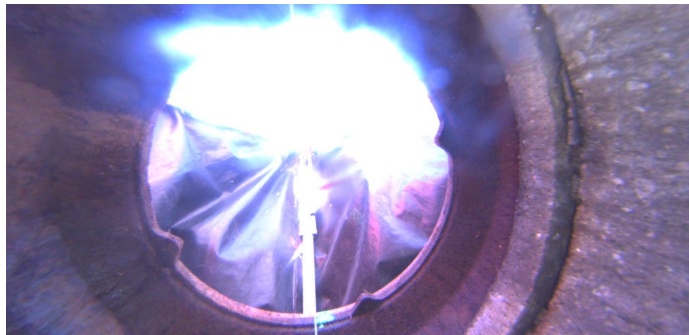
Code: **MGO**
Description: **General Observation**

Distance (ft): **1.7**
Structural Grade: **0**
O&M Grade: **0**
Clock Start/From:
Clock To:
1st Value:
2nd Value:
Value Percent:
Step: **NO**
Remarks: **UNDERSIDE OF FRAME**

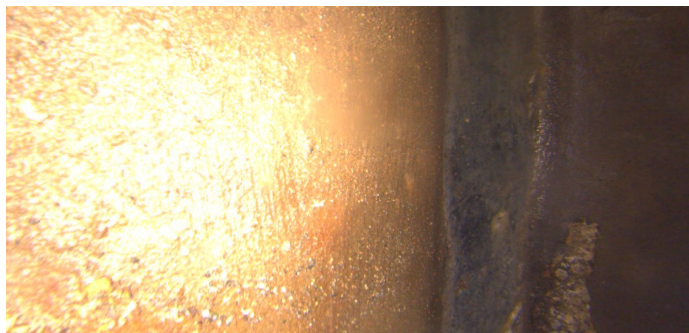
Code: **MGO**
Description: **General Observation**

Distance (ft): **6.1**
Structural Grade: **0**
O&M Grade: **0**
Clock Start/From:
Clock To:
1st Value:
2nd Value:
Value Percent:
Step: **NO**
Remarks: **END SURVEY**
