Manhole Inspection Report

Date:	04/25/2018	Weather:		Coding:	RZMACP
MH#:	M-507-037	Owner:	NA	Len. Surveyed:	7.3
P.O.#:		Surveyor:	John Kuglmaier	Rim to Invert:	7.0
Customer:	8.7	Cert. #:	U-1215-07002349	Wall Material:	Concrete (reinforced)

Street:	10th St. Wisconsin St	Project:	Hobart, IN
City:	Hobart, IN	GPS Northing:	0.0
Location:		GPS Easting:	0.0
Drain Area:	Southwest	GPS Accuracy:	Nearest Meter
Cover Shape:	Circular	Evidence of Surcharge:	Yes
Cover Size:	22.5	Potential for Runoff:	None
Comments:

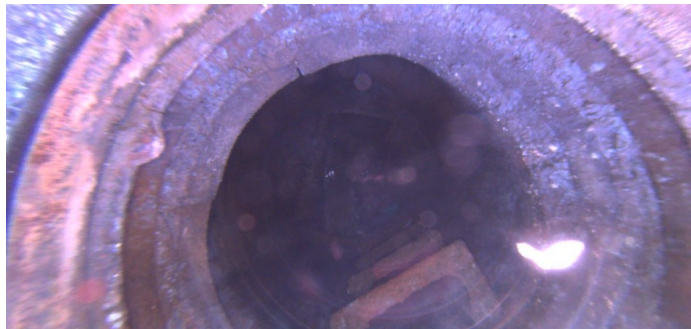
Code: **MGP**
Description: **General Photo**

Distance (ft): **.0**
Structural Grade: **0**
O&M Grade: **0**
Clock Start/From:
Clock To:
1st Value:
2nd Value:
Value Percent:
Step: **NO**
Remarks:

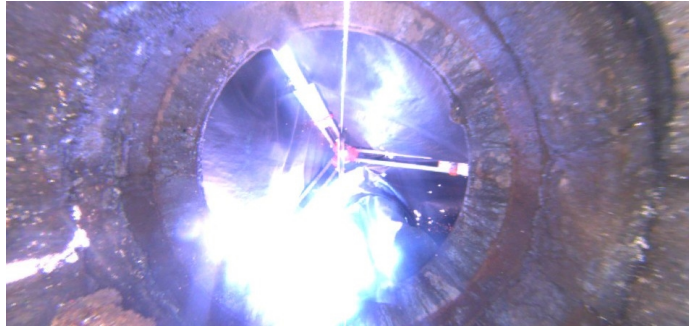
Code: **MGP**
Description: **General Photo**

Distance (ft): **2.9**
Structural Grade: **0**
O&M Grade: **0**
Clock Start/From:
Clock To:
1st Value:
2nd Value:
Value Percent:
Step: **NO**
Remarks:

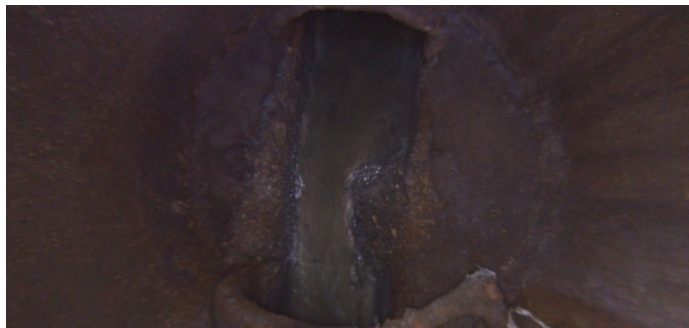
Code: **DSF**
Description: **Deposits Settled Fine**

Distance (ft): **4.2**
Structural Grade: **0**
O&M Grade: **3**
Clock Start/From: **12**
Clock To: **12**
1st Value:
2nd Value:
Value Percent: **15.000**
Step: **NO**
Remarks:

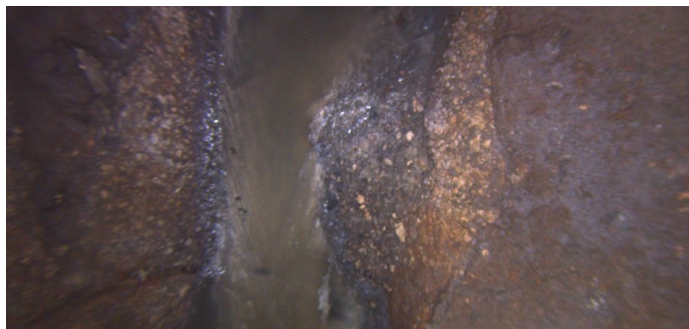
Code: **MGO**
Description: **General Observation**

Distance (ft): **6.3**
Structural Grade: **0**
O&M Grade: **0**
Clock Start/From:
Clock To:
1st Value:
2nd Value:
Value Percent:
Step: **NO**
Remarks: **Ins. Comp.**
