Manhole Inspection Report

Date:	04/25/2018	Weather:		Coding:	RZMACP
MH#:	M-507-038	Owner:	NA	Len. Surveyed:	7.4
P.O.#:		Surveyor:	John Kuglmaier	Rim to Invert:	7.9
Customer:	8.7	Cert. #:	U-1215-07002349	Wall Material:	Concrete (reinforced)

Street:	10th St. 238' East of Virginia St.	Project:	Hobart, IN
City:	Hobart, IN	GPS Northing:	0.0
Location:		GPS Easting:	0.0
Drain Area:	Southwest	GPS Accuracy:	Nearest Meter
Cover Shape:	Circular	Evidence of Surcharge:	Yes
Cover Size:	22.5	Potential for Runoff:	None
Comments:

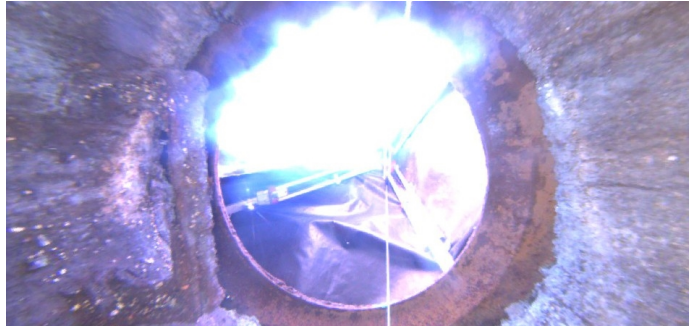
Code:	MGP
Description:	General Photo

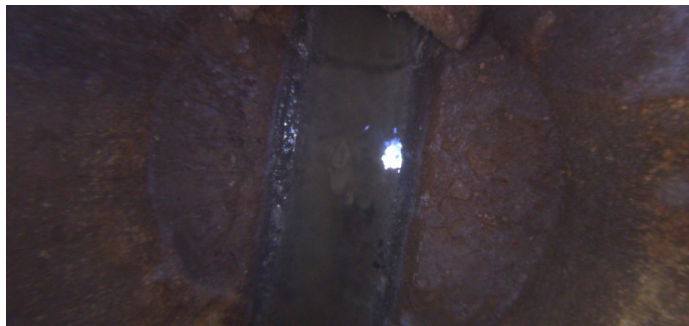
Code: **MGP**
Description: **General Photo**

Distance (ft): **2.8**
Structural Grade: **0**
O&M Grade: **0**
Clock Start/From:
Clock To:
1st Value:
2nd Value:
Value Percent:
Step: **NO**
Remarks:

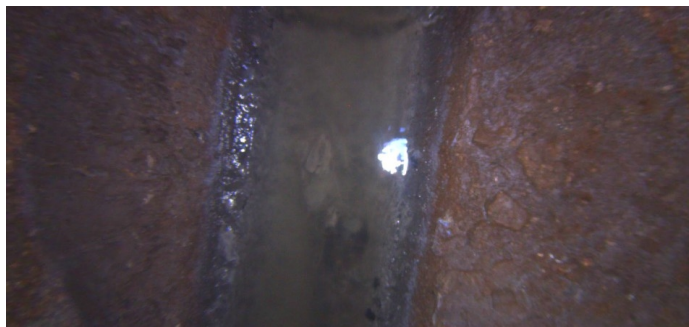
Code: **DSF**
Description: **Deposits Settled Fine**

Distance (ft): **5.3**
Structural Grade: **0**
O&M Grade: **3**
Clock Start/From: **12**
Clock To: **12**
1st Value:
2nd Value:
Value Percent: **15.000**
Step: **NO**
Remarks:
