Manhole Inspection Report

Date:	04/25/2018	Weather:		Coding:	RZMACP
MH#:	M-507-038A	Owner:	NA	Len. Surveyed:	5.7
P.O.#:		Surveyor:	Jen Costello	Rim to Invert:	7.0
Customer:	8.7	Cert. #:	U-907-5518	Wall Material:	Concrete (reinforced)

Street:	10th St. Wisconsin St	Project:	Hobart, IN
City:	Hobart, IN	GPS Northing:	0.0
Location:		GPS Easting:	0.0
Drain Area:	Southwest	GPS Accuracy:	Nearest Meter
Cover Shape:	Circular	Evidence of Surcharge:	No
Cover Size:	22.5	Potential for Runoff:	None
Comments:

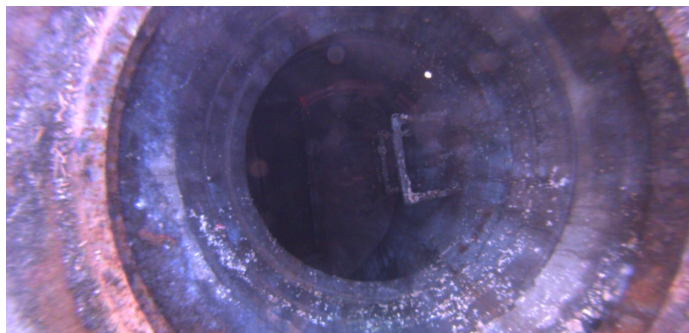
Code: **MGO**
Description: **General Observation**

Distance (ft): **.0**
Structural Grade: **0**
O&M Grade: **0**
Clock Start/From:
Clock To:
1st Value:
2nd Value:
Value Percent:
Step: **NO**
Remarks: **ACCESS MH**

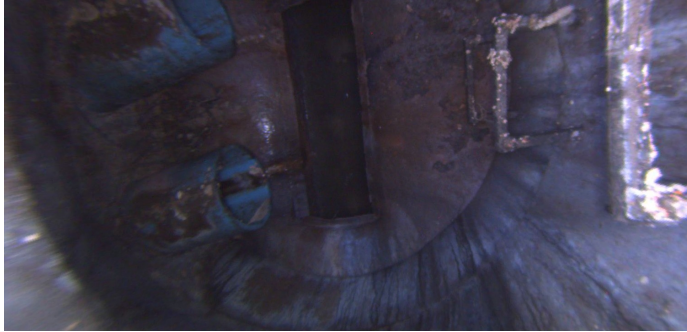
Code: **IS**
Description: **Infil Stain**

Distance (ft): **1.9**
Structural Grade: **0**
O&M Grade: **0**
Clock Start/From: **12**
Clock To: **12**
1st Value:
2nd Value:
Value Percent:
Step: **NO**
Remarks:

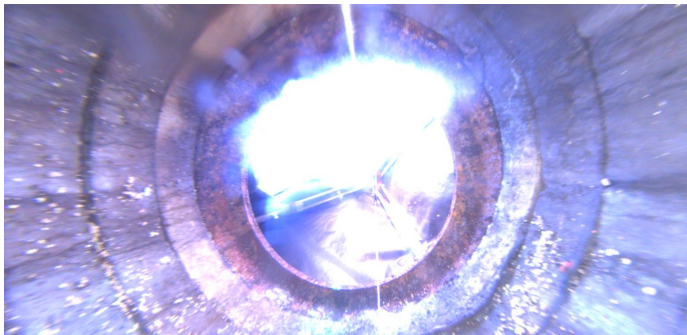
Code: **MGO**
Description: **General Observation**

Distance (ft): **2.6**
Structural Grade: **0**
O&M Grade: **0**
Clock Start/From:
Clock To:
1st Value:
2nd Value:
Value Percent:
Step: **NO**
Remarks: **UNDERSIDE OF FRAME**

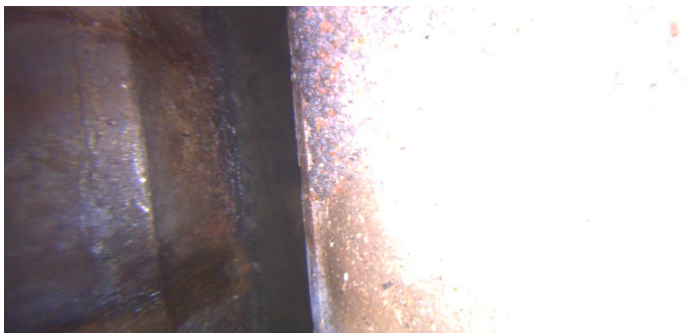
Code: **MGO**
Description: **General Observation**

Distance (ft): **5.7**
Structural Grade: **0**
O&M Grade: **0**
Clock Start/From:
Clock To:
1st Value:
2nd Value:
Value Percent:
Step: **NO**
Remarks: **END SURVEY**
