Manhole Inspection Report

Date:	04/25/2018	Weather:		Coding:	RZMACP
MH#:	M-507-039.2	Owner:	NA	Len. Surveyed:	3.9
P.O.#:		Surveyor:	Jen Costello	Rim to Invert:	3.6
Customer:		Cert. #:	U-907-5518	Wall Material:	Concrete (reinforced)

Street:	132' West of Virginia St. South of 10	Project:	Hobart, IN
City:	Hobart, IN	GPS Northing:	2901211.19
Location:		GPS Easting:	2901211.19
Drain Area:	Southwest	GPS Accuracy:	Sub-Meter
Cover Shape:	Circular	Evidence of Surcharge:	No
Cover Size:	22.5	Potential for Runoff:	None
Comments:

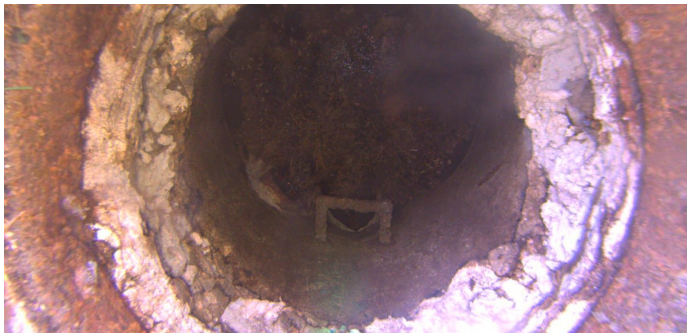
Code:	MGO
Description:	General Observation

Distance (ft):	.0
Structural Grade:	0
O&M Grade:	0
Clock Start/From:	
Clock To:	
1st Value:	
2nd Value:	
Value Percent:	
Step:	NO
Remarks:	ac

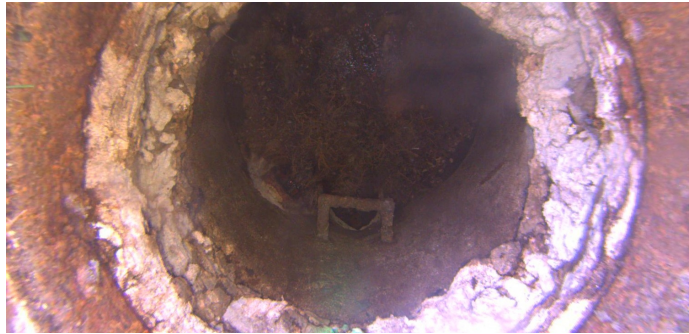
Code:	DAE
Description:	Deposits Attached Encrustation
Distance (ft):	.0
Structural Grade:	0
O&M Grade:	2
Clock Start/From:	12
Clock To:	12
1st Value:	
2nd Value:	
Value Percent:	10.000
Step:	NO
Remarks:

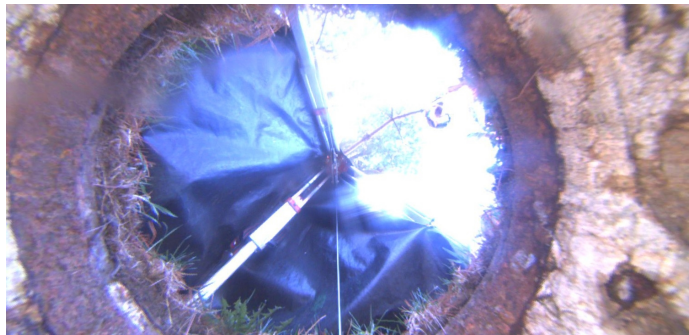
Code:	MGP
Description:	General Photo
Distance (ft):	1.6
Structural Grade:	0
O&M Grade:	0
Clock Start/From:	
Clock To:	
1st Value:	
2nd Value:	
Value Percent:	
Step:	NO
Remarks:	UNDERSIDE OF FRAME

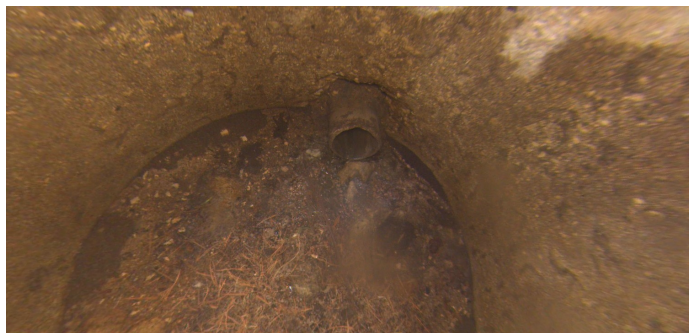
Code:	SAV
Description:	Surface Aggregate Visible
Distance (ft):	1.6
Structural Grade:	3
O&M Grade:	0
Clock Start/From:	12
Clock To:	12
1st Value:	
2nd Value:	
Value Percent:	
Step:	NO
Remarks:

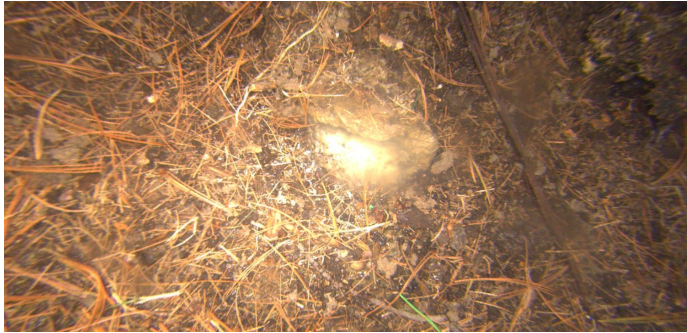
Code: **DSF**
Description: **Deposits Settled Fine**

Distance (ft): **3.7**
Structural Grade: **0**
O&M Grade: **2**
Clock Start/From: **12**
Clock To: **12**
1st Value:
2nd Value:
Value Percent: **10.000**
Step: **NO**
Remarks:

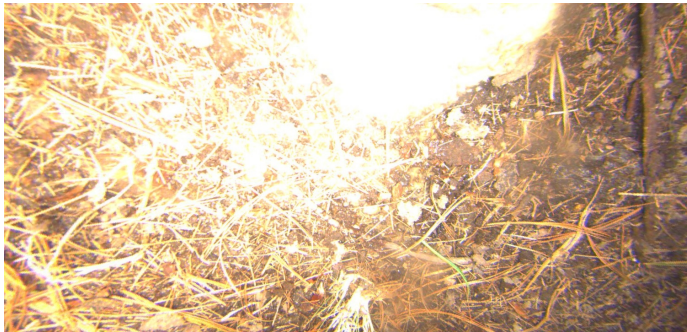
Code: **MGO**
Description: **General Observation**

Distance (ft): **3.9**
Structural Grade: **0**
O&M Grade: **0**
Clock Start/From:
Clock To:
1st Value:
2nd Value:
Value Percent:
Step: **NO**
Remarks: **END SURVEY**
