Manhole Inspection Report

Date:	04/25/2018	Weather:		Coding:	RZMACP
MH#:	M-507-039.3	Owner:	NA	Len. Surveyed:	4.7
P.O.#:		Surveyor:	Jen Costello	Rim to Invert:	4.8
Customer:		Cert. #:	U-907-5518	Wall Material:	Concrete (reinforced)

Street:	260' West of Virginia St. North of 10	Project:	Hobart, IN
City:	Hobart, IN	GPS Northing:	2901134.078
Location:		GPS Easting:	2901134.078
Drain Area:	Southwest	GPS Accuracy:	Sub-Meter
Cover Shape:	Circular	Evidence of Surcharge:	No
Cover Size:	22.5	Potential for Runoff:	None
Comments:

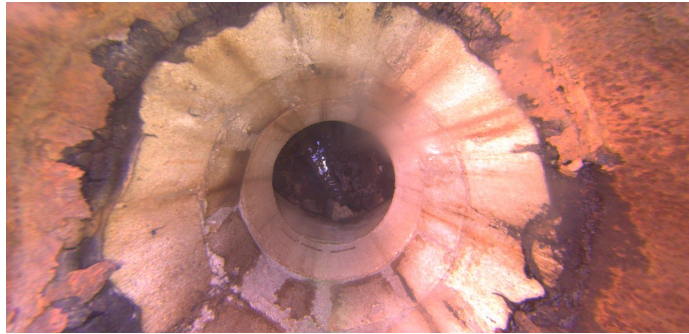
Code: **FM**
Description: **Fracture Multiple**

Distance (ft): **.0**
Structural Grade: **4**
O&M Grade: **0**
Clock Start/From: **12**
Clock To: **12**
1st Value:
2nd Value:
Value Percent:
Step: **NO**
Remarks:

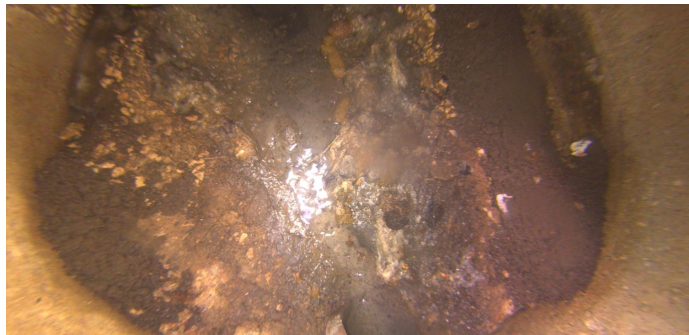
Code: **DSF**
Description: **Deposits Settled Fine**

Distance (ft): **3.6**
Structural Grade: **0**
O&M Grade: **2**
Clock Start/From: **12**
Clock To: **12**
1st Value:
2nd Value:
Value Percent: **5.000**
Step: **NO**
Remarks:

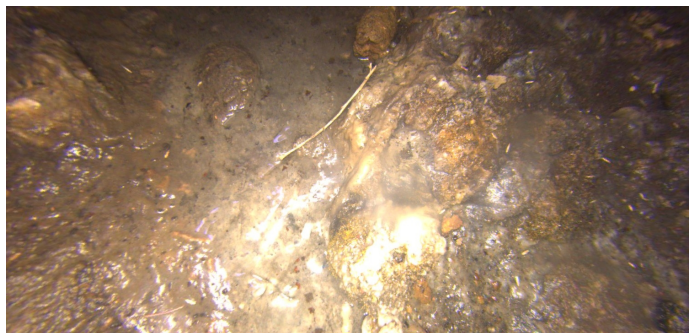
Code: **MGO**
Description: **General Observation**

Distance (ft): **4.7**
Structural Grade: **0**
O&M Grade: **0**
Clock Start/From:
Clock To:
1st Value:
2nd Value:
Value Percent:
Step: **NO**
Remarks: **END SURVEY**
