# Manhole Inspection Report

Date:	<b>04/26/2018</b>	Weather:		Coding:	<b>RZMACP</b>
MH#:	<b>M-507-039.4</b>	Owner:	<b>NA</b>	Len. Surveyed:	<b>4.3</b>
P.O.#:		Surveyor:	<b>Jen Costello</b>	Rim to Invert:	<b>4.4</b>
Customer:		Cert. #:	<b>U-907-5518</b>	Wall Material:	<b>Concrete (reinforced)</b>

Street:	<b>North of 10th Pl. 508' West of Virgin</b>	Project:	<b>Hobart, IN</b>
City:	<b>Hobart, IN</b>	GPS Northing:	<b>2900899.451</b>
Location:		GPS Easting:	<b>2900899.451</b>
Drain Area:	<b>Southwest</b>	GPS Accuracy:	<b>Sub-Meter</b>
Cover Shape:	<b>Circular</b>	Evidence of Surcharge:	<b>No</b>
Cover Size:	<b>22.5</b>	Potential for Runoff:	<b>None</b>
Comments:

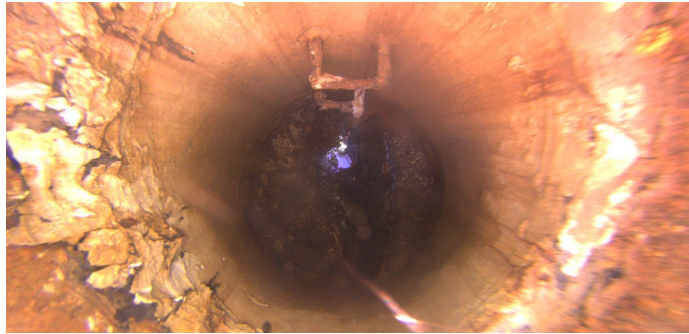
Code:	<b>DAE</b>
Description:	<b>Deposits Attached Encrustation</b>
Distance (ft):	<b>.0</b>
Structural Grade:	<b>0</b>
O&M Grade:	<b>2</b>
Clock Start/From:	<b>12</b>
Clock To:	<b>12</b>
1st Value:	
2nd Value:	
Value Percent:	<b>10.000</b>
Step:	<b>NO</b>
Remarks:

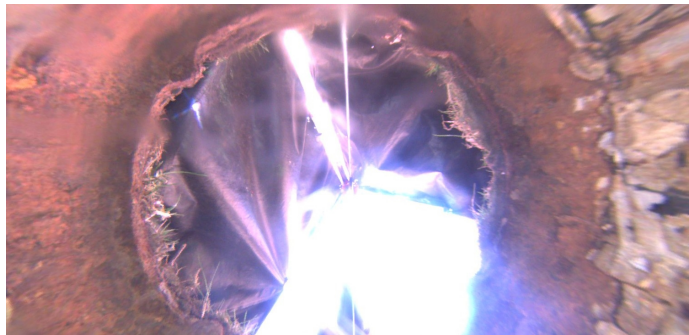
Code:	<b>MGO</b>
Description:	<b>General Observation</b>
Distance (ft):	<b>1.6</b>
Structural Grade:	<b>0</b>
O&M Grade:	<b>0</b>
Clock Start/From:	
Clock To:	
1st Value:	
2nd Value:	
Value Percent:	
Step:	<b>NO</b>
Remarks:	<b>UNDERSIDE OF FRAME</b>

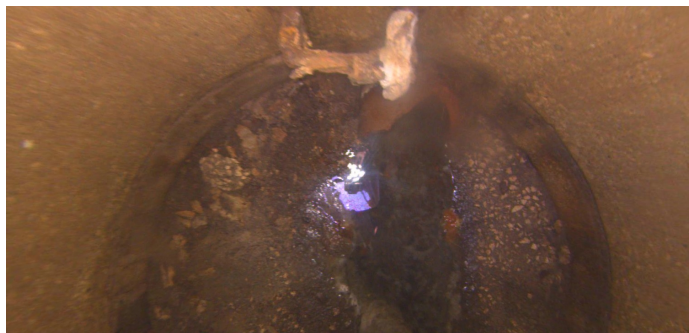
Code:	<b>SAV</b>
Description:	<b>Surface Aggregate Visible</b>
Distance (ft):	<b>1.6</b>
Structural Grade:	<b>3</b>
O&M Grade:	<b>0</b>
Clock Start/From:	<b>12</b>
Clock To:	<b>12</b>
1st Value:	
2nd Value:	
Value Percent:	
Step:	<b>NO</b>
Remarks:

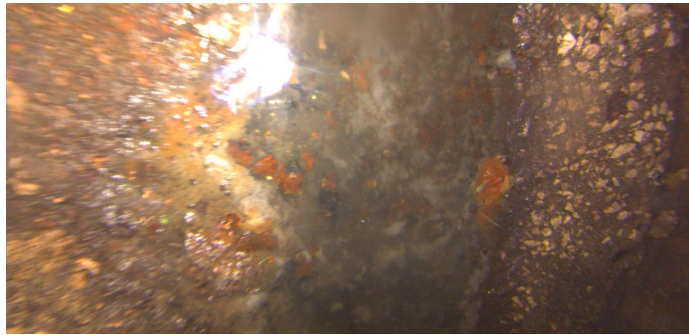
Code:	<b>SAP</b>
Description:	<b>Surface Aggregate Projecting</b>
Distance (ft):	<b>3.4</b>
Structural Grade:	<b>3</b>
O&M Grade:	<b>0</b>
Clock Start/From:	<b>12</b>
Clock To:	<b>12</b>
1st Value:	
2nd Value:	
Value Percent:	
Step:	<b>NO</b>
Remarks:

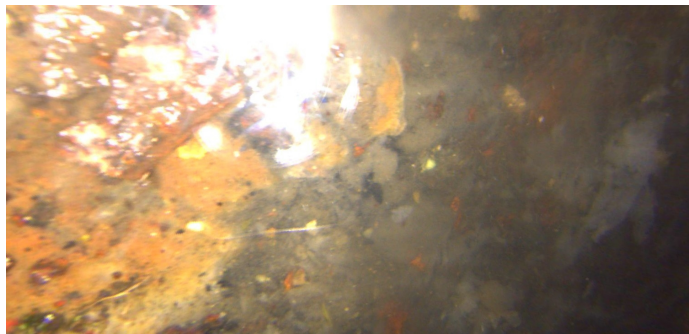
Code:	<b>MGO</b>
Description:	<b>General Observation</b>
Distance (ft):	<b>4.3</b>
Structural Grade:	<b>0</b>
O&M Grade:	<b>0</b>
Clock Start/From:	
Clock To:	
1st Value:	
2nd Value:	
Value Percent:	
Step:	<b>NO</b>
Remarks:	<b>END SURVEY</b>
