Manhole Inspection Report

Date:	04/24/2018	Weather:		Coding:	RZMACP
MH#:	M-507-039.6	Owner:	NA	Len. Surveyed:	5.2
P.O.#:		Surveyor:	Jen Costello	Rim to Invert:	5.6
Customer:		Cert. #:	U-907-5518	Wall Material:	Concrete (reinforced)

Street:	499' East of Decatur St. North of 10t	Project:	Hobart, IN
City:	Hobart, IN	GPS Northing:	2900784.319
Location:		GPS Easting:	2900784.319
Drain Area:	Southwest	GPS Accuracy:	Sub-Meter
Cover Shape:	Circular	Evidence of Surcharge:	No
Cover Size:	26.0	Potential for Runoff:	None
Comments:

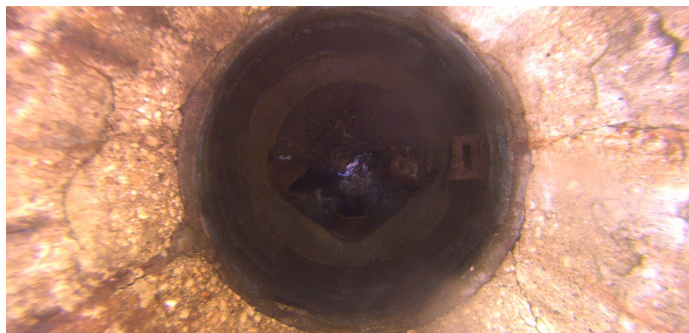
Code: **MGO**
Description: **General Observation**

Distance (ft): **.0**
Structural Grade: **0**
O&M Grade: **0**
Clock Start/From:
Clock To:
1st Value:
2nd Value:
Value Percent:
Step: **NO**
Remarks: **ACCESS MH**

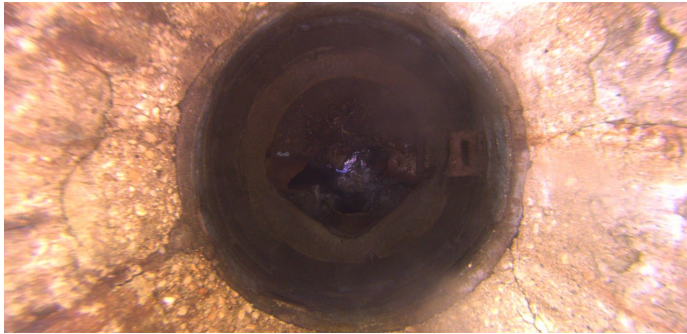
Code: **FM**
Description: **Fracture Multiple**

Distance (ft): **.0**
Structural Grade: **4**
O&M Grade: **0**
Clock Start/From: **12**
Clock To: **12**
1st Value:
2nd Value:
Value Percent:
Step: **NO**
Remarks:

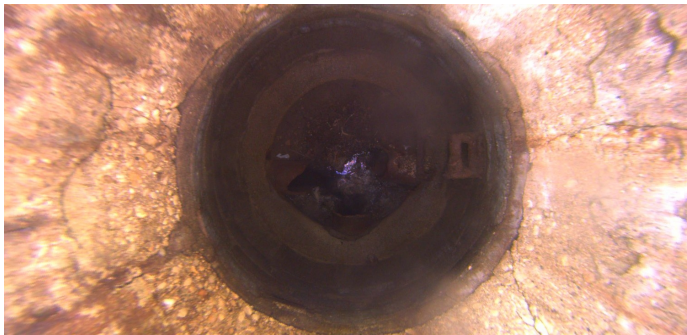
Code: **SAP**
Description: **Surface Aggregate Projecting**

Distance (ft): **.0**
Structural Grade: **3**
O&M Grade: **0**
Clock Start/From: **12**
Clock To: **12**
1st Value:
2nd Value:
Value Percent:
Step: **NO**
Remarks:

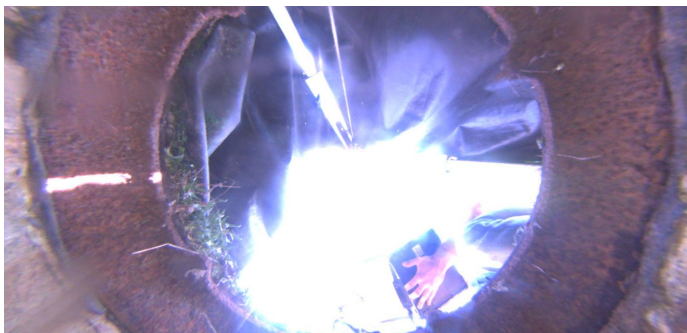
Code: **MGO**
Description: **General Observation**

Distance (ft): **1.2**
Structural Grade: **0**
O&M Grade: **0**
Clock Start/From:
Clock To:
1st Value:
2nd Value:
Value Percent:
Step: **NO**
Remarks: **UNDERSIDE OF FRAME**

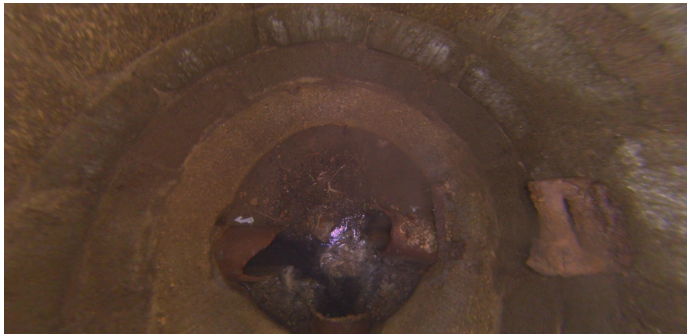
Code:	SAV
Description:	Surface Aggregate Visible
Distance (ft):	1.6
Structural Grade:	3
O&M Grade:	0
Clock Start/From:	12
Clock To:	12
1st Value:	
2nd Value:	
Value Percent:	
Step:	NO
Remarks:

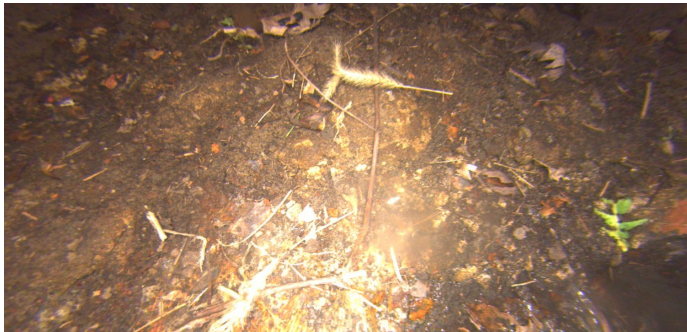
Code:	DSF
Description:	Deposits Settled Fine
Distance (ft):	5.2
Structural Grade:	0
O&M Grade:	2
Clock Start/From:	12
Clock To:	12
1st Value:	
2nd Value:	
Value Percent:	5.000
Step:	NO
Remarks:
