Manhole Inspection Report

Date:	04/24/2018	Weather:		Coding:	RZMACP
MH#:	M-507-042	Owner:	NA	Len. Surveyed:	7.2
P.O.#:		Surveyor:	John Kuglmaier	Rim to Invert:	7.7
Customer:		Cert. #:	U-1215-07002349	Wall Material:	Concrete (reinforced)

Street:	Delaware St. and 11th St.	Project:	Hobart, IN
City:	Hobart, IN	GPS Northing:	2901116.078
Location:		GPS Easting:	2901116.078
Drain Area:	Southwest	GPS Accuracy:	Sub-Meter
Cover Shape:	Circular	Evidence of Surcharge:	Yes
Cover Size:	22.5	Potential for Runoff:	None
Comments:

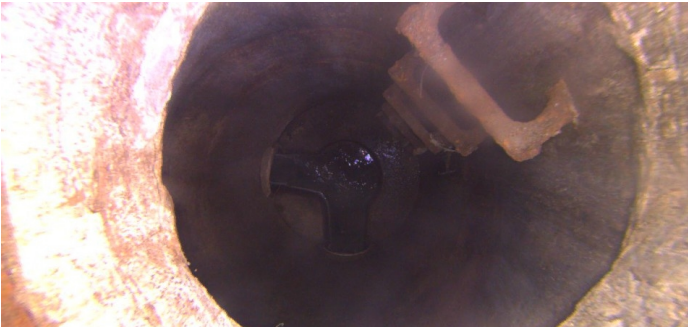
MGP

General Photo

.0

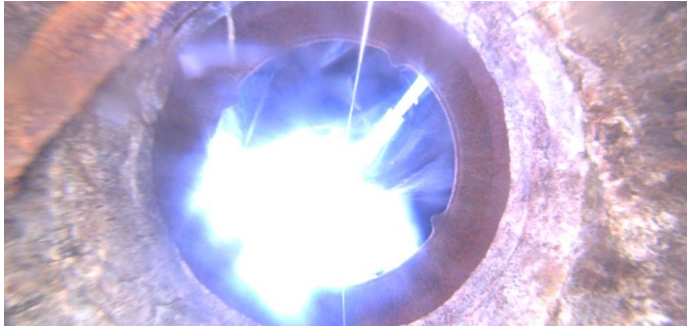
Code:	MGP
Description:	General Photo
Distance (ft):	2.4
Structural Grade:	0
O&M Grade:	0
Clock Start/From:	
Clock To:	
1st Value:	
2nd Value:	
Value Percent:	
Step:	NO
Remarks:

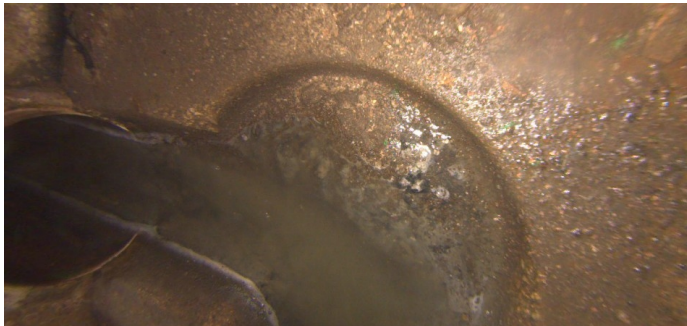
Code:	MGO
Description:	General Observation
Distance (ft):	6.4
Structural Grade:	0
O&M Grade:	0
Clock Start/From:	
Clock To:	
1st Value:	
2nd Value:	
Value Percent:	
Step:	NO
Remarks:	Ins. Comp.
