Manhole Inspection Report

Date:	03/28/2018	Weather:		Coding:	RZMACP
MH#:	M-507-046	Owner:	NA	Len. Surveyed:	4.8
P.O.#:		Surveyor:	John Kuglmaier	Rim to Invert:	5.8
Customer:		Cert. #:	U-1215-07002349	Wall Material:	Concrete (reinforced)

Street:	13th Pl. and Virginia St.	Project:	Hobart, IN
City:	Hobart, IN	GPS Northing:	0.0
Location:		GPS Easting:	0.0
Drain Area:	Southwest	GPS Accuracy:	Nearest Meter
Cover Shape:	Circular	Evidence of Surcharge:	No
Cover Size:	22.5	Potential for Runoff:	None
Comments:

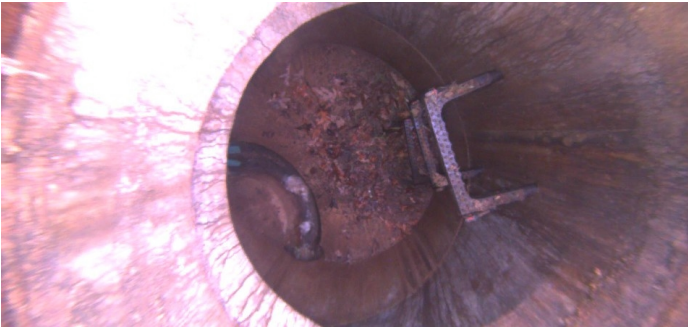
MGP

General Photo

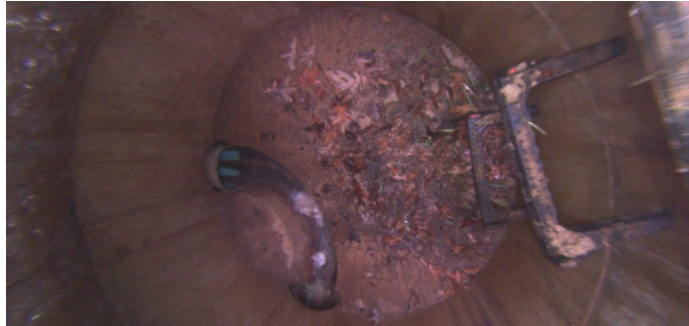
Code: **DAZ**
Description: **Deposits Attached Other**

Distance (ft): **1.7**
Structural Grade: **0**
O&M Grade: **2**
Clock Start/From: **12**
Clock To: **12**
1st Value:
2nd Value:
Value Percent: **5.000**
Step: **NO**
Remarks: **Mixed materials**

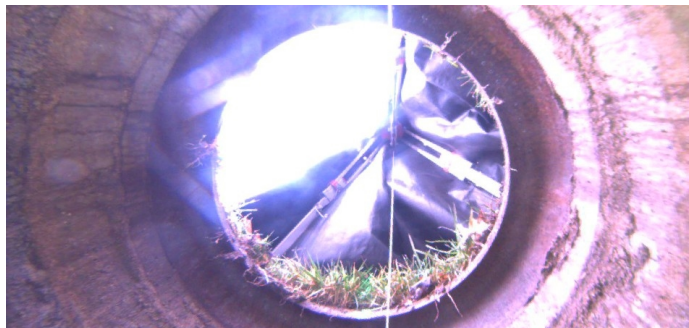
Code: **MGP**
Description: **General Photo**

Distance (ft): **2.0**
Structural Grade: **0**
O&M Grade: **0**
Clock Start/From:
Clock To:
1st Value:
2nd Value:
Value Percent:
Step: **NO**
Remarks:

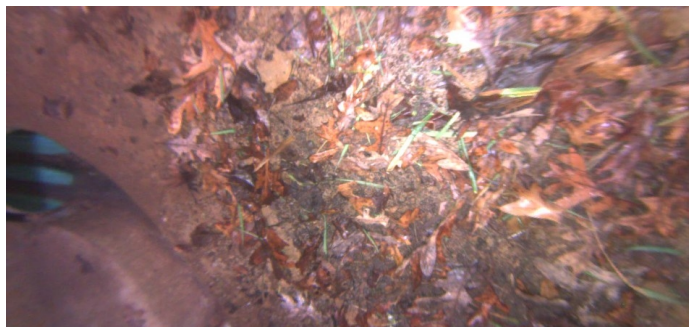
Code: **MGO**
Description: **General Observation**

Distance (ft): **4.0**
Structural Grade: **0**
O&M Grade: **0**
Clock Start/From:
Clock To:
1st Value:
2nd Value:
Value Percent:
Step: **NO**
Remarks: **Ins. Comp.**
