# Manhole Inspection Report

Date:	<b>03/28/2018</b>	Weather:		Coding:	<b>RZMACP</b>
MH#:	<b>M-507-047</b>	Owner:	<b>NA</b>	Len. Surveyed:	<b>6.7</b>
P.O.#:		Surveyor:	<b>John Kuglmaier</b>	Rim to Invert:	<b>7.2</b>
Customer:		Cert. #:	<b>U-1215-07002349</b>	Wall Material:	<b>Concrete (reinforced)</b>

Street:	<b>Virginia St. 216' North of 13th Pl.</b>	Project:	<b>Hobart, IN</b>
City:	<b>Hobart, IN</b>	GPS Northing:	<b>0.0</b>
Location:		GPS Easting:	<b>0.0</b>
Drain Area:	<b>Southwest</b>	GPS Accuracy:	<b>Nearest Meter</b>
Cover Shape:	<b>Circular</b>	Evidence of Surcharge:	<b>No</b>
Cover Size:	<b>22.5</b>	Potential for Runoff:	<b>None</b>
Comments:

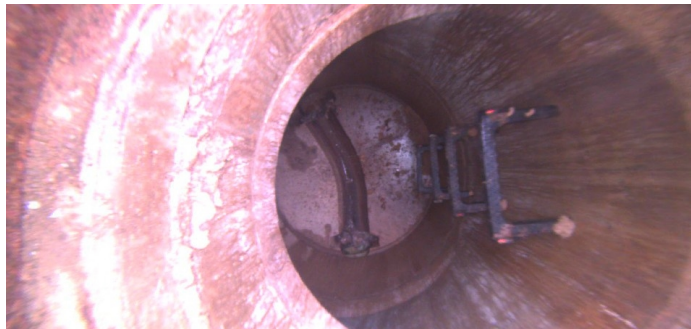
Code: **MGP**  
Description: **General Photo**

Distance (ft): **.0**  
Structural Grade: **0**  
O&M Grade: **0**  
Clock Start/From:  
Clock To:  
1st Value:  
2nd Value:  
Value Percent:  
Step: **NO**  
Remarks:

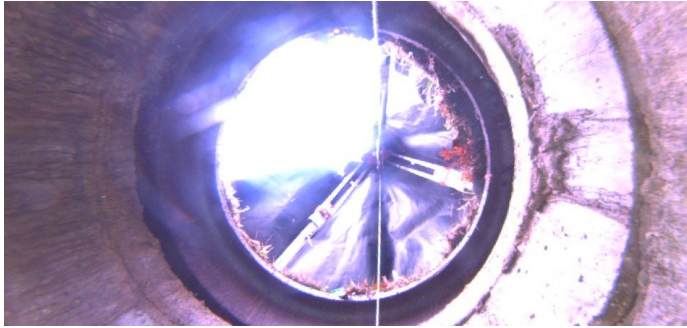
Code: **MGP**  
Description: **General Photo**

Distance (ft): **2.4**  
Structural Grade: **0**  
O&M Grade: **0**  
Clock Start/From:  
Clock To:  
1st Value:  
2nd Value:  
Value Percent:  
Step: **NO**  
Remarks:

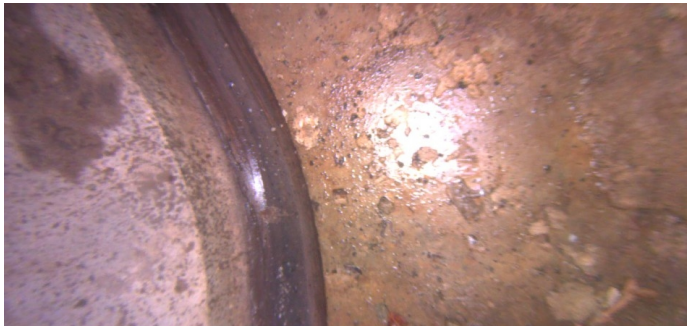
Code: **MGO**  
Description: **General Observation**

Distance (ft): **5.5**  
Structural Grade: **0**  
O&M Grade: **0**  
Clock Start/From:  
Clock To:  
1st Value:  
2nd Value:  
Value Percent:  
Step: **NO**  
Remarks: **Ins. Comp.**
