Manhole Inspection Report

Date:	03/28/2018	Weather:		Coding:	RZMACP
MH#:	M-507-048	Owner:	NA	Len. Surveyed:	7.3
P.O.#:		Surveyor:	John Kuglmaier	Rim to Invert:	8.1
Customer:		Cert. #:	U-1215-07002349	Wall Material:	Concrete (reinforced)

Street:	Csokasy Ln. Virginia St.	Project:	Hobart, IN
City:	Hobart, IN	GPS Northing:	0.0
Location:		GPS Easting:	0.0
Drain Area:	Southwest	GPS Accuracy:	Nearest Meter
Cover Shape:	Circular	Evidence of Surcharge:	No
Cover Size:	22.5	Potential for Runoff:	None
Comments:

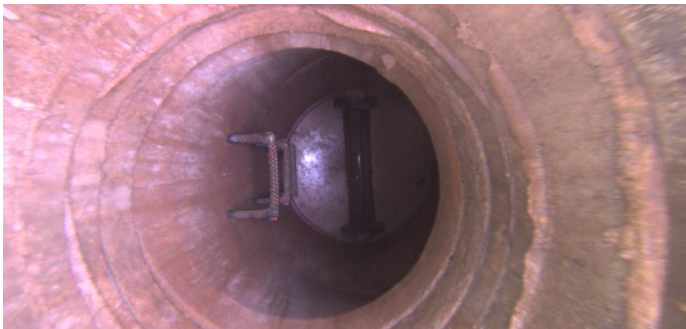
Code:	MGP
Description:	General Photo

Distance (ft):	.0
Structural Grade:	0
O&M Grade:	0
Clock Start/From:	
Clock To:	
1st Value:	
2nd Value:	
Value Percent:	
Step:	NO
Remarks:

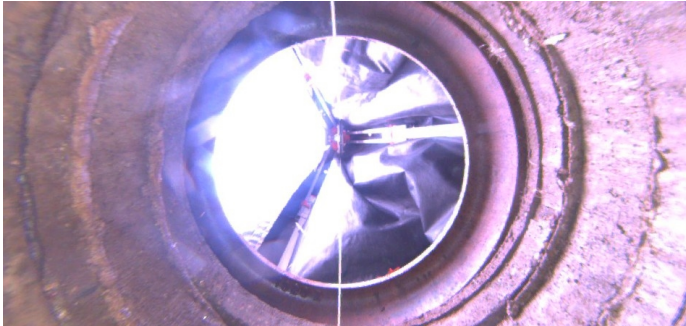
Code:	MGP
Description:	General Photo

Distance (ft):	2.2
Structural Grade:	0
O&M Grade:	0
Clock Start/From:	
Clock To:	
1st Value:	
2nd Value:	
Value Percent:	
Step:	NO
Remarks:

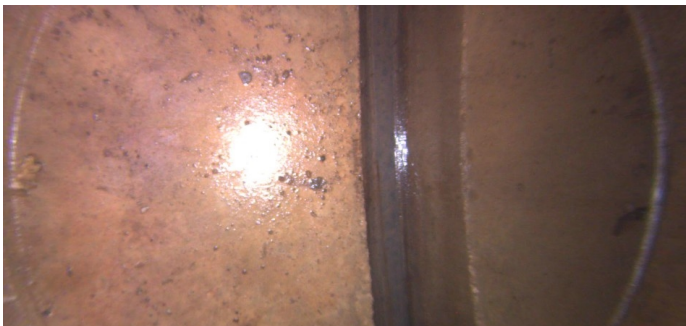
Code:	MGO
Description:	General Observation

Distance (ft):	6.0
Structural Grade:	0
O&M Grade:	0
Clock Start/From:	
Clock To:	
1st Value:	
2nd Value:	
Value Percent:	
Step:	NO
Remarks:	Ins. Comp.
