Manhole Inspection Report

Date:	03/28/2018	Weather:		Coding:	RZMACP
MH#:	M-507-049	Owner:	NA	Len. Surveyed:	9.4
P.O.#:		Surveyor:	John Kuglmaier	Rim to Invert:	10.0
Customer:		Cert. #:	U-1215-07002349	Wall Material:	Concrete (reinforced)

Street:	Virginia St. 279' North of Csokasy Ln.	Project:	Hobart, IN
City:	Hobart, IN	GPS Northing:	0.0
Location:		GPS Easting:	0.0
Drain Area:	Southwest	GPS Accuracy:	Nearest Meter
Cover Shape:	Circular	Evidence of Surcharge:	No
Cover Size:	22.5	Potential for Runoff:	None
Comments:

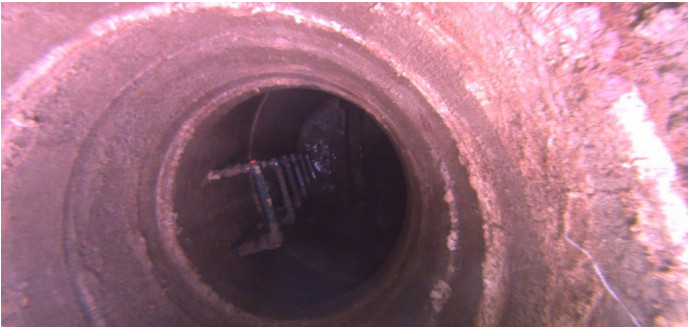
Code:

MGP

Description:

General Photo

Distance (ft):

.0

Structural Grade:

0

O&M Grade:

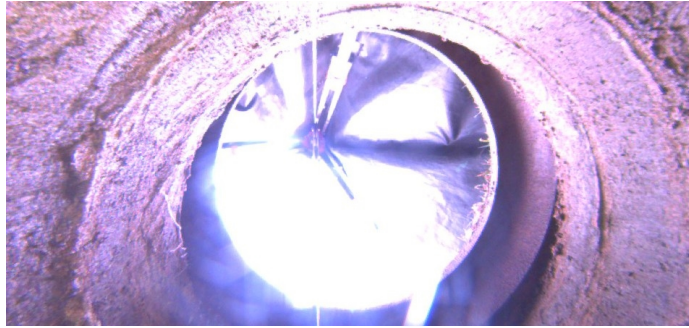
Code: **MGP**
Description: **General Photo**

Distance (ft): **2.1**
Structural Grade: **0**
O&M Grade: **0**
Clock Start/From:
Clock To:
1st Value:
2nd Value:
Value Percent:
Step: **NO**
Remarks:

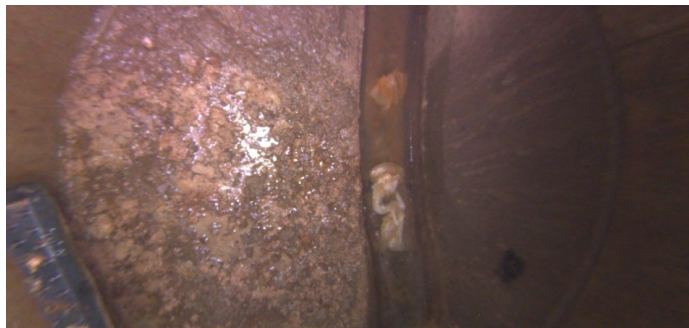
Code: **MGO**
Description: **General Observation**

Distance (ft): **7.8**
Structural Grade: **0**
O&M Grade: **0**
Clock Start/From:
Clock To:
1st Value:
2nd Value:
Value Percent:
Step: **NO**
Remarks: **Ins. Comp.**
