# Manhole Inspection Report

Date:	<b>03/28/2018</b>	Weather:		Coding:	<b>RZMACP</b>
MH#:	<b>M-507-050</b>	Owner:	<b>NA</b>	Len. Surveyed:	<b>11.1</b>
P.O.#:		Surveyor:	<b>John Kuglmaier</b>	Rim to Invert:	<b>10.7</b>
Customer:		Cert. #:	<b>U-1215-07002349</b>	Wall Material:	<b>Concrete (reinforced)</b>

Street:	<b>Virginia St. 590' North of Csokasy Ln.</b>	Project:	<b>Hobart, IN</b>
City:	<b>Hobart, IN</b>	GPS Northing:	<b>0.0</b>
Location:		GPS Easting:	<b>0.0</b>
Drain Area:	<b>Southwest</b>	GPS Accuracy:	<b>Nearest Meter</b>
Cover Shape:	<b>Circular</b>	Evidence of Surcharge:	<b>No</b>
Cover Size:	<b>22.5</b>	Potential for Runoff:	<b>None</b>
Comments:

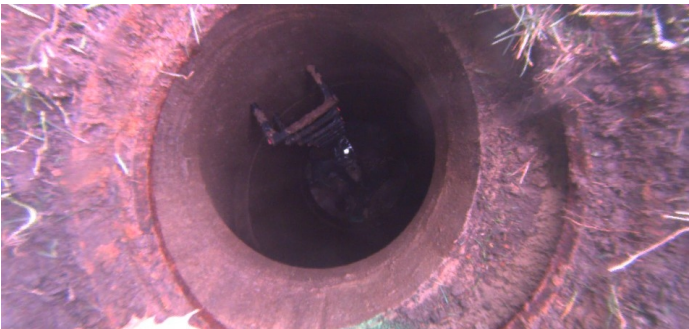
Code: **MGP**  
Description: **General Photo**

Distance (ft): **.0**  
Structural Grade: **0**  
O&M Grade: **0**  
Clock Start/From:  
Clock To:  
1st Value:  
2nd Value:  
Value Percent:  
Step: **NO**  
Remarks:

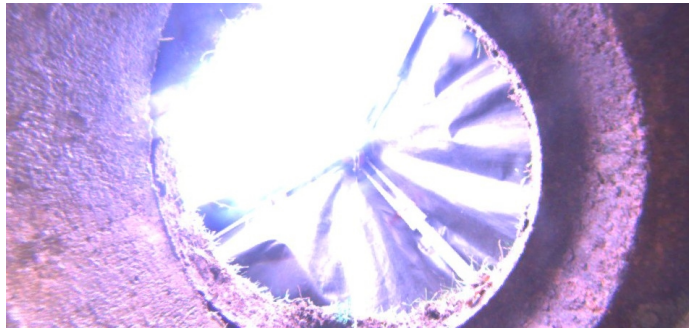
Code: **MGP**  
Description: **General Photo**

Distance (ft): **2.6**  
Structural Grade: **0**  
O&M Grade: **0**  
Clock Start/From:  
Clock To:  
1st Value:  
2nd Value:  
Value Percent:  
Step: **NO**  
Remarks:

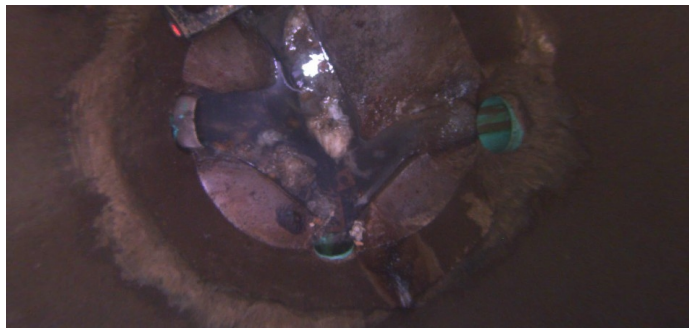
Code: **IS**  
Description: **Infil Stain**

Distance (ft): **7.3**  
Structural Grade: **0**  
O&M Grade: **0**  
Clock Start/From: **5**  
Clock To:  
1st Value:  
2nd Value:  
Value Percent:  
Step: **NO**  
Remarks:

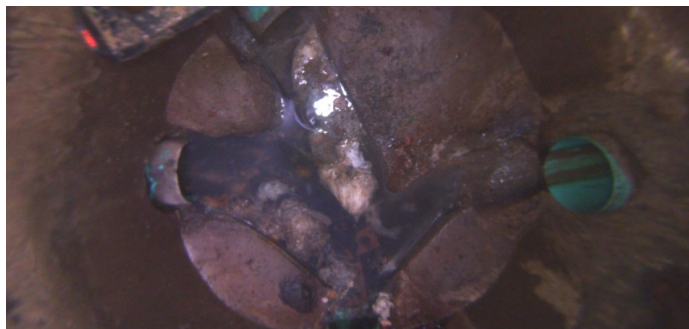
Code: **MGO**  
Description: **General Observation**

Distance (ft): **8.3**  
Structural Grade: **0**  
O&M Grade: **0**  
Clock Start/From:  
Clock To:  
1st Value:  
2nd Value:  
Value Percent:  
Step: **NO**  
Remarks: **Ins. Comp.**
