Manhole Inspection Report

Date:	04/24/2018	Weather:		Coding:	RZMACP
MH#:	M-507-055	Owner:	NA	Len. Surveyed:	8.0
P.O.#:		Surveyor:	John Kuglmaier	Rim to Invert:	8.5
Customer:		Cert. #:	U-1215-07002349	Wall Material:	Concrete (reinforced)

Street:	Delaware St. 11th St. to the East.	Project:	Hobart, IN
City:	Hobart, IN	GPS Northing:	2901268.016
Location:		GPS Easting:	2901268.016
Drain Area:	Southwest	GPS Accuracy:	Sub-Meter
Cover Shape:	Circular	Evidence of Surcharge:	No
Cover Size:	22.5	Potential for Runoff:	None
Comments:

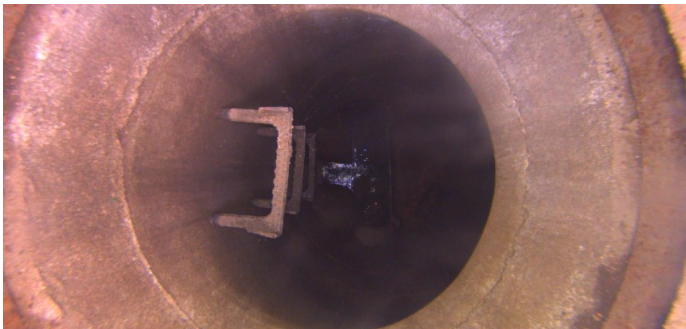
Code:	MGP
Description:	General Photo

Distance (ft):	.0
Structural Grade:	0
O&M Grade:	0
Clock Start/From:	
Clock To:	
1st Value:	
2nd Value:	
Value Percent:	
Step:	NO
Remarks:

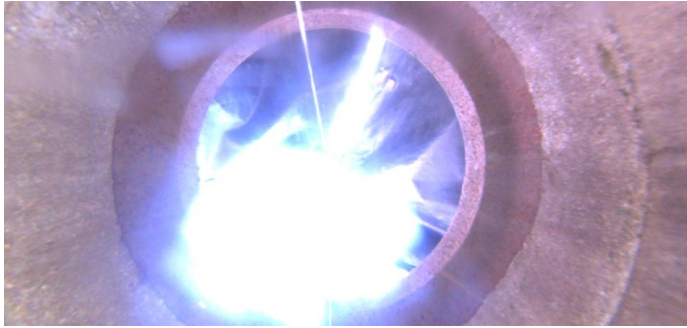
Code:	MGP
Description:	General Photo
Distance (ft):	2.4
Structural Grade:	0
O&M Grade:	0
Clock Start/From:	
Clock To:	
1st Value:	
2nd Value:	
Value Percent:	
Step:	NO
Remarks:

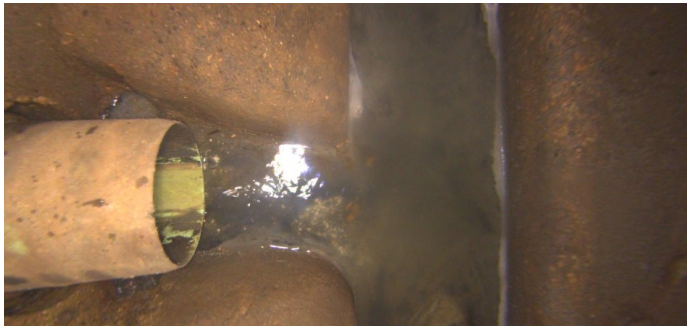
Code:	MGO
Description:	General Observation
Distance (ft):	6.8
Structural Grade:	0
O&M Grade:	0
Clock Start/From:	
Clock To:	
1st Value:	
2nd Value:	
Value Percent:	
Step:	NO
Remarks:	Ins. Comp.
