Manhole Inspection Report

Date:	03/28/2018	Weather:		Coding:	RZMACP
MH#:	M-507-059	Owner:	NA	Len. Surveyed:	9.0
P.O.#:		Surveyor:	John Kuglmaier	Rim to Invert:	9.6
Customer:		Cert. #:	U-1215-07002349	Wall Material:	Concrete (reinforced)

Street:	West of Virginia St. 506' North of Cs	Project:	Hobart, IN
City:	Hobart, IN	GPS Northing:	0.0
Location:		GPS Easting:	0.0
Drain Area:	Southwest	GPS Accuracy:	Nearest Meter
Cover Shape:	Circular	Evidence of Surcharge:	No
Cover Size:	22.5	Potential for Runoff:	None
Comments:

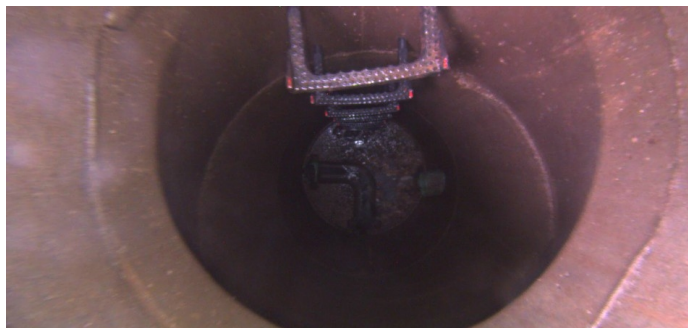
Code: **MGP**
Description: **General Photo**

Distance (ft): **.0**
Structural Grade: **0**
O&M Grade: **0**
Clock Start/From:
Clock To:
1st Value:
2nd Value:
Value Percent:
Step: **NO**
Remarks:

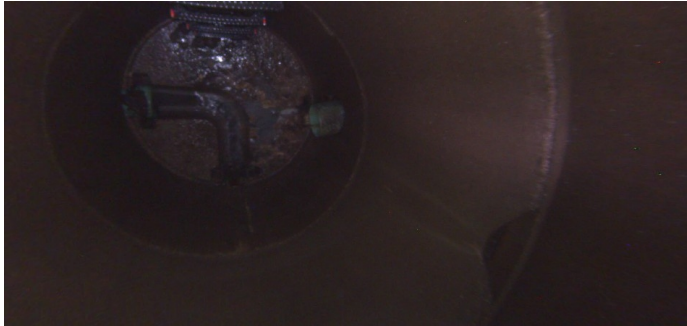
Code: **IS**
Description: **Infil Stain**

Distance (ft): **2.0**
Structural Grade: **0**
O&M Grade: **0**
Clock Start/From: **4**
Clock To:
1st Value:
2nd Value:
Value Percent:
Step: **NO**
Remarks:

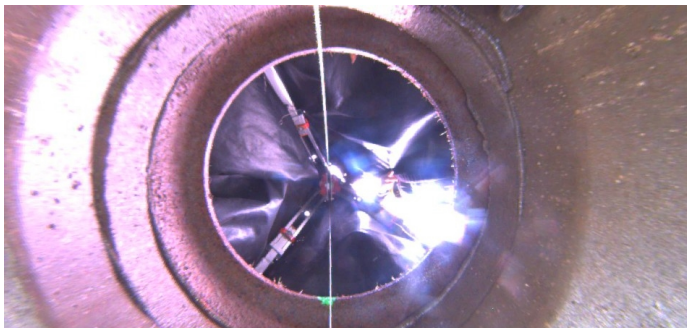
Code: **MGP**
Description: **General Photo**

Distance (ft): **2.4**
Structural Grade: **0**
O&M Grade: **0**
Clock Start/From:
Clock To:
1st Value:
2nd Value:
Value Percent:
Step: **NO**
Remarks:

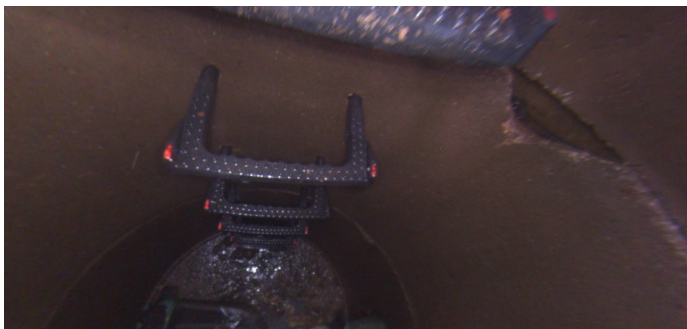
Code: **SSS**
Description: **Surface Spalling**

Distance (ft): **2.4**
Structural Grade: **2**
O&M Grade: **0**
Clock Start/From: **2**
Clock To:
1st Value:
2nd Value:
Value Percent:
Step: **NO**
Remarks:

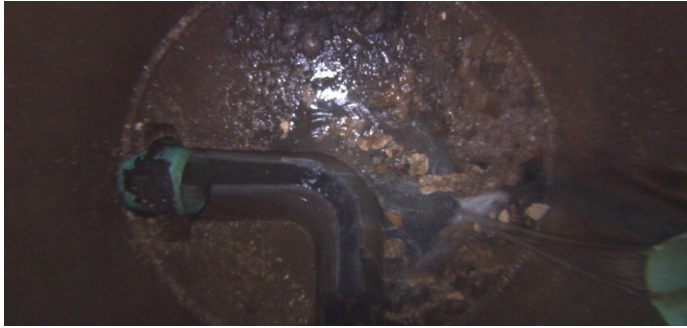
Code:	MGO
Description:	General Observation
Distance (ft):	6.7
Structural Grade:	0
O&M Grade:	0
Clock Start/From:	
Clock To:	
1st Value:	
2nd Value:	
Value Percent:	
Step:	NO
Remarks:	Ins. Comp.
