Manhole Inspection Report

Date:	03/28/2018	Weather:		Coding:	RZMACP
MH#:	M-507-060	Owner:	NA	Len. Surveyed:	5.9
P.O.#:		Surveyor:	John Kuglmaier	Rim to Invert:	6.3
Customer:		Cert. #:	U-1215-07002349	Wall Material:	Concrete (reinforced)

Street:	West of Virginia St. 194' North of Cs	Project:	Hobart, IN
City:	Hobart, IN	GPS Northing:	0.0
Location:		GPS Easting:	0.0
Drain Area:	Southwest	GPS Accuracy:	Nearest Meter
Cover Shape:	Circular	Evidence of Surcharge:	No
Cover Size:	22.5	Potential for Runoff:	None
Comments:

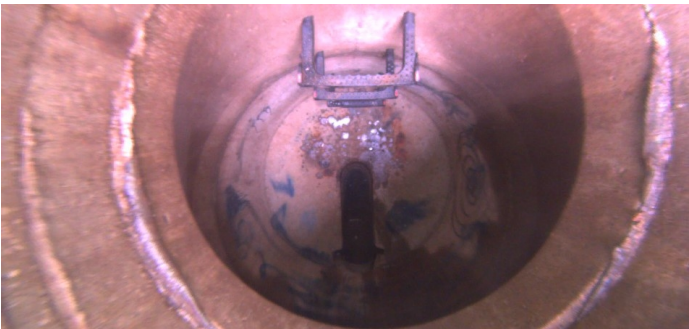
Code:
MGP

Description:
General Photo

Distance (ft):
.0

Structural Grade:
0

O&M Grade:
0

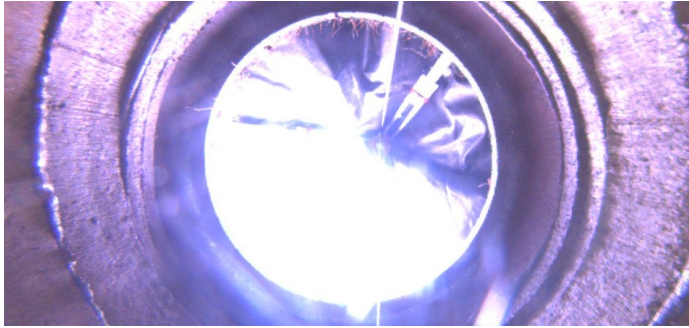
Code: **MGP**
Description: **General Photo**

Distance (ft): **2.2**
Structural Grade: **0**
O&M Grade: **0**
Clock Start/From:
Clock To:
1st Value:
2nd Value:
Value Percent:
Step: **NO**
Remarks:

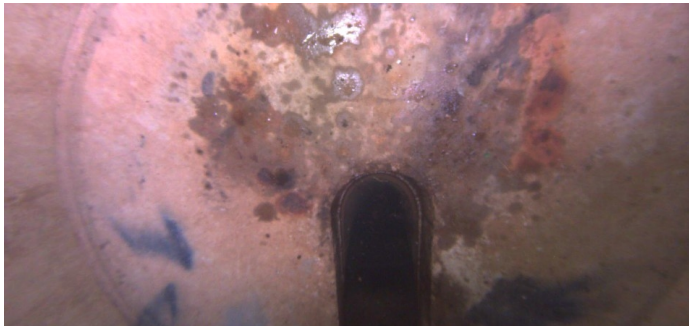
Code: **MGO**
Description: **General Observation**

Distance (ft): **4.4**
Structural Grade: **0**
O&M Grade: **0**
Clock Start/From:
Clock To:
1st Value:
2nd Value:
Value Percent:
Step: **NO**
Remarks: **Ins. Comp.**
