Manhole Inspection Report

Date:	03/28/2018	Weather:		Coding:	RZMACP
MH#:	M-507-061	Owner:	NA	Len. Surveyed:	3.3
P.O.#:		Surveyor:	John Kuglmaier	Rim to Invert:	3.7
Customer:		Cert. #:	U-1215-07002349	Wall Material:	Concrete (reinforced)

Street:	13th Pl. 402' East of Virginia St.	Project:	Hobart, IN
City:	Hobart, IN	GPS Northing:	0.0
Location:		GPS Easting:	0.0
Drain Area:	Southwest	GPS Accuracy:	Nearest Meter
Cover Shape:	Circular	Evidence of Surcharge:	No
Cover Size:	22.5	Potential for Runoff:	None
Comments:

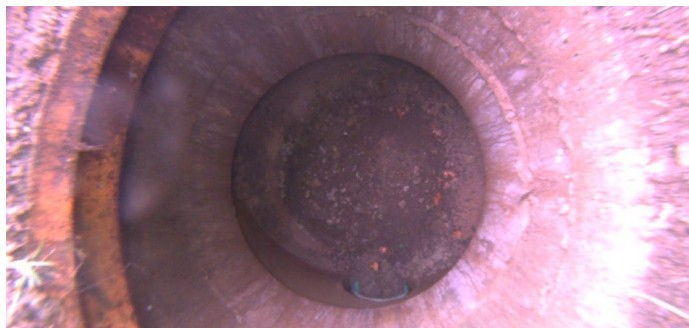
Code: **MGP**
Description: **General Photo**

Distance (ft): **.0**
Structural Grade: **0**
O&M Grade: **0**
Clock Start/From:
Clock To:
1st Value:
2nd Value:
Value Percent:
Step: **NO**
Remarks:

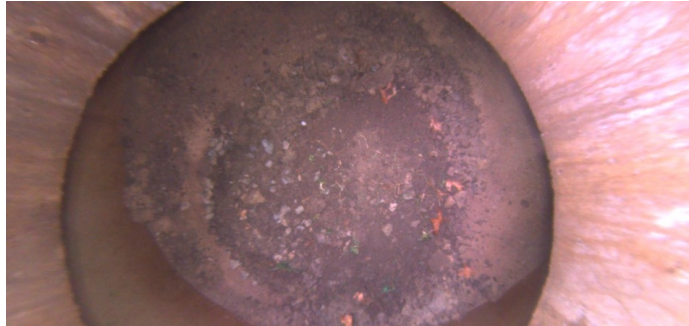
Code: **DAZ**
Description: **Deposits Attached Other**

Distance (ft): **1.2**
Structural Grade: **0**
O&M Grade: **2**
Clock Start/From: **12**
Clock To: **12**
1st Value:
2nd Value:
Value Percent: **10.000**
Step: **NO**
Remarks: **Mixed materials**

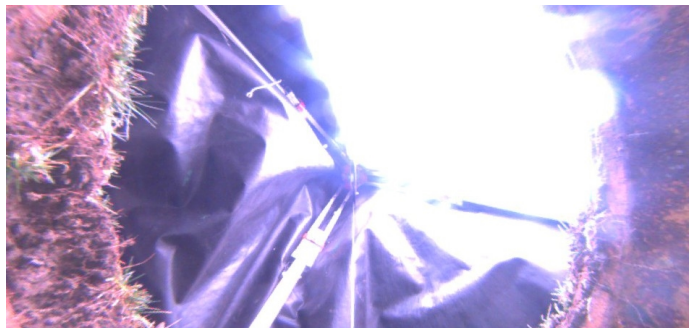
Code: **MGP**
Description: **General Photo**

Distance (ft): **1.5**
Structural Grade: **0**
O&M Grade: **0**
Clock Start/From:
Clock To:
1st Value:
2nd Value:
Value Percent:
Step: **NO**
Remarks:

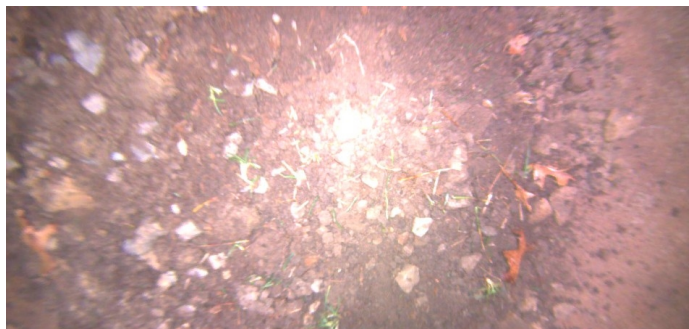
Code: **MGO**
Description: **General Observation**

Distance (ft): **2.5**
Structural Grade: **0**
O&M Grade: **0**
Clock Start/From:
Clock To:
1st Value:
2nd Value:
Value Percent:
Step: **NO**
Remarks: **Ins. Comp.**
