# Manhole Inspection Report

Date:	<b>03/28/2018</b>	Weather:		Coding:	<b>RZMACP</b>
MH#:	<b>M-507-062</b>	Owner:	<b>NA</b>	Len. Surveyed:	<b>6.6</b>
P.O.#:		Surveyor:	<b>John Kuglmaier</b>	Rim to Invert:	<b>7.3</b>
Customer:		Cert. #:	<b>U-1215-07002349</b>	Wall Material:	<b>Concrete (reinforced)</b>

Street:	<b>13th Pl. 240' West of S. California St.</b>	Project:	<b>Hobart, IN</b>
City:	<b>Hobart, IN</b>	GPS Northing:	<b>0.0</b>
Location:		GPS Easting:	<b>0.0</b>
Drain Area:	<b>Southwest</b>	GPS Accuracy:	<b>Nearest Meter</b>
Cover Shape:	<b>Circular</b>	Evidence of Surcharge:	<b>No</b>
Cover Size:	<b>22.5</b>	Potential for Runoff:	<b>None</b>
Comments:

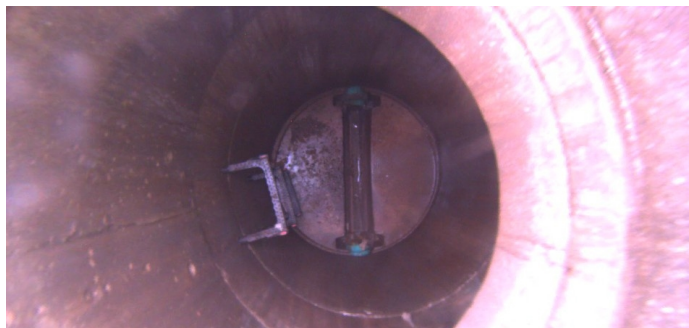
Code: **MGP**  
Description: **General Photo**

Distance (ft): **.0**  
Structural Grade: **0**  
O&M Grade: **0**  
Clock Start/From:  
Clock To:  
1st Value:  
2nd Value:  
Value Percent:  
Step: **NO**  
Remarks:

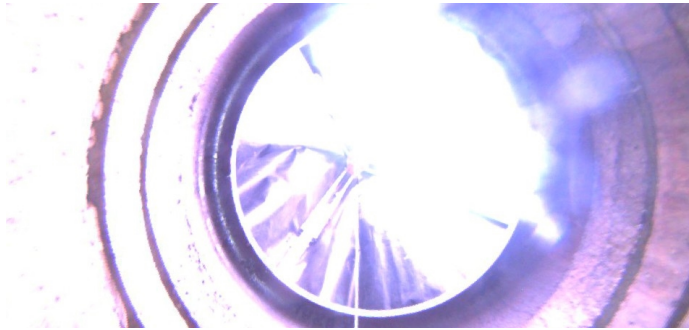
Code: **MGP**  
Description: **General Photo**

Distance (ft): **2.1**  
Structural Grade: **0**  
O&M Grade: **0**  
Clock Start/From:  
Clock To:  
1st Value:  
2nd Value:  
Value Percent:  
Step: **NO**  
Remarks:

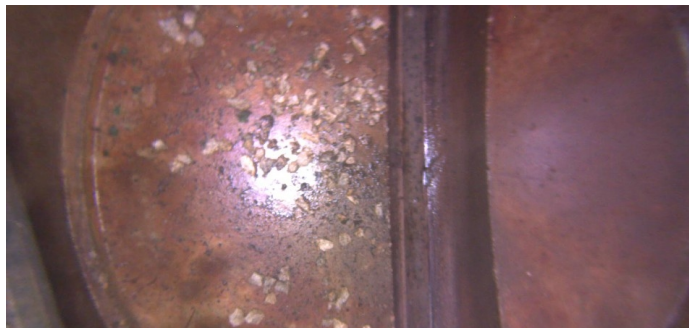
Code: **MGO**  
Description: **General Observation**

Distance (ft): **5.1**  
Structural Grade: **0**  
O&M Grade: **0**  
Clock Start/From:  
Clock To:  
1st Value:  
2nd Value:  
Value Percent:  
Step: **NO**  
Remarks: **Ins. Comp.**
