# Manhole Inspection Report

Date:	<b>03/28/2018</b>	Weather:		Coding:	<b>RZMACP</b>
MH#:	<b>M-507-066</b>	Owner:	<b>NA</b>	Len. Surveyed:	<b>8.0</b>
P.O.#:		Surveyor:	<b>John Kuglmaier</b>	Rim to Invert:	<b>8.5</b>
Customer:		Cert. #:	<b>U-1215-07002349</b>	Wall Material:	<b>Concrete (reinforced)</b>

Street:	<b>Csokasy Ln. 374' East of Virginia St.</b>	Project:	<b>Hobart, IN</b>
City:	<b>Hobart, IN</b>	GPS Northing:	<b>0.0</b>
Location:		GPS Easting:	<b>0.0</b>
Drain Area:	<b>Southwest</b>	GPS Accuracy:	<b>Nearest Meter</b>
Cover Shape:	<b>Circular</b>	Evidence of Surcharge:	<b>No</b>
Cover Size:	<b>22.5</b>	Potential for Runoff:	<b>None</b>
Comments:

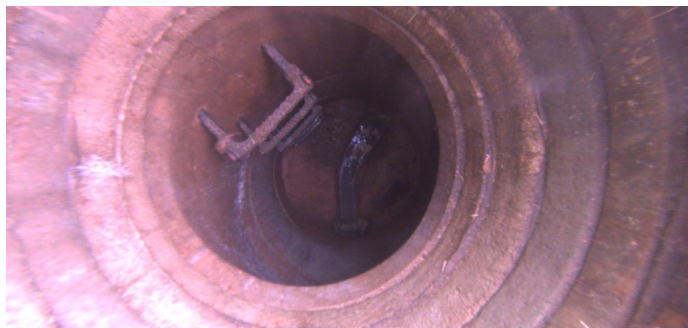
Code: **MGP**  
Description: **General Photo**

Distance (ft): **.0**  
Structural Grade: **0**  
O&M Grade: **0**  
Clock Start/From:  
Clock To:  
1st Value:  
2nd Value:  
Value Percent:  
Step: **NO**  
Remarks:

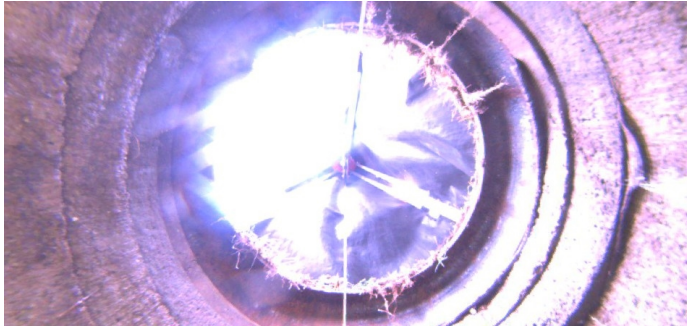
Code: **MGP**  
Description: **General Photo**

Distance (ft): **2.3**  
Structural Grade: **0**  
O&M Grade: **0**  
Clock Start/From:  
Clock To:  
1st Value:  
2nd Value:  
Value Percent:  
Step: **NO**  
Remarks:

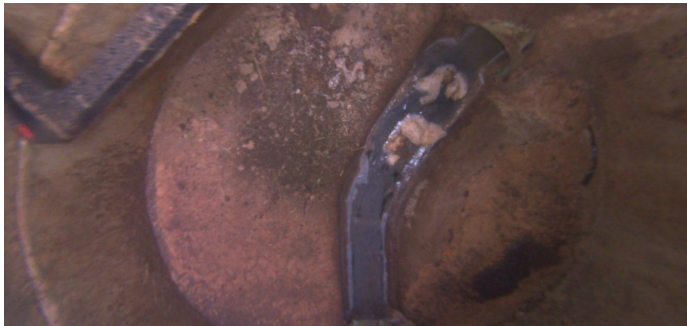
Code: **MGO**  
Description: **General Observation**

Distance (ft): **5.7**  
Structural Grade: **0**  
O&M Grade: **0**  
Clock Start/From:  
Clock To:  
1st Value:  
2nd Value:  
Value Percent:  
Step: **NO**  
Remarks: **Ins. Comp.**
