Manhole Inspection Report

Date:	03/28/2018	Weather:		Coding:	RZMACP
MH#:	M-507-067	Owner:	NA	Len. Surveyed:	9.0
P.O.#:		Surveyor:	John Kuglmaier	Rim to Invert:	9.5
Customer:		Cert. #:	U-1215-07002349	Wall Material:	Concrete (reinforced)

Street:	Csokasy Ln. S. California St.	Project:	Hobart, IN
City:	Hobart, IN	GPS Northing:	0.0
Location:		GPS Easting:	0.0
Drain Area:	Southwest	GPS Accuracy:	Nearest Meter
Cover Shape:	Circular	Evidence of Surcharge:	No
Cover Size:	22.5	Potential for Runoff:	None
Comments:

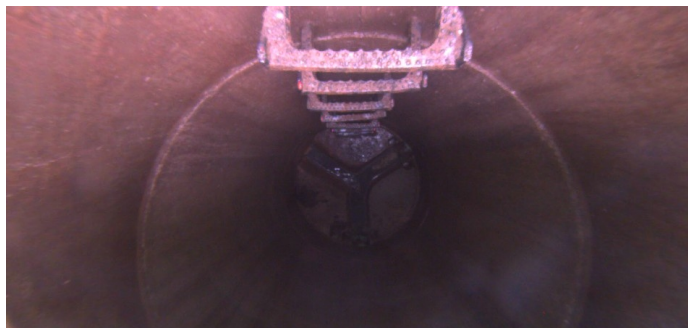
Code: **MGP**
Description: **General Photo**

Distance (ft): **.0**
Structural Grade: **0**
O&M Grade: **0**
Clock Start/From:
Clock To:
1st Value:
2nd Value:
Value Percent:
Step: **NO**
Remarks:

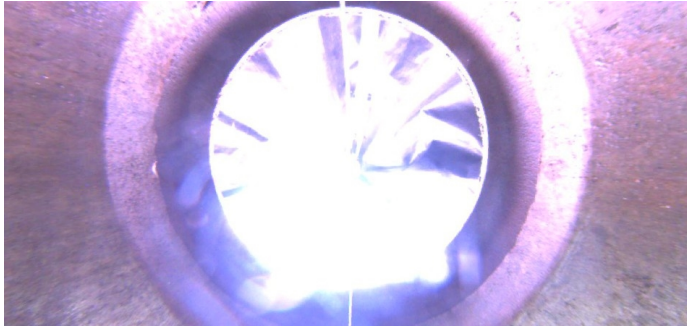
Code: **MGP**
Description: **General Photo**

Distance (ft): **2.2**
Structural Grade: **0**
O&M Grade: **0**
Clock Start/From:
Clock To:
1st Value:
2nd Value:
Value Percent:
Step: **NO**
Remarks:

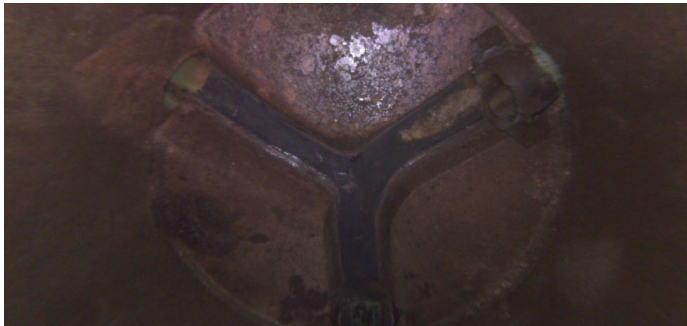
Code: **MGO**
Description: **General Observation**

Distance (ft): **6.5**
Structural Grade: **0**
O&M Grade: **0**
Clock Start/From:
Clock To:
1st Value:
2nd Value:
Value Percent:
Step: **NO**
Remarks: **Ins. Comp.**
