Manhole Inspection Report

Date:	03/28/2018	Weather:		Coding:	RZMACP
MH#:	M-507-072	Owner:	NA	Len. Surveyed:	6.9
P.O.#:		Surveyor:	John Kuglmaier	Rim to Invert:	7.1
Customer:		Cert. #:	U-1215-07002349	Wall Material:	Concrete (reinforced)

Street:	Csokasy Ct. to the Northeast.	Project:	Hobart, IN
City:	Hobart, IN	GPS Northing:	0.0
Location:		GPS Easting:	0.0
Drain Area:	Southwest	GPS Accuracy:	Nearest Meter
Cover Shape:	Circular	Evidence of Surcharge:	No
Cover Size:	22.5	Potential for Runoff:	None
Comments:

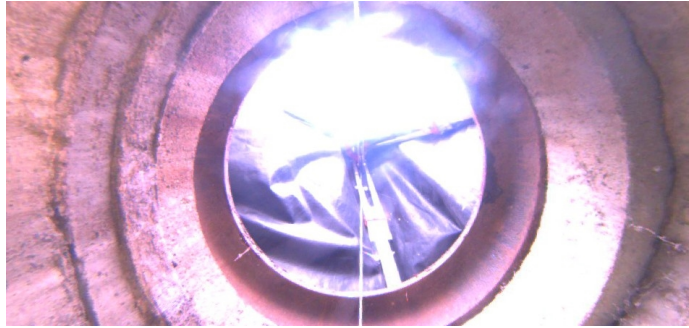
Code: **MGP**
Description: **General Photo**

Distance (ft): **2.8**
Structural Grade: **0**
O&M Grade: **0**
Clock Start/From:
Clock To:
1st Value:
2nd Value:
Value Percent:
Step: **NO**
Remarks:

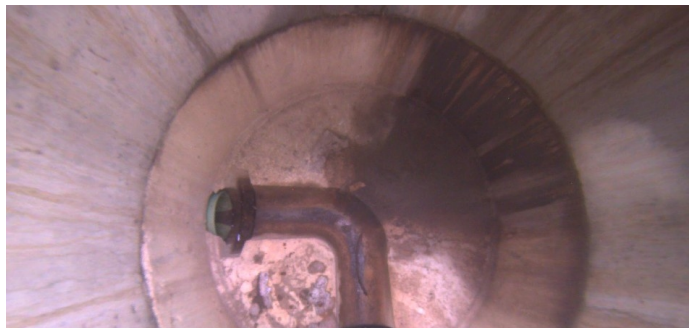
Code: **IS**
Description: **Infil Stain**

Distance (ft): **3.1**
Structural Grade: **0**
O&M Grade: **0**
Clock Start/From: **1**
Clock To: **4**
1st Value:
2nd Value:
Value Percent:
Step: **NO**
Remarks:

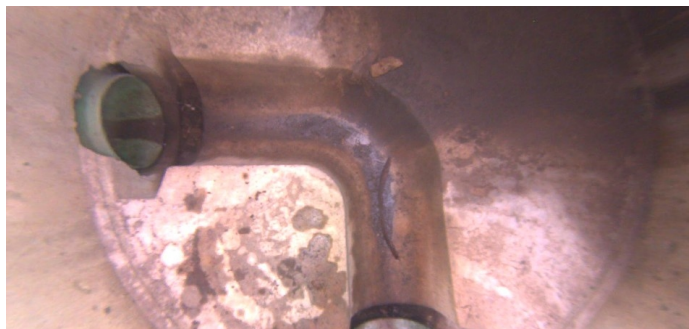
Code: **MGO**
Description: **General Observation**

Distance (ft): **5.1**
Structural Grade: **0**
O&M Grade: **0**
Clock Start/From:
Clock To:
1st Value:
2nd Value:
Value Percent:
Step: **NO**
Remarks: **Ins. Comp.**
